Jonathan Bray Home Inspections  
P.O.Box 3971  
Fresno, CA 93650  
jbrayinspections@yahoo.com

# PROPERTY INSPECTION REPORT

Prepared Especially for Jimmy Cannizzaro  
1262 N. Marks Ave., Fresno 93722  
June 23, 2026

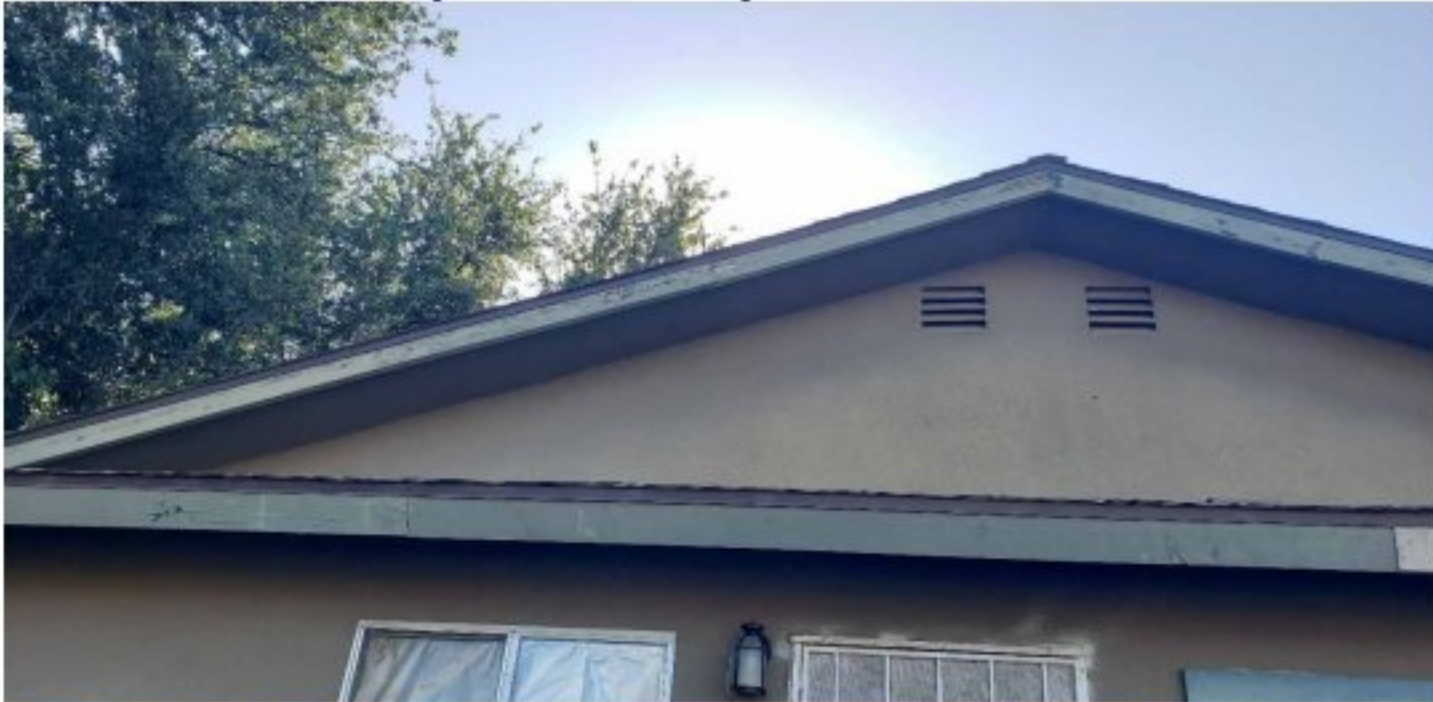
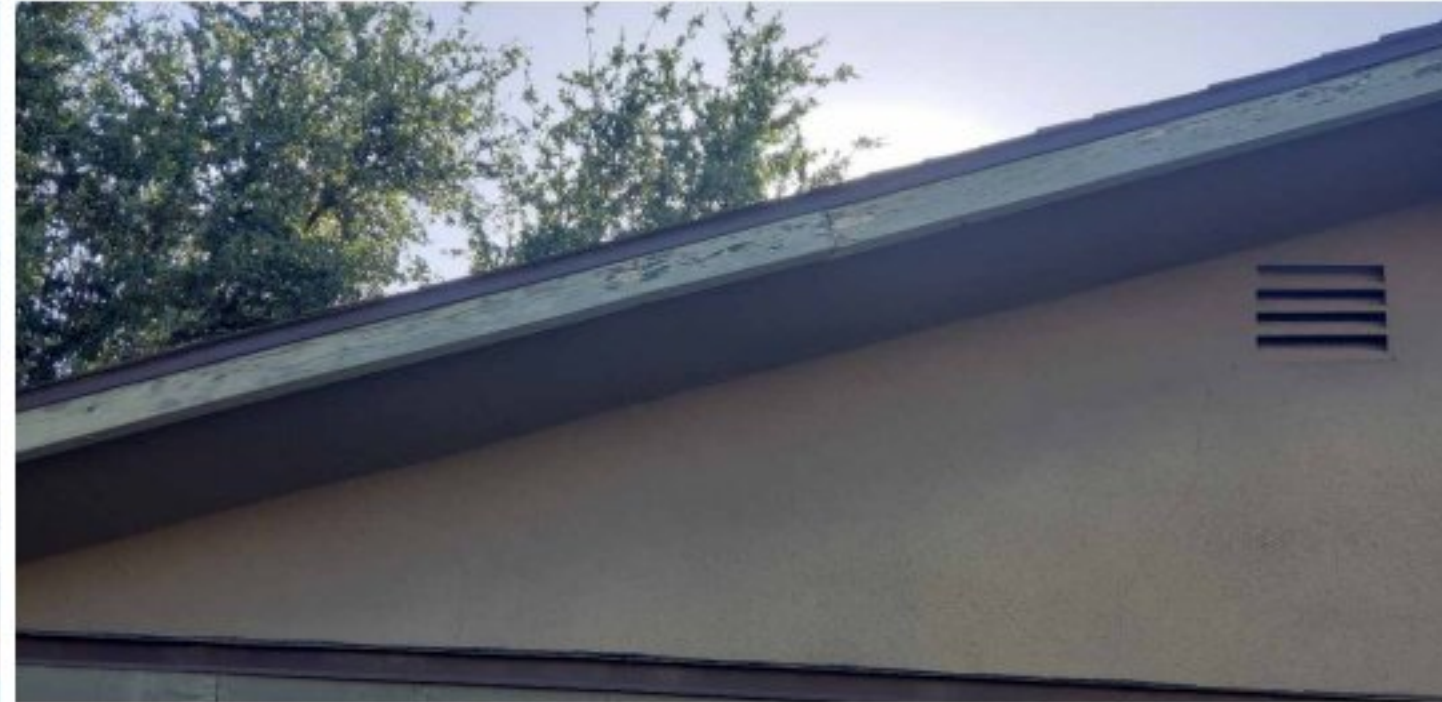
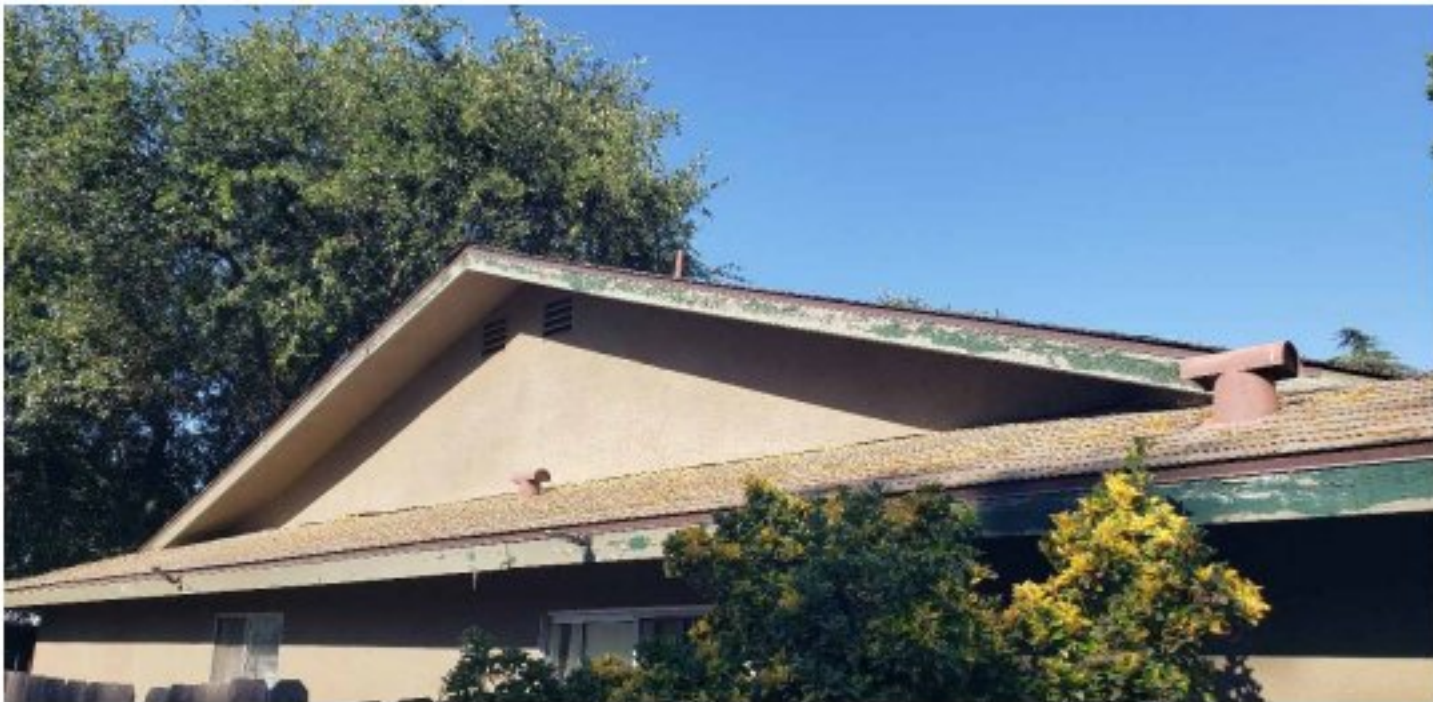
#### 1. Trim: Wood -

Chipping/peeling paint noted. Recommend keeping a good coat of paint on all exterior surfaces to prevent premature deterioration.

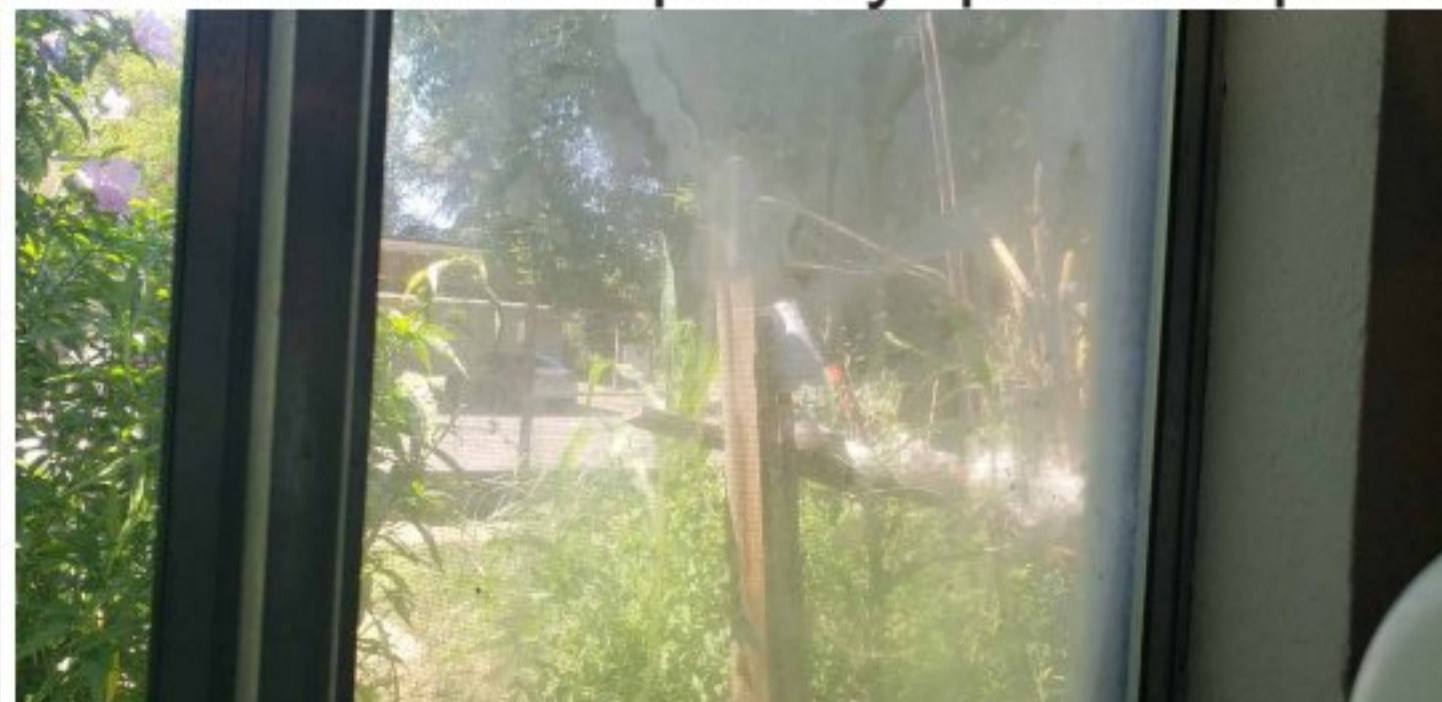
#### 2. Windows: Functional -

105, 120: Dual pane window noted to be fogged up indicating seal has failed. This not only allows condensation to build up between the panes, but also negates the energy efficiency of the window. Recommend evaluation and repair by qualified professional.

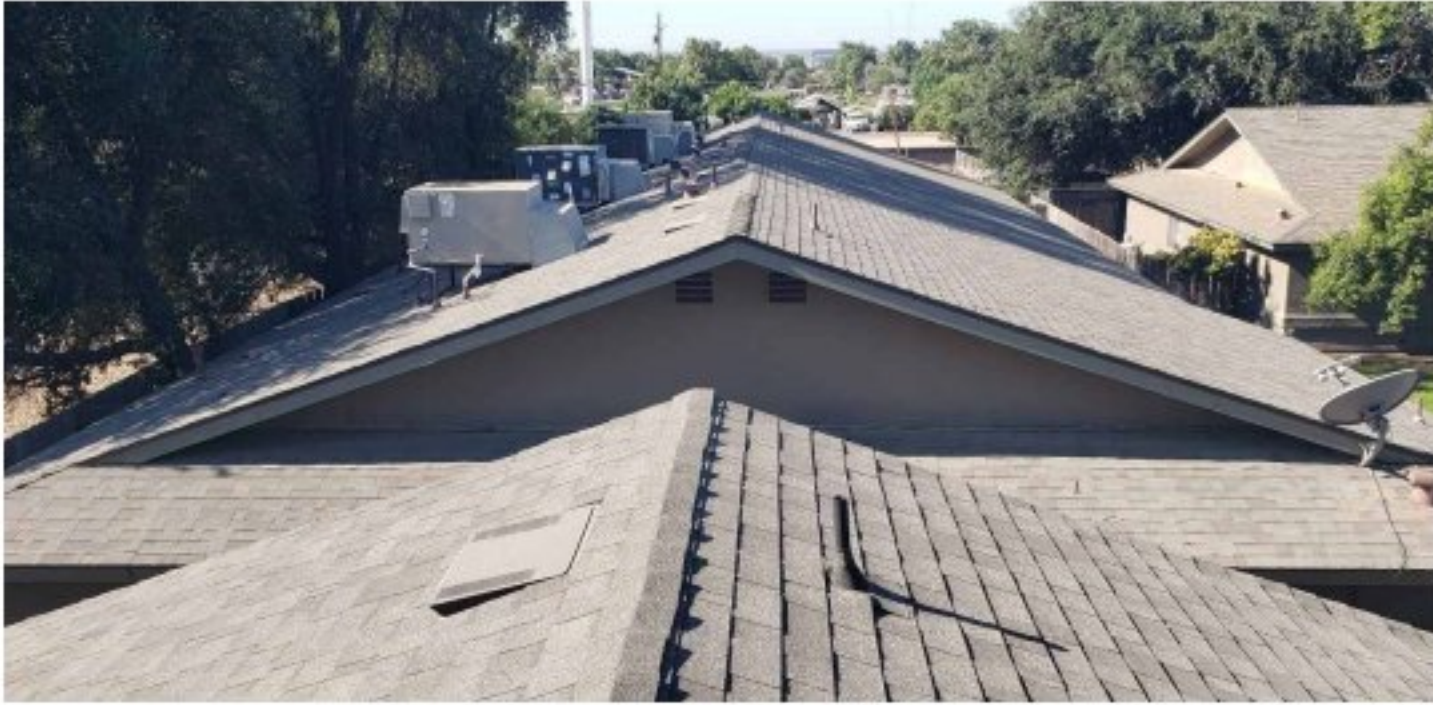
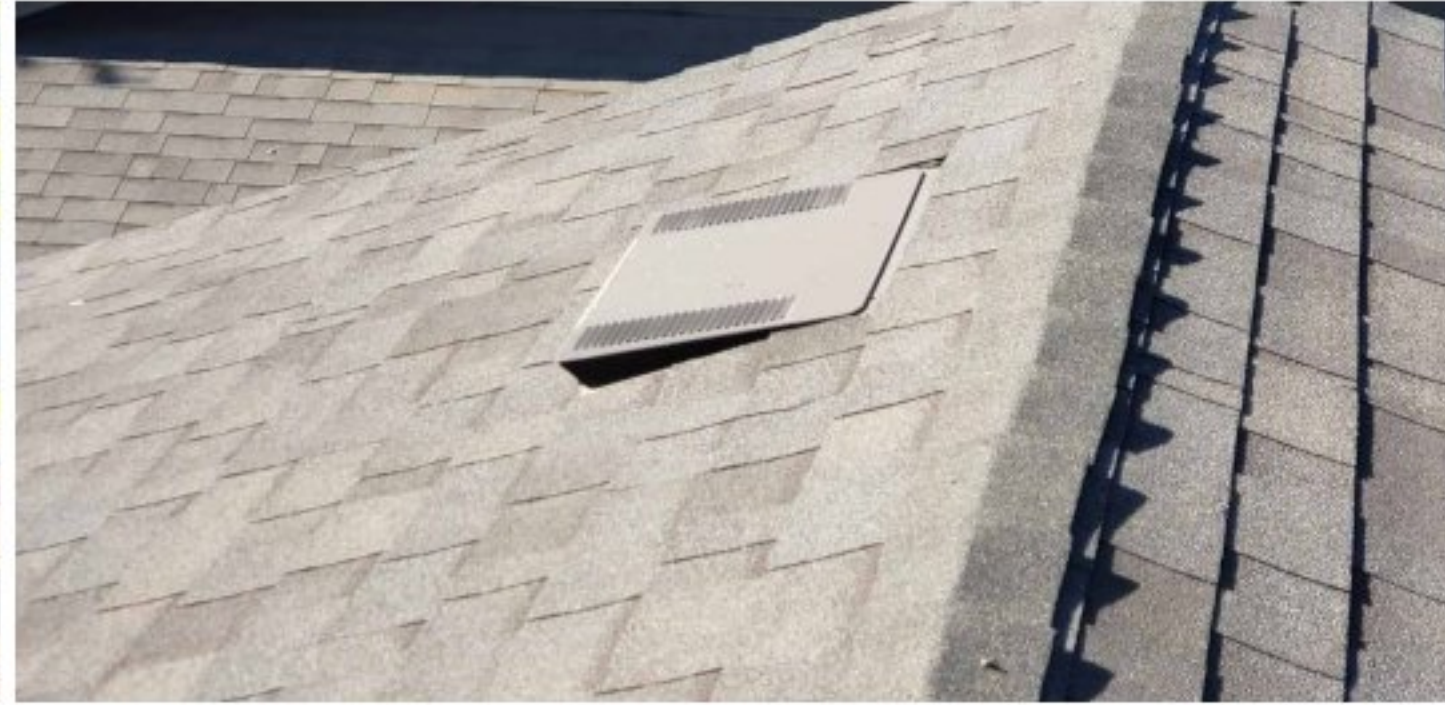
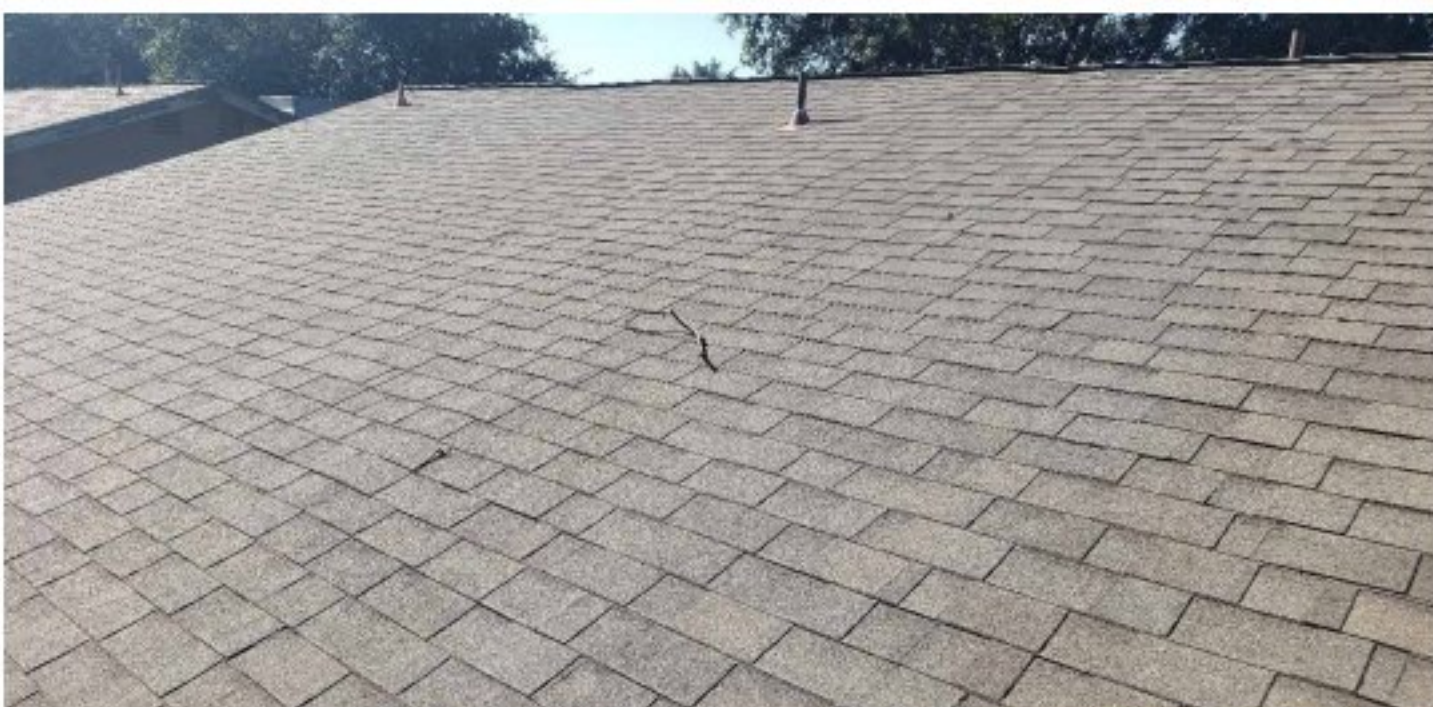
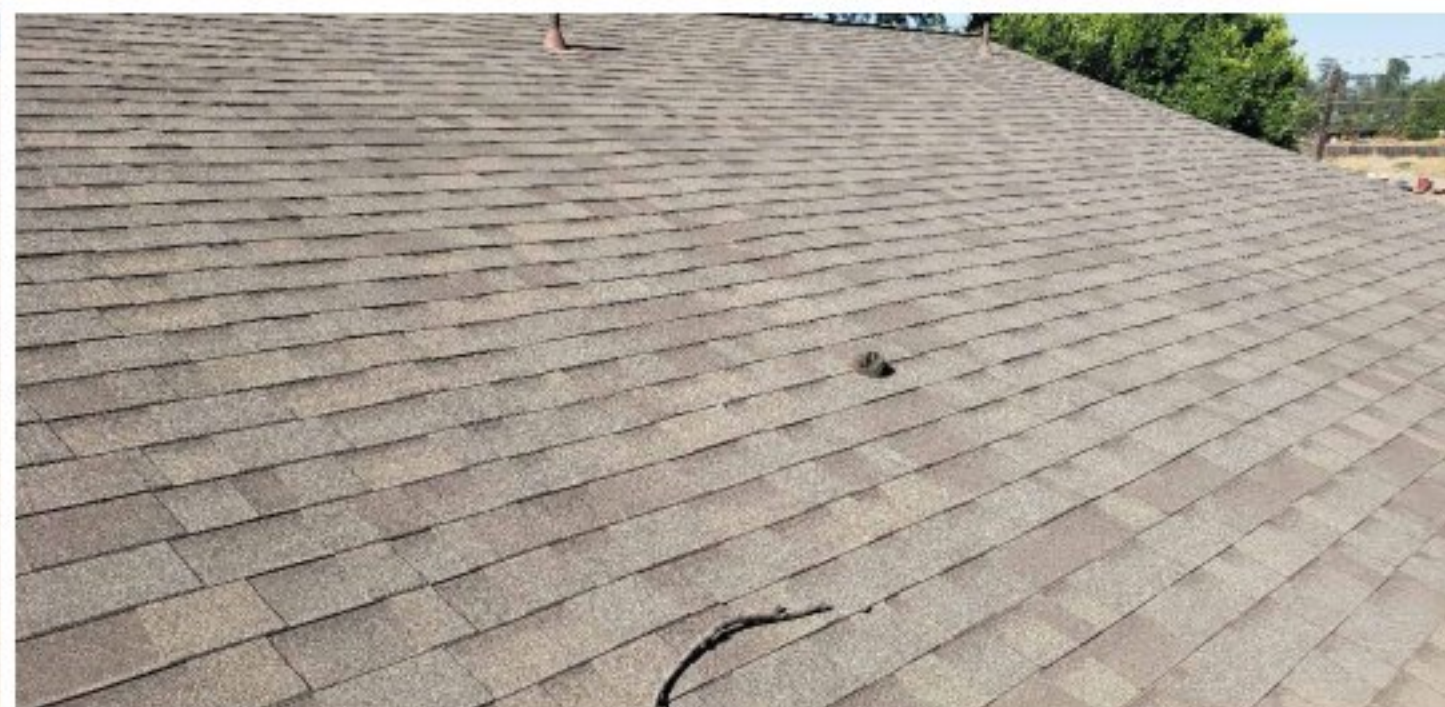
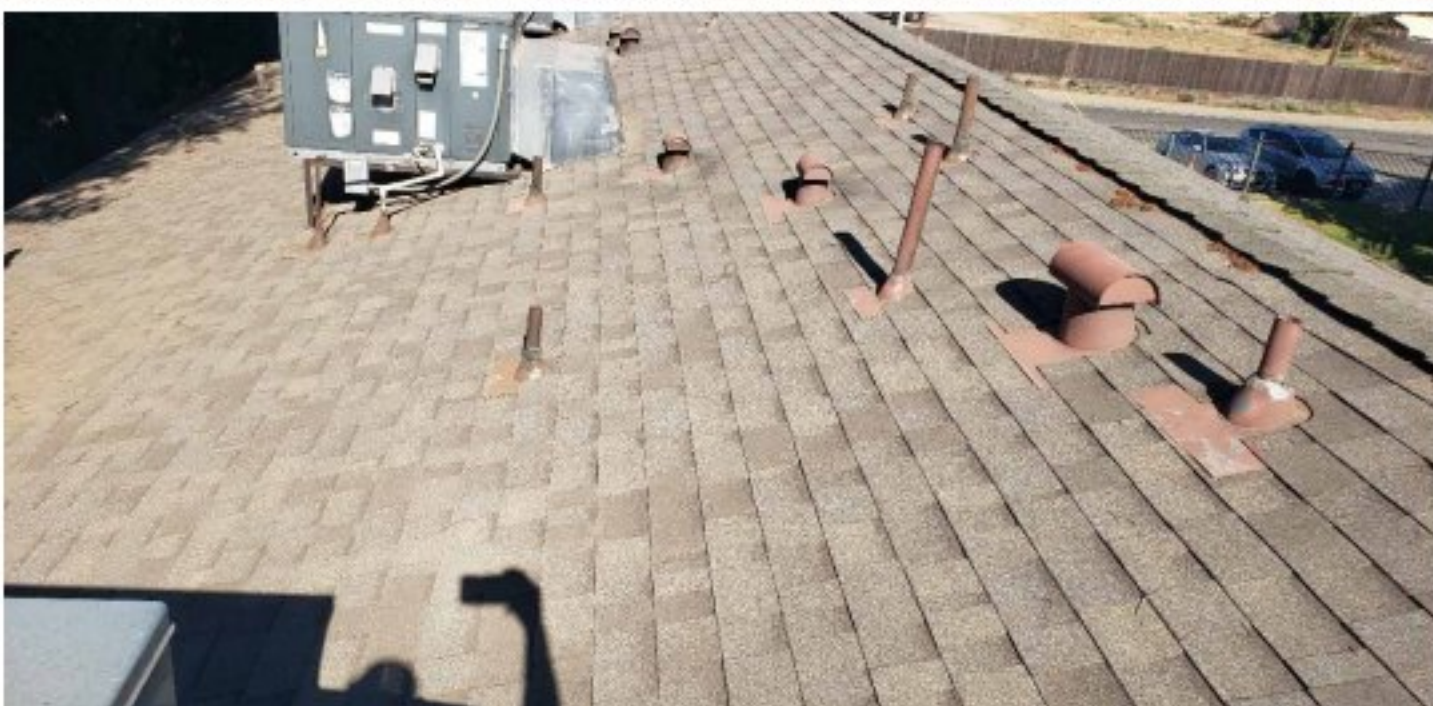
#### 3. Roof Surface Material: Asphalt shingle (Approx. 10-12 yrs. Old) -

Recommend keeping leaves and debris off of roof materials to prevent premature damage.

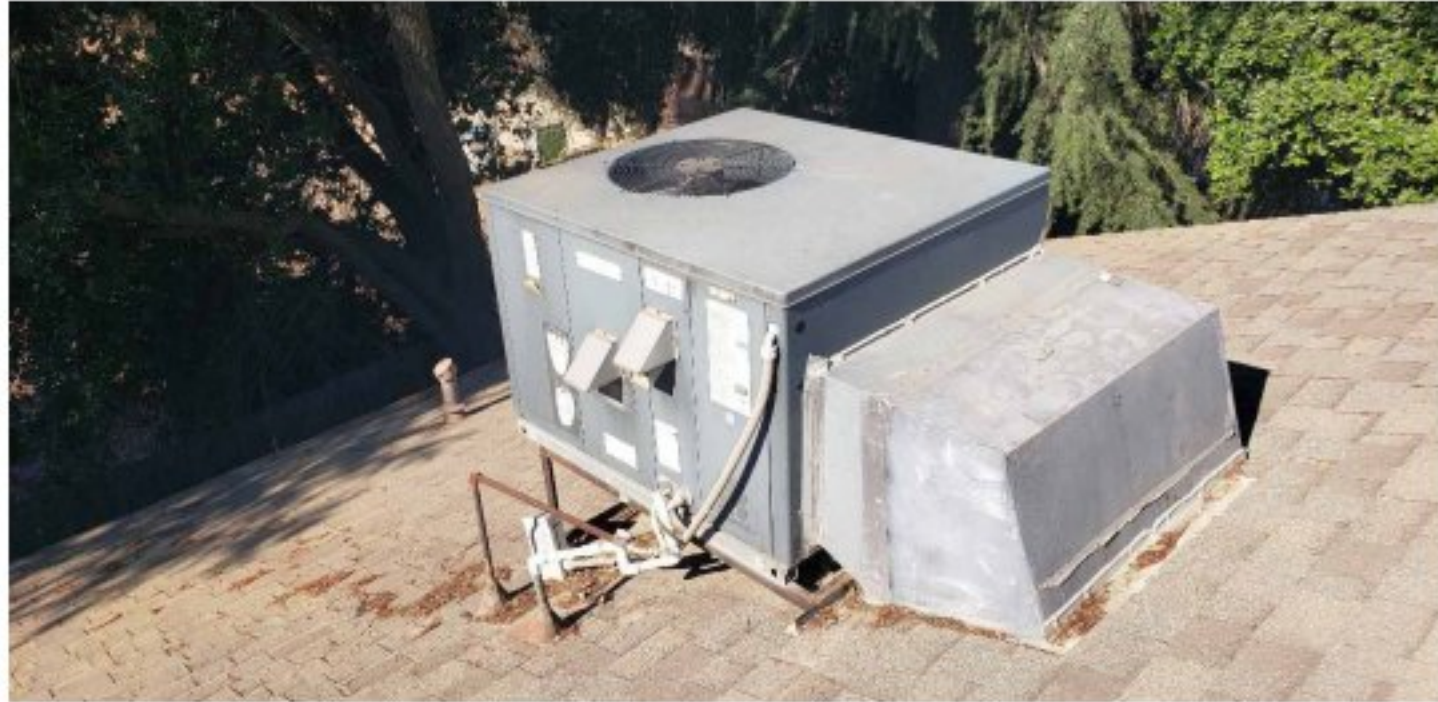
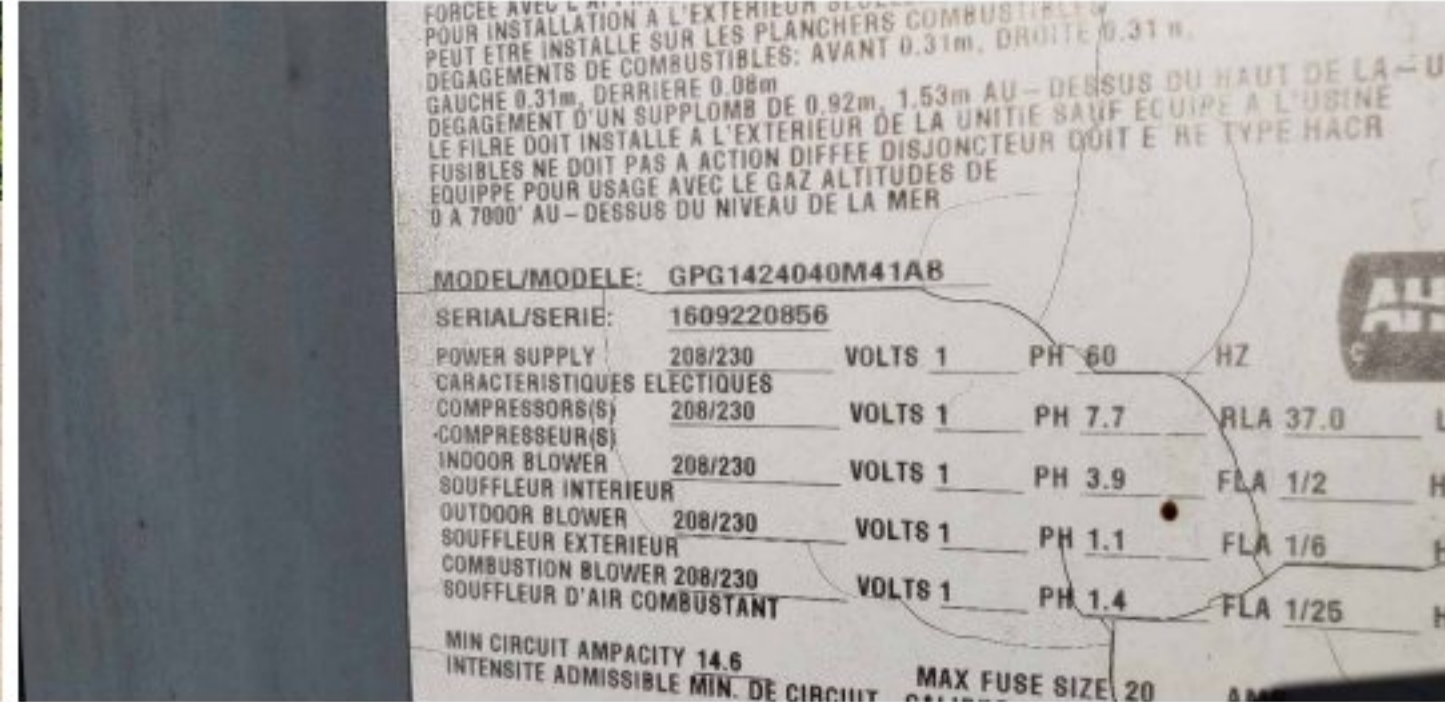
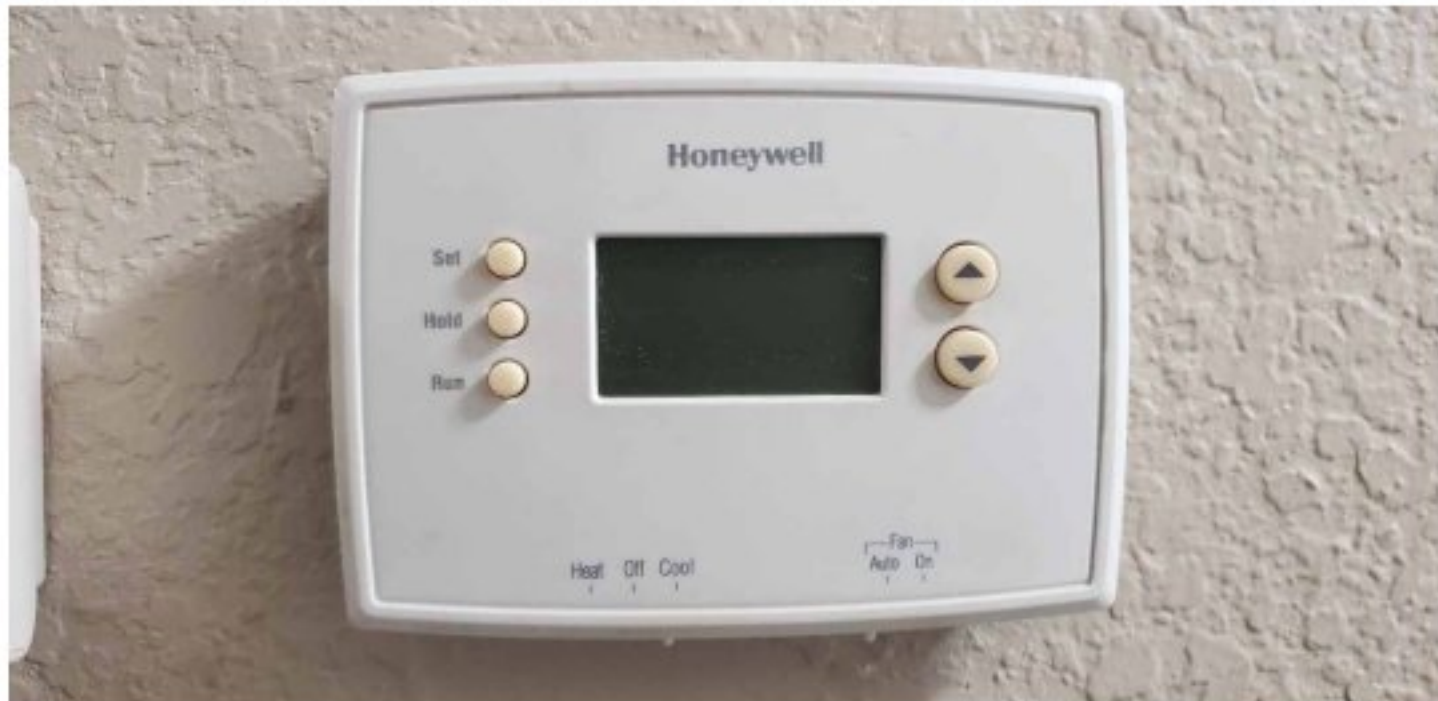
4. **AC System A/C System Operation:** Appears serviceable -  
Unit 101: Thermostat batteries dead. Not able to test.

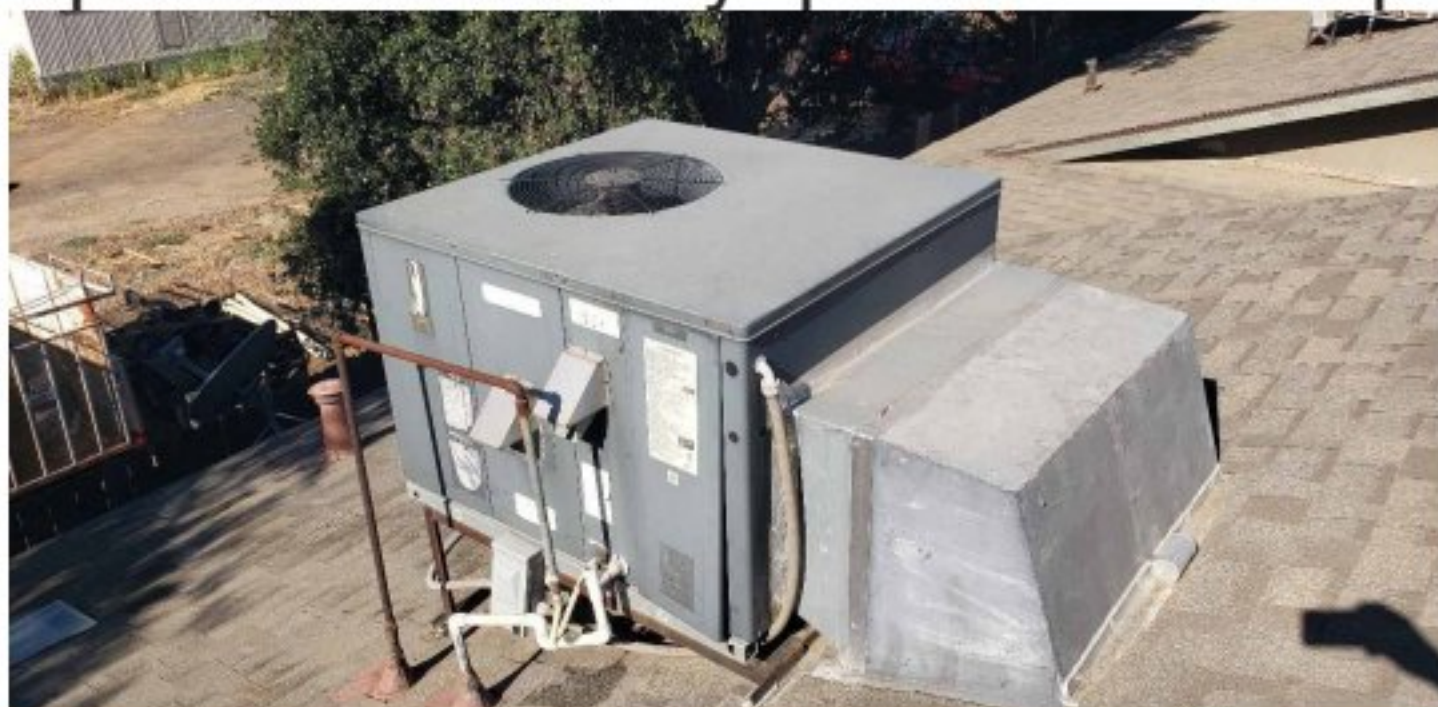
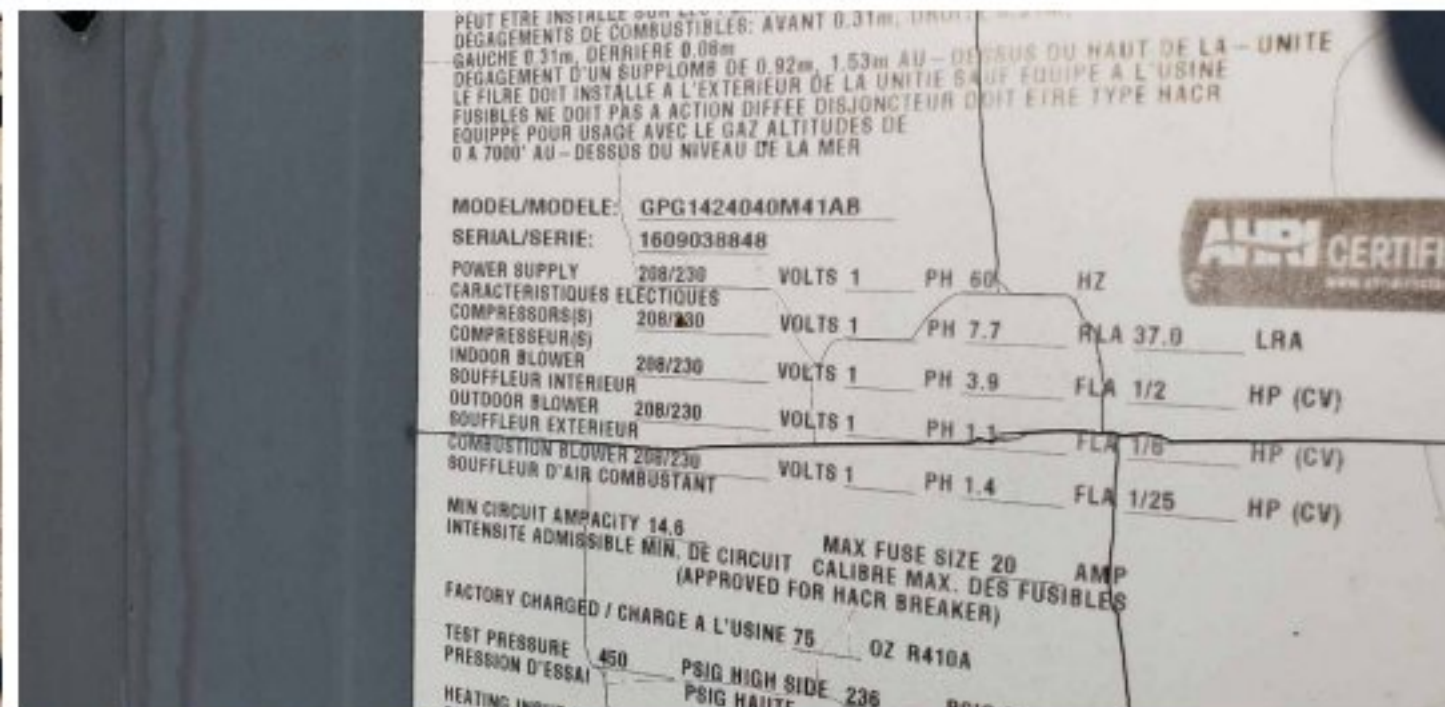
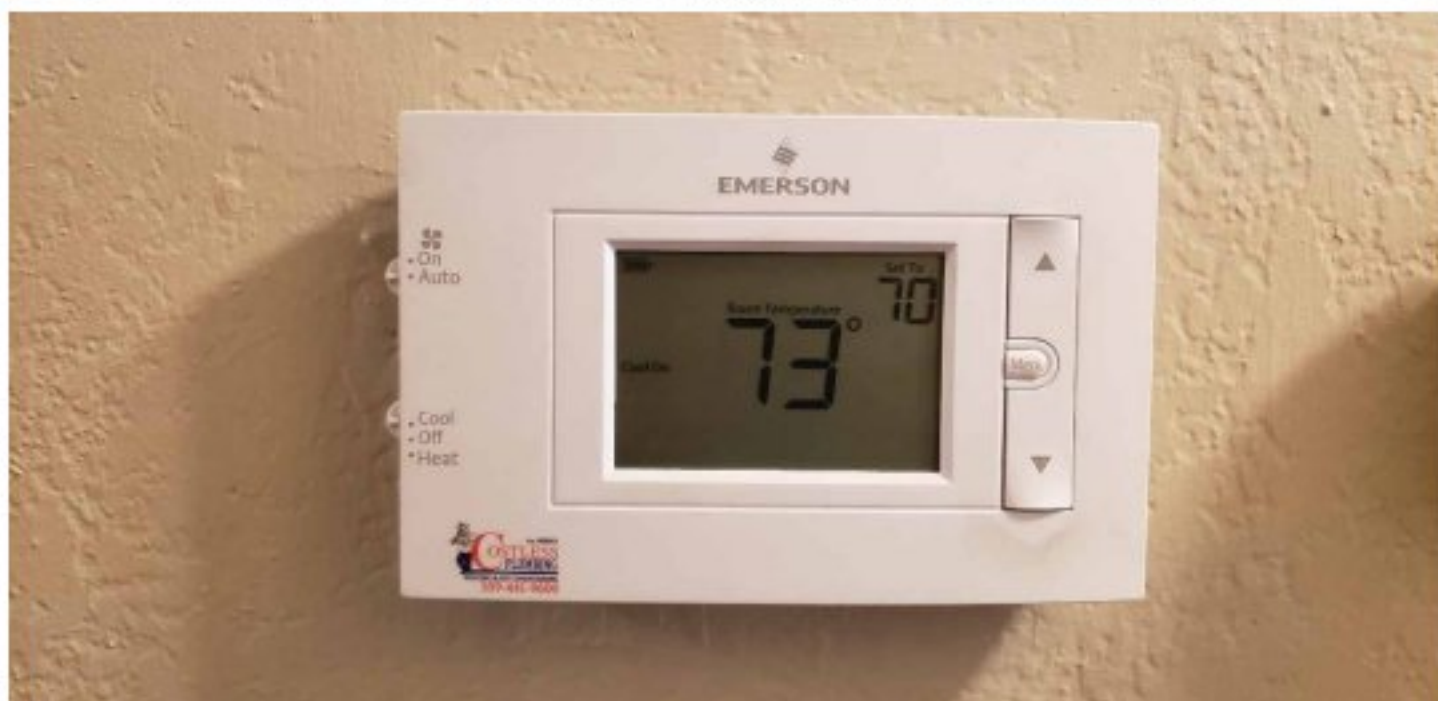
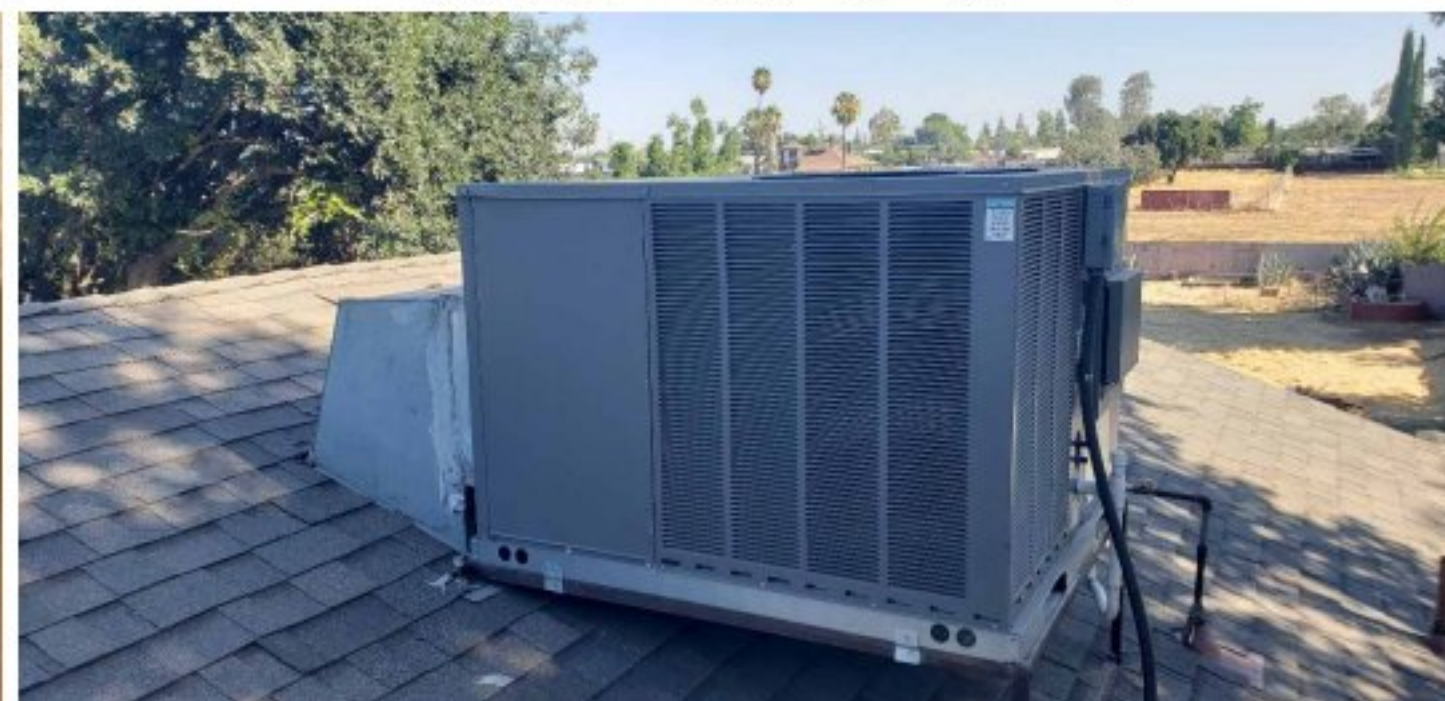
- 5. AC System A/C System Operation:** Appears serviceable -  
 104, 115, 117: Air coming out of vents was not cooled as expected. Temperature differential did not reach the desired -18 to -25 degree. Recommend evaluation and repair as needed by qualified HVAC professional.

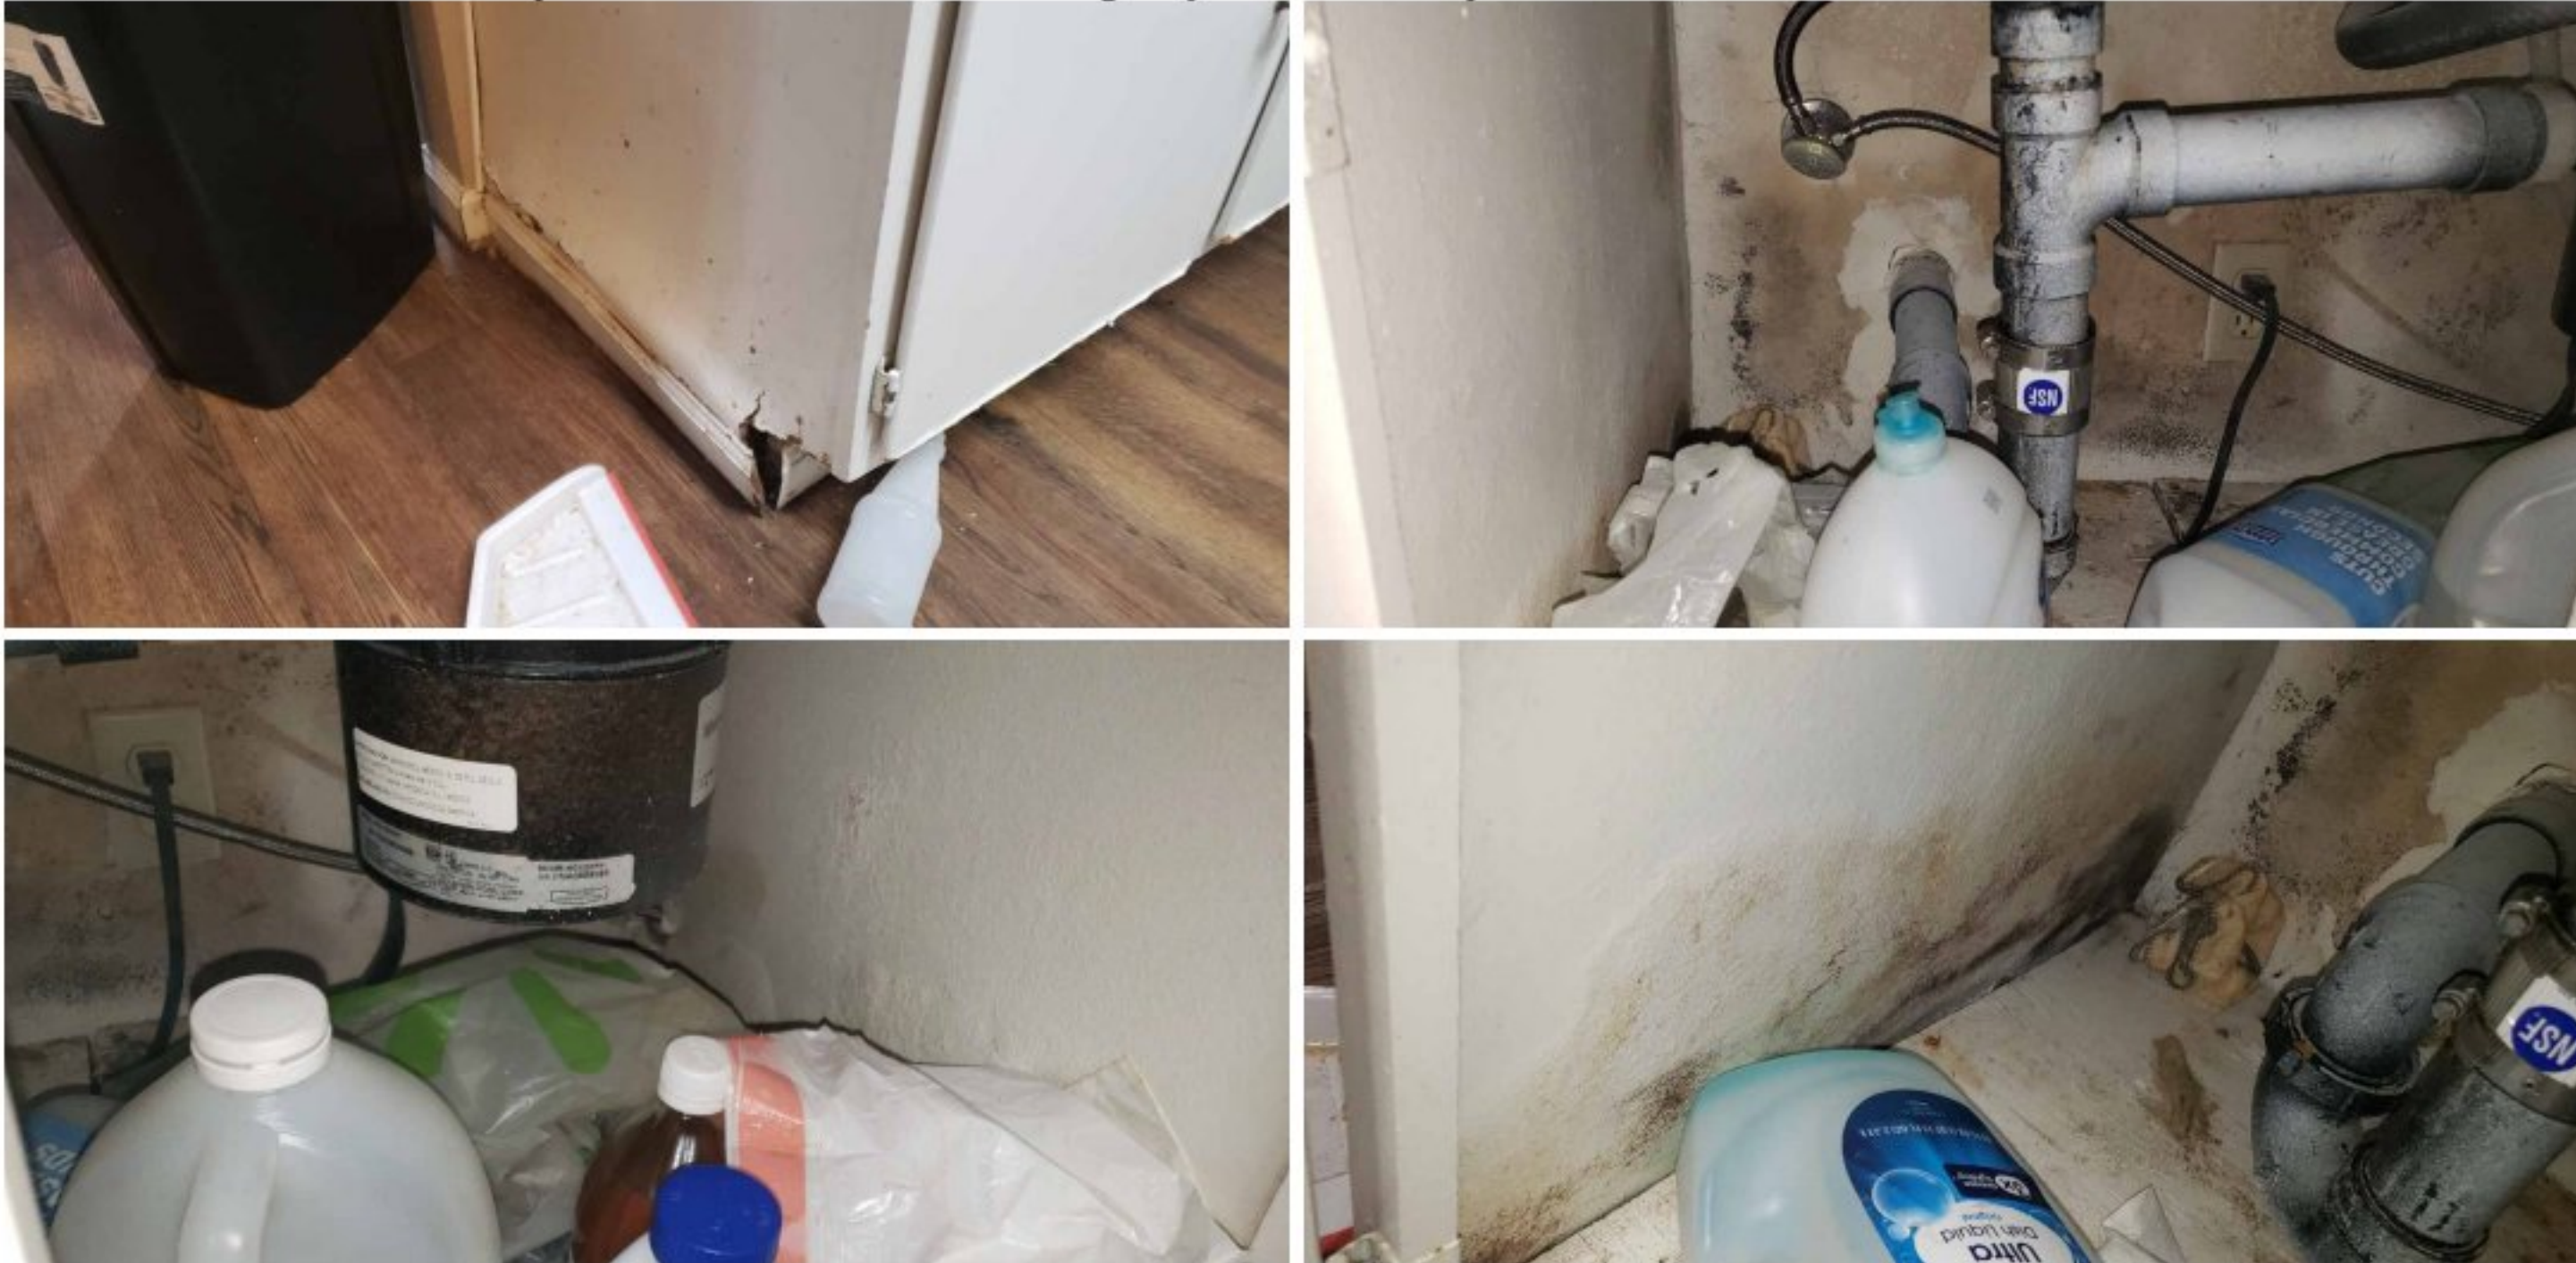
#### 11. Kitchen Kitchen finishes: Solid surface tops and wood cabinets -

121: Kitchen cabinet noted to be water damaged under kitchen sink. Recommend evaluation and repair as needed by qualified professional.

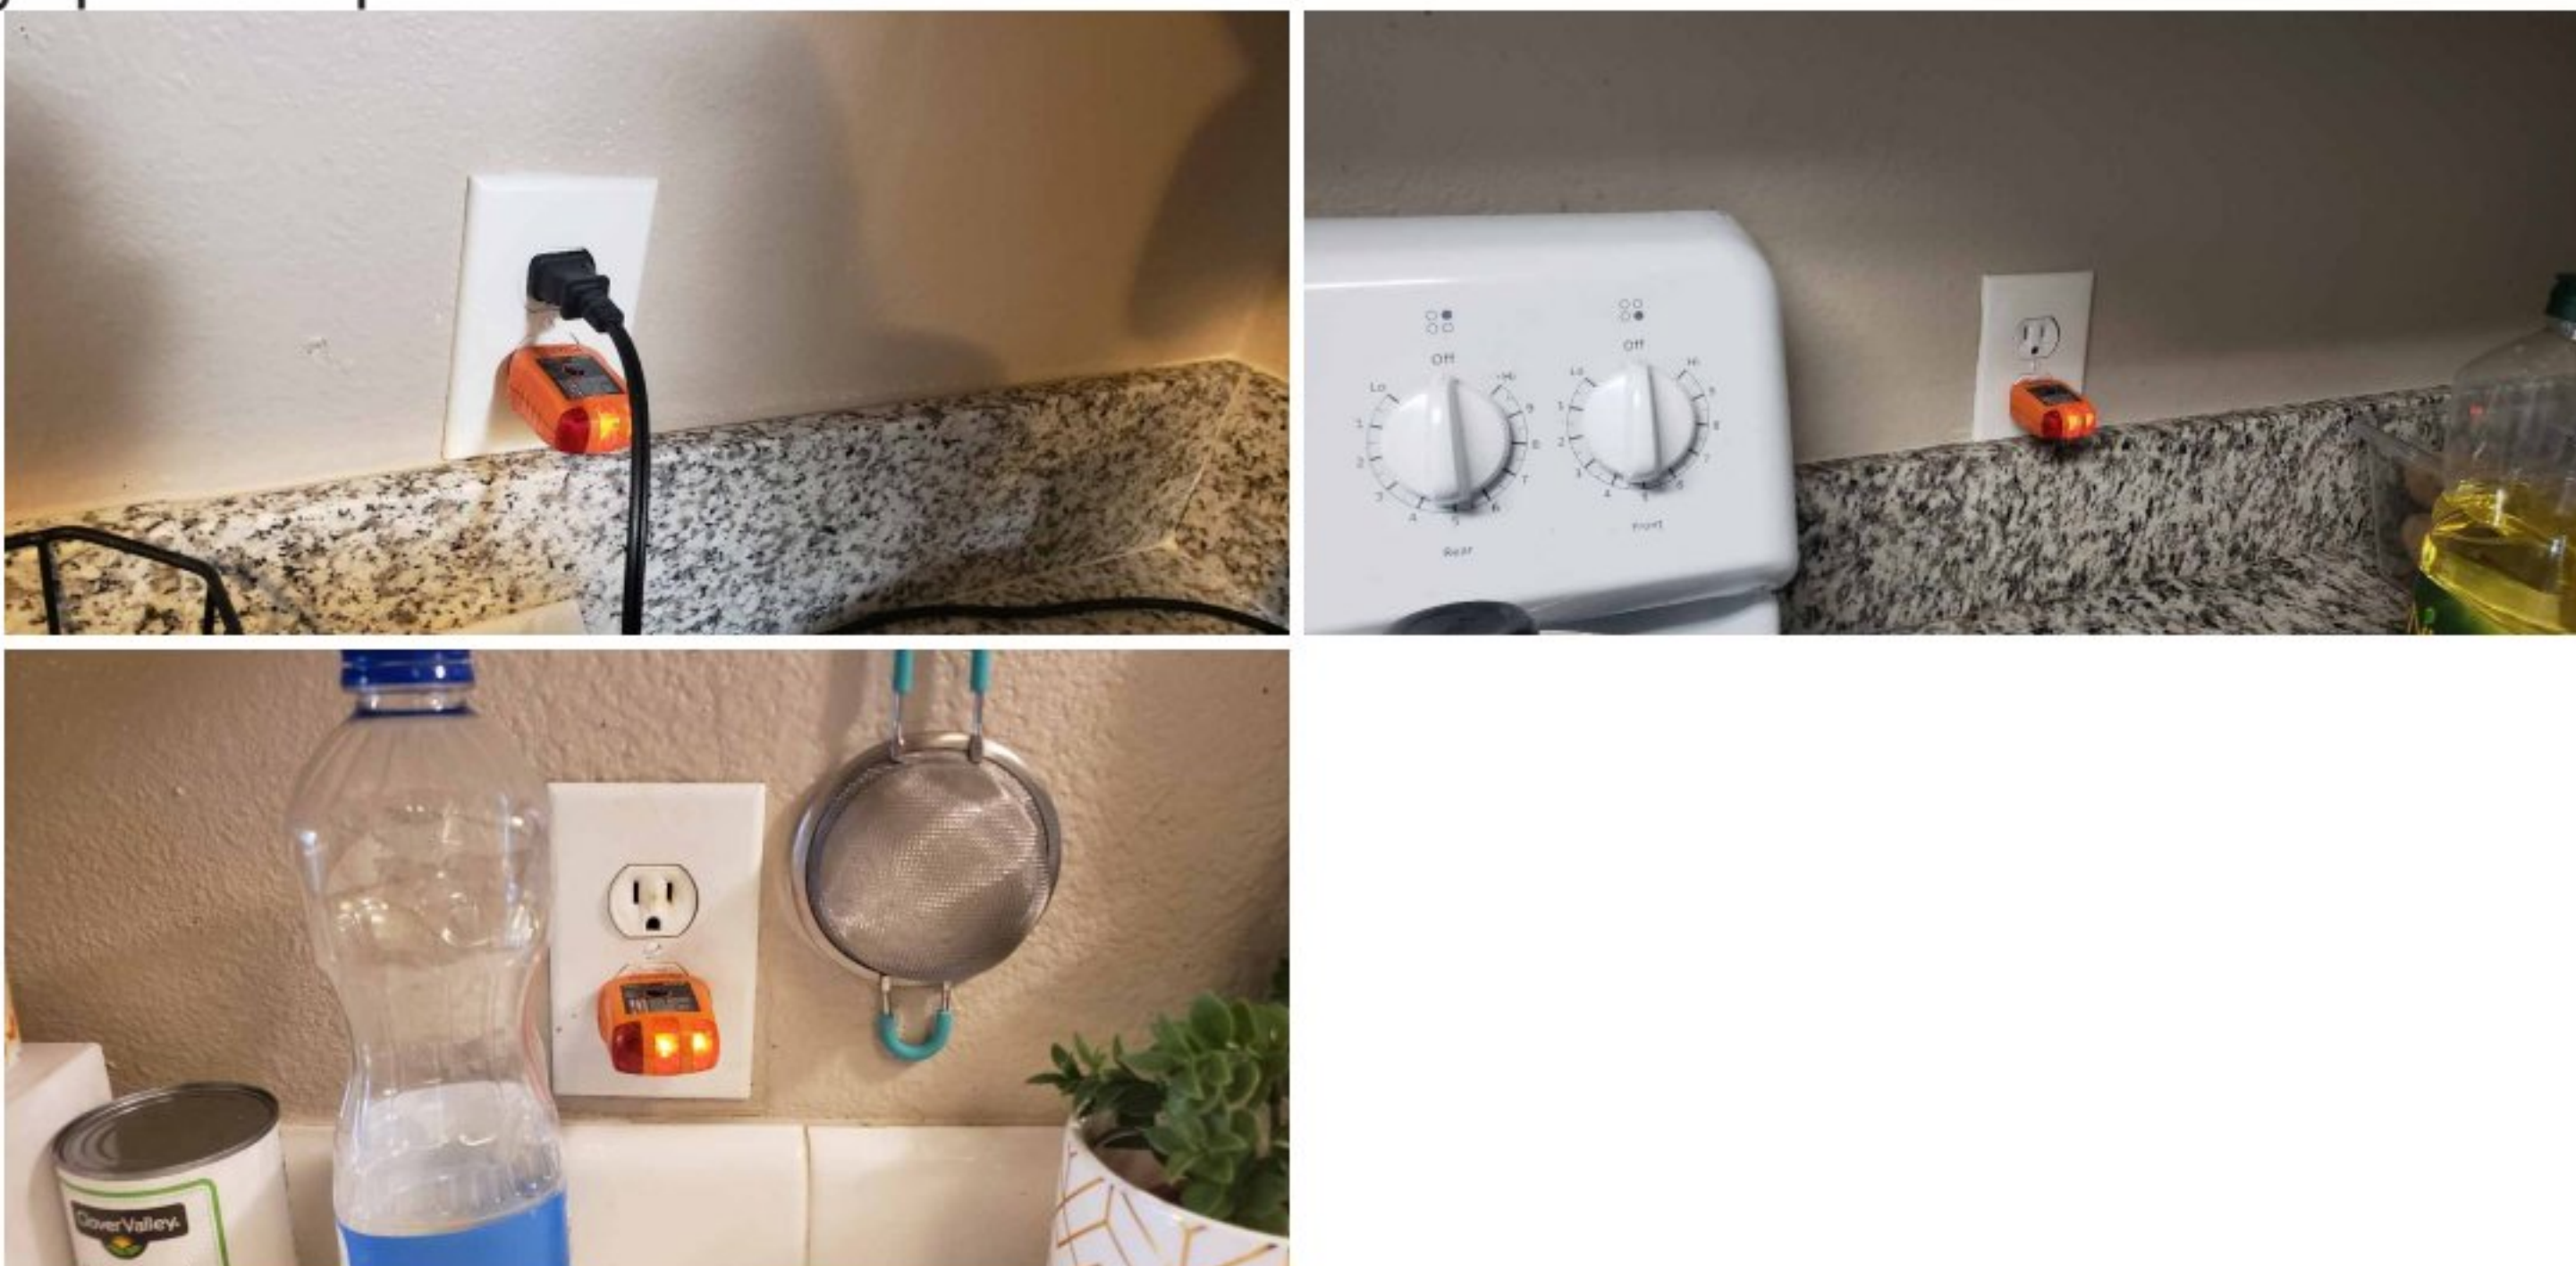
#### 12. Kitchen Electrical: 110 VAC outlets and lighting circuits -

104, 105, 113: Kitchen outlets are recommended to be protected by GFCI outlets. No GFCI protection was detected in kitchen. Recommend evaluation and repair as needed by qualified professional.
