Jonathan Bray Home Inspections  
P.O.Box 3971  
Fresno, CA 93650  
jbrayinspections@yahoo.com

# PROPERTY INSPECTION REPORT

Prepared Especially for Jimmy Cannizzaro  
1262 N. Marks Ave., Fresno 93722  
June 23, 2026

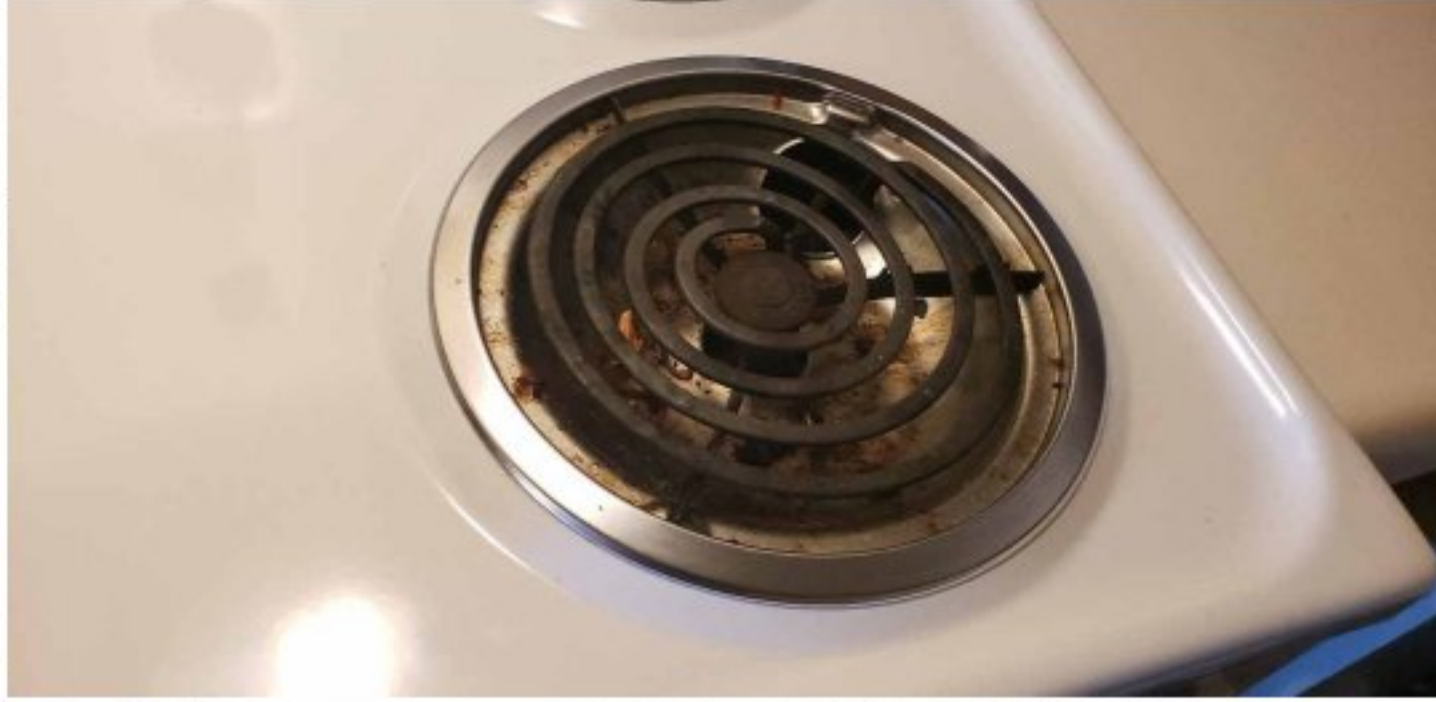
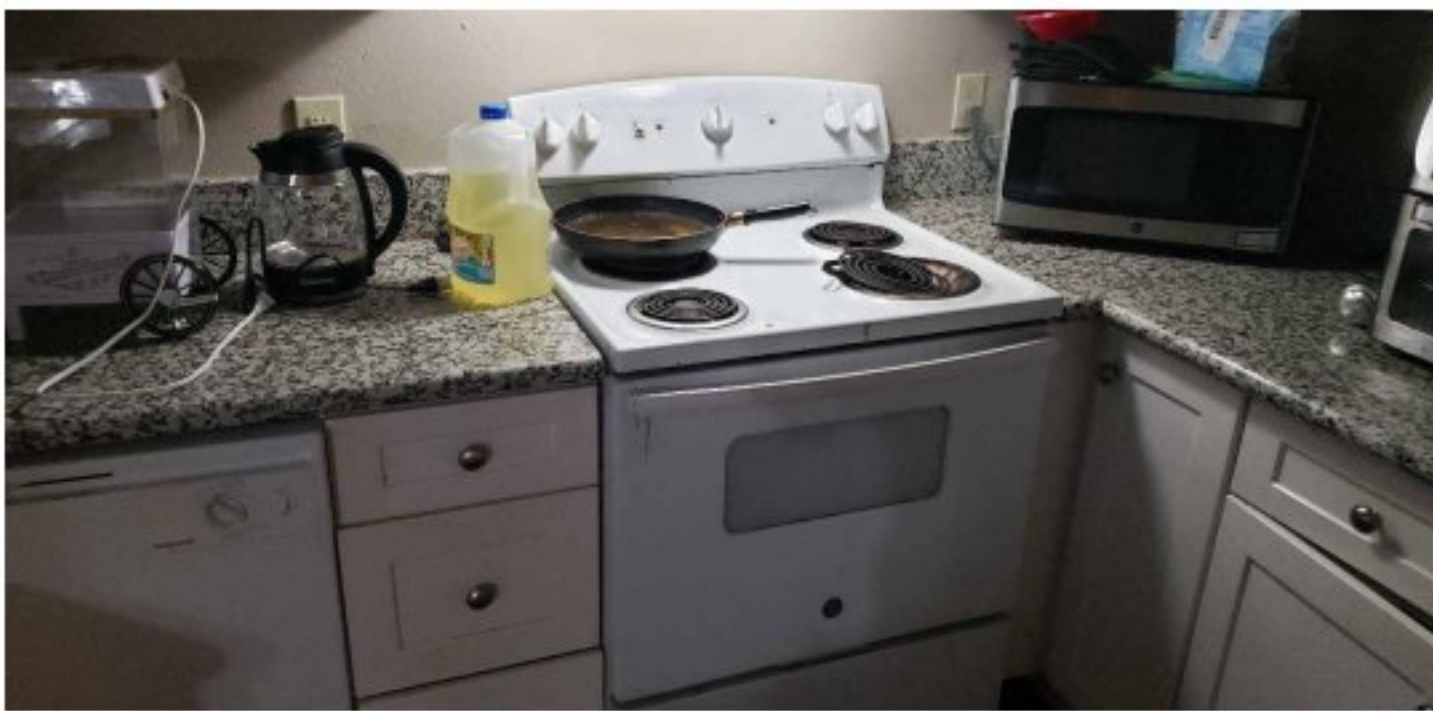
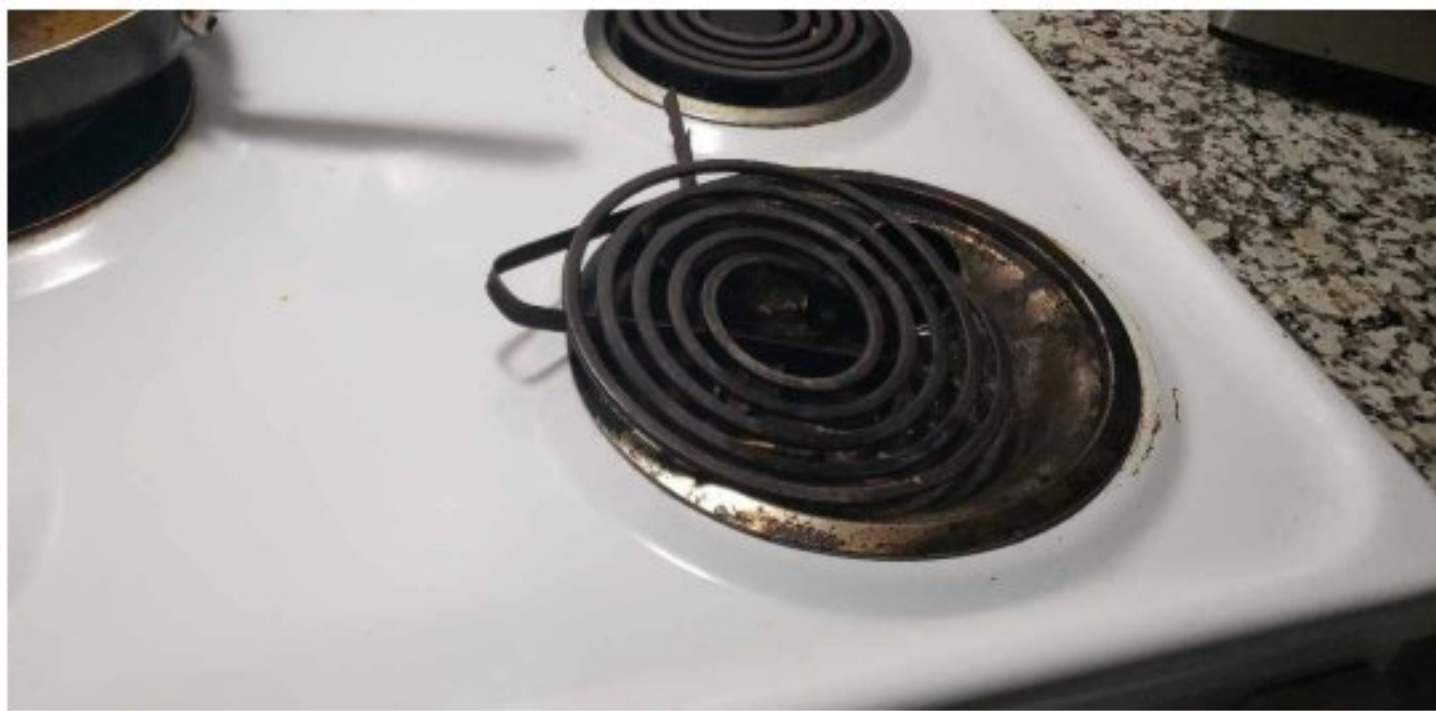
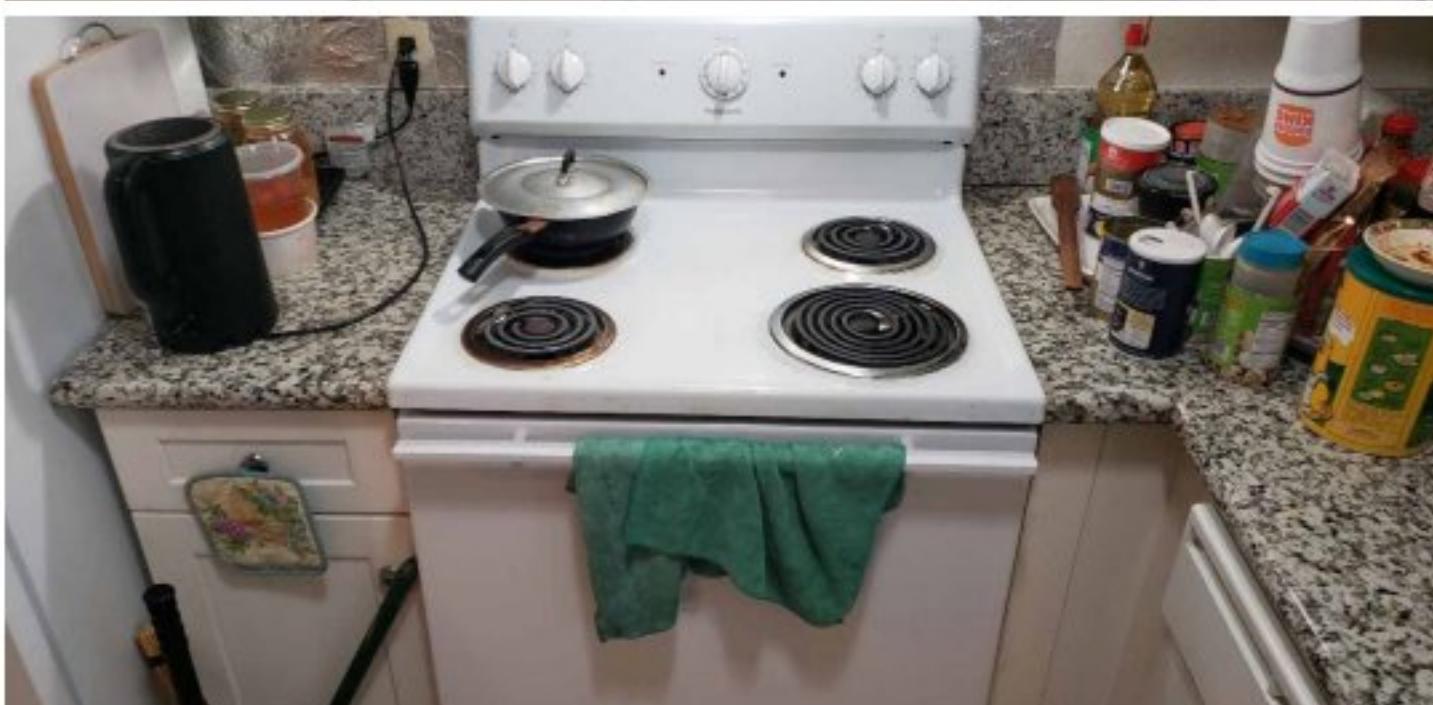
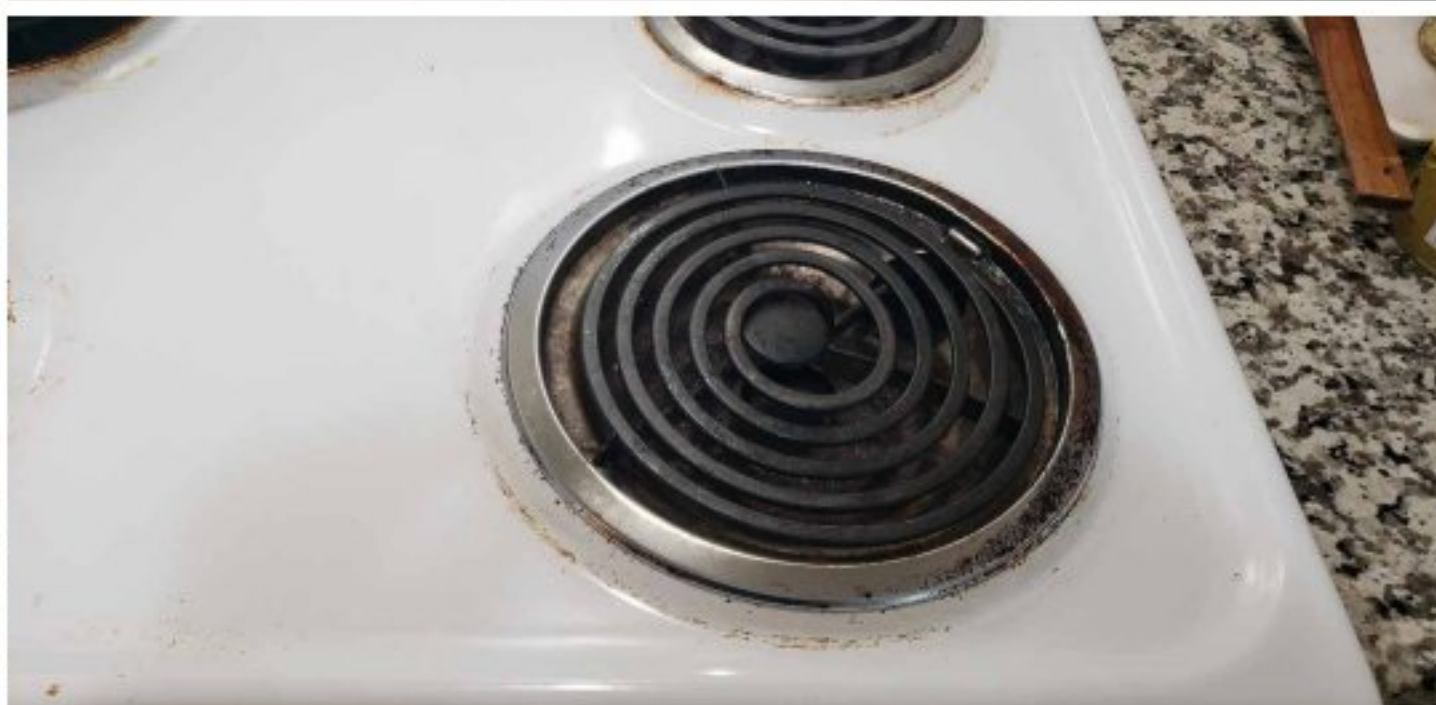
### 13. Kitchen Oven: Functional -

110, 117, 120: Front right burner did not turn on when tested. Recommend evaluation and repair as needed by qualified professional.

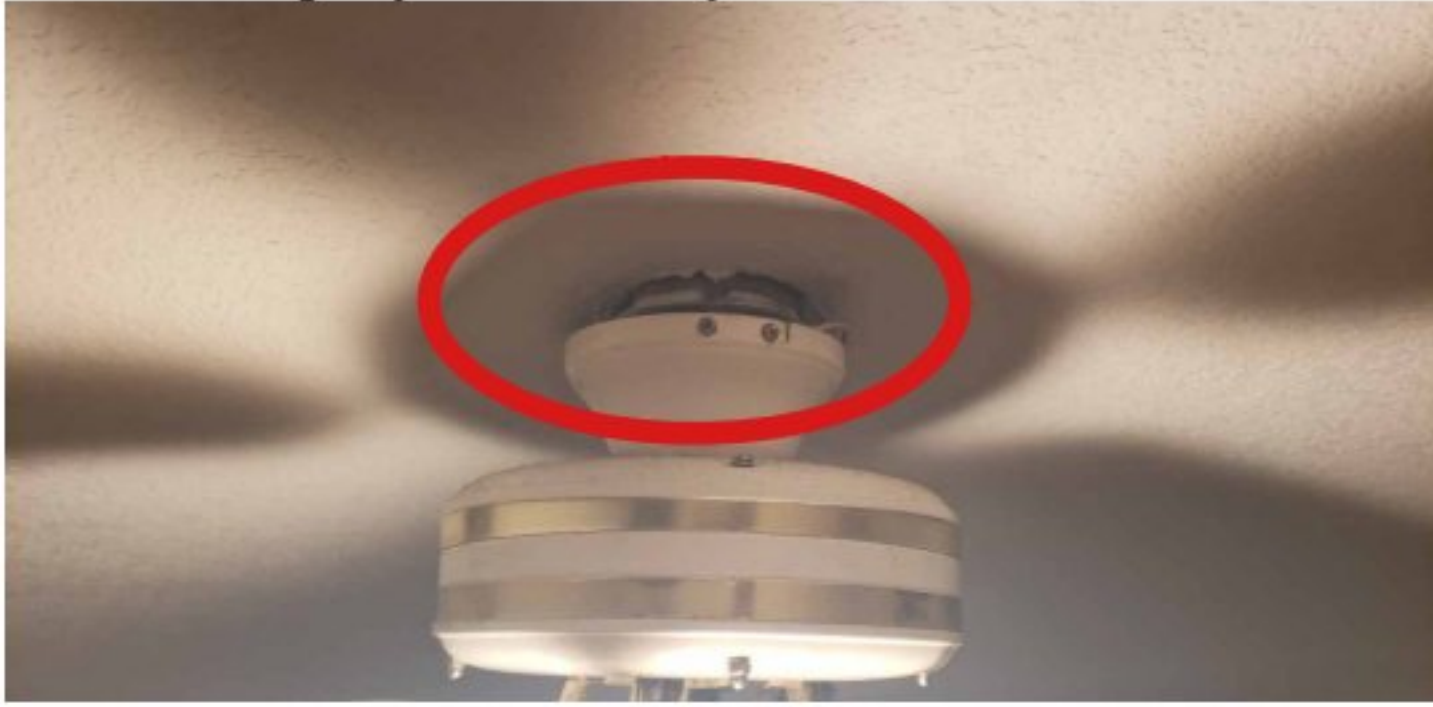
#### 15. Living Space Electrical: 110 VAC outlets and lighting circuits -

122: Ceiling fan noted to be loose to the ceiling. Recommend evaluation and repair as needed by qualified professional.

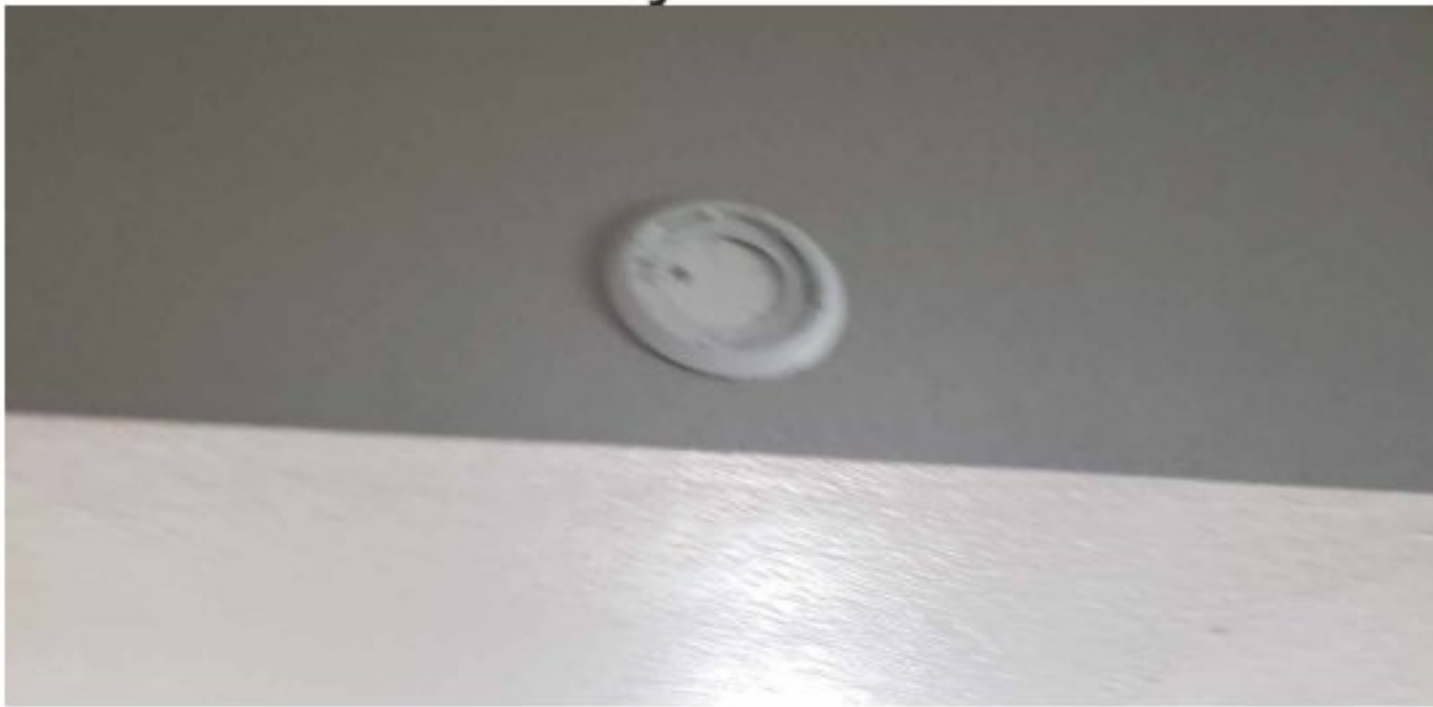
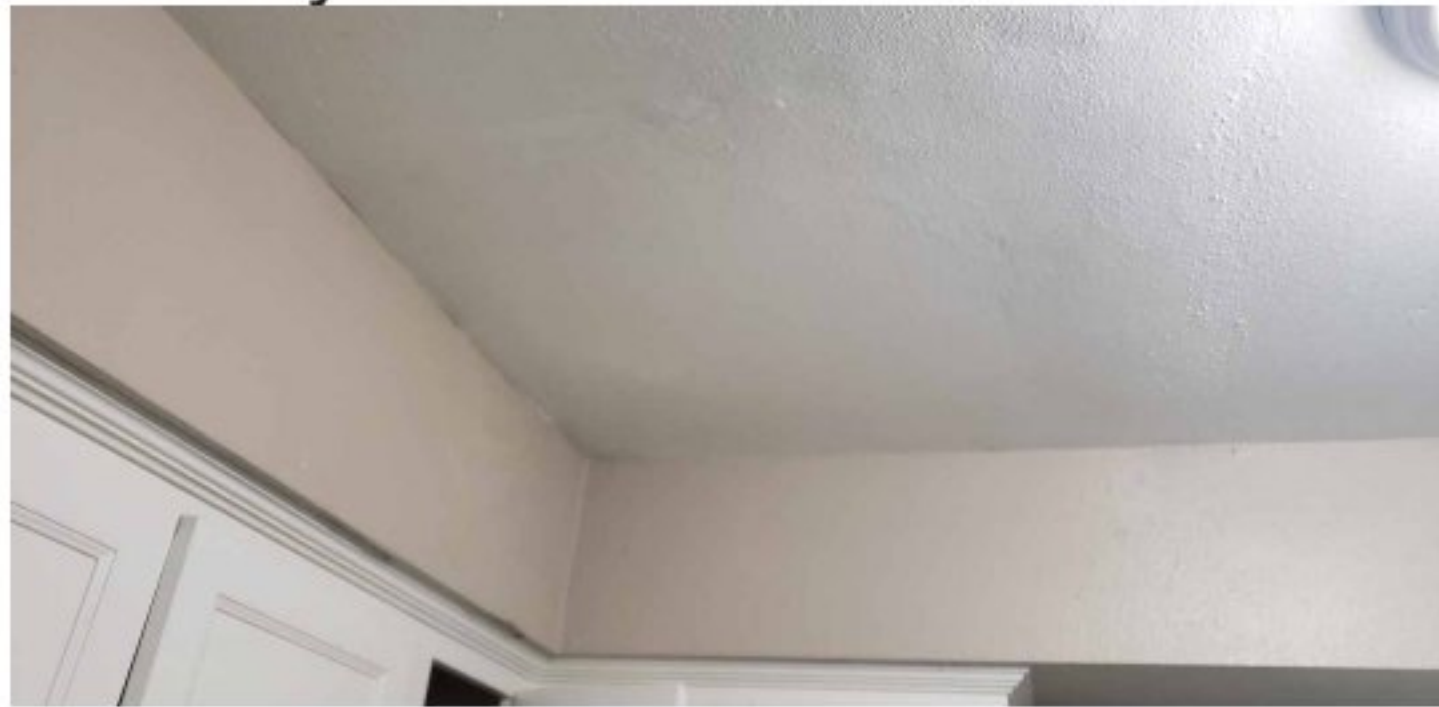
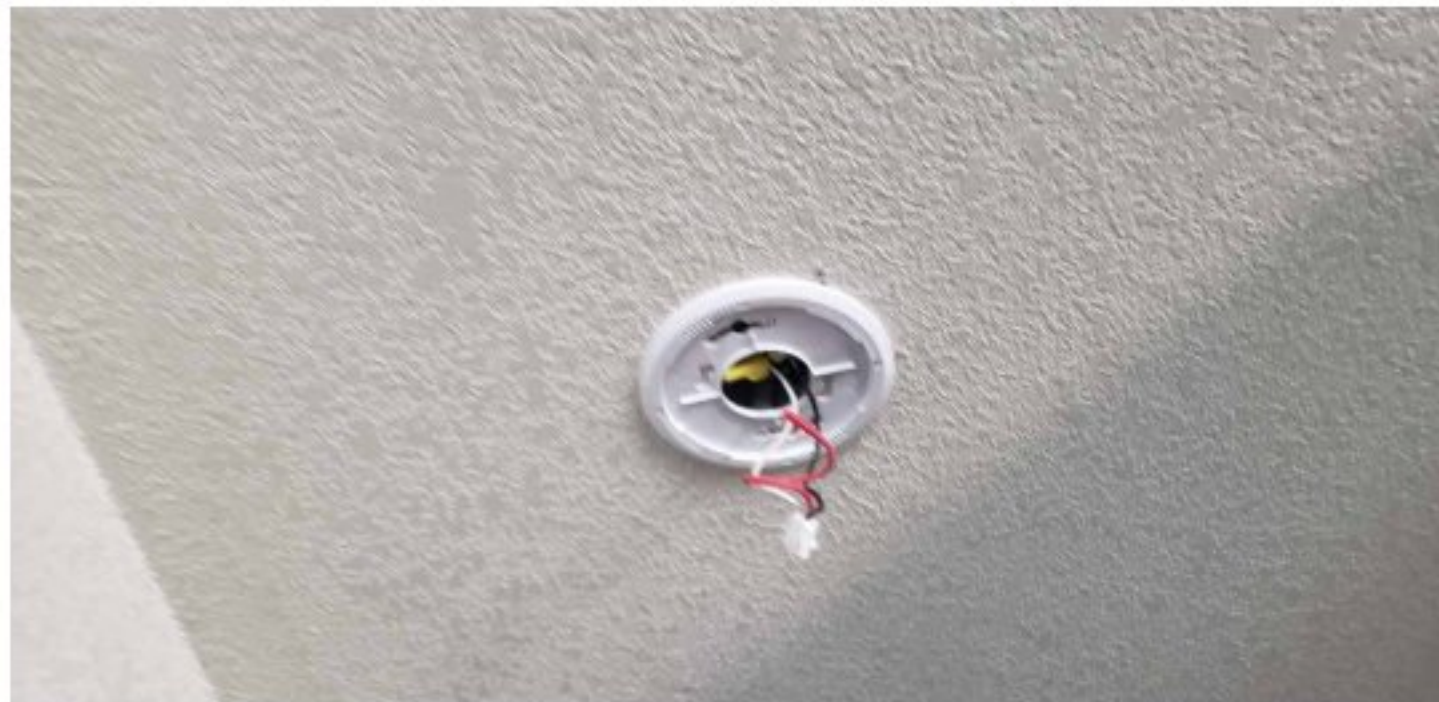
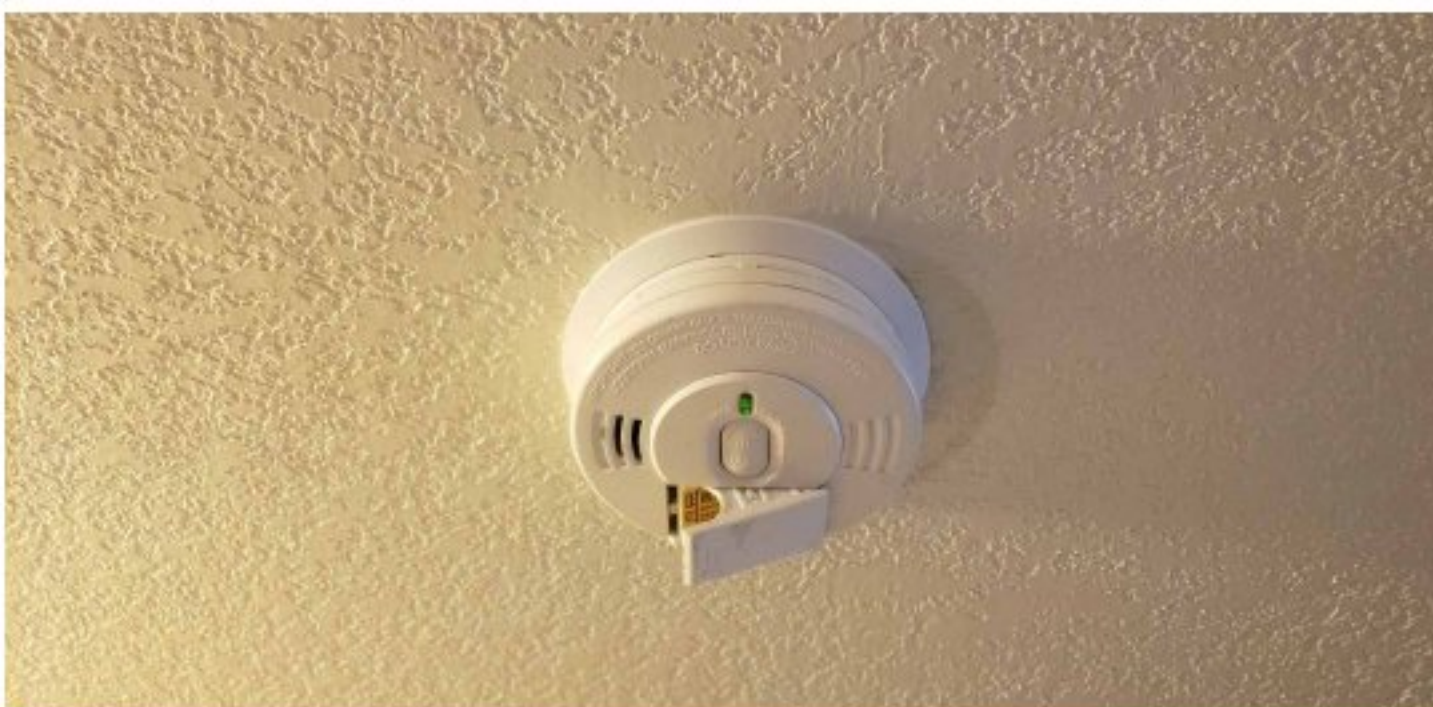
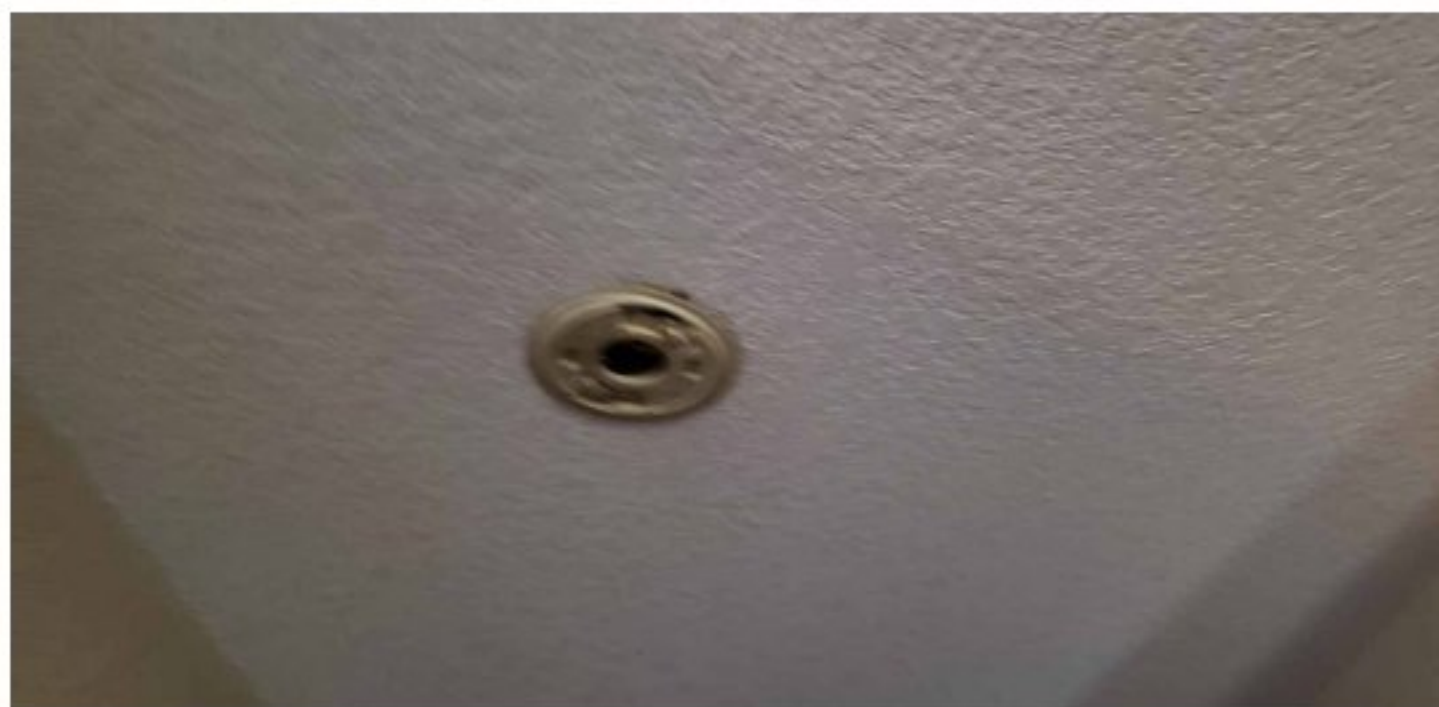
#### 16. Living Space Smoke Detector:

104, 115, 119, 121, 122: Recommend installing and maintaining functional smoke detectors in hallway and each bedroom for safety.

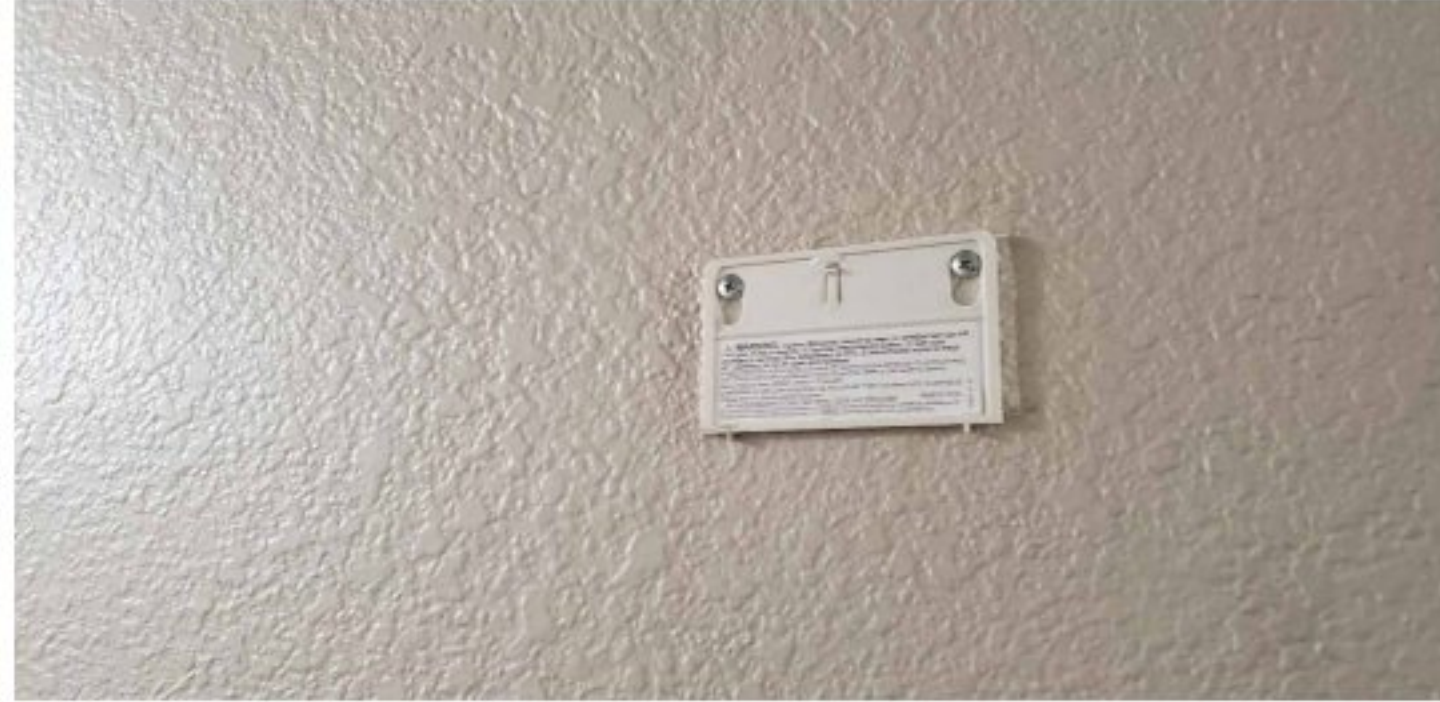
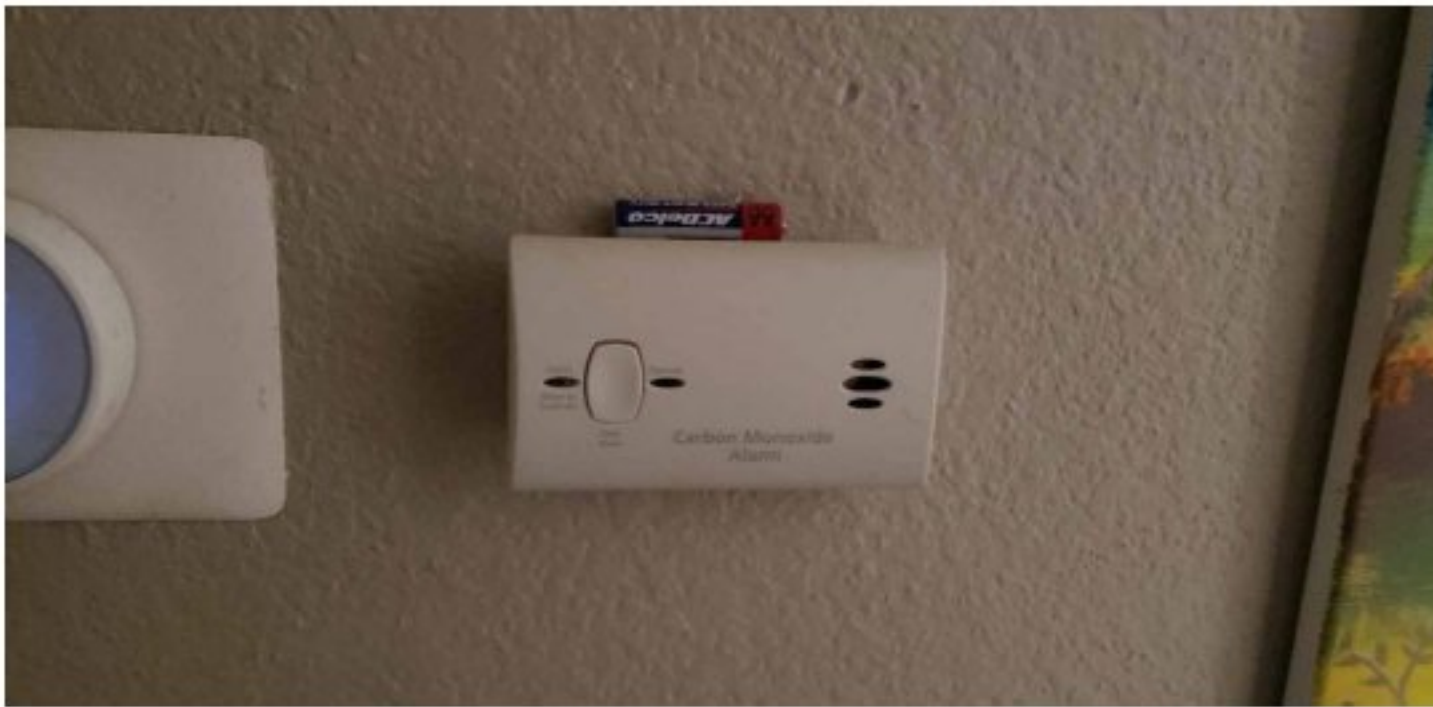
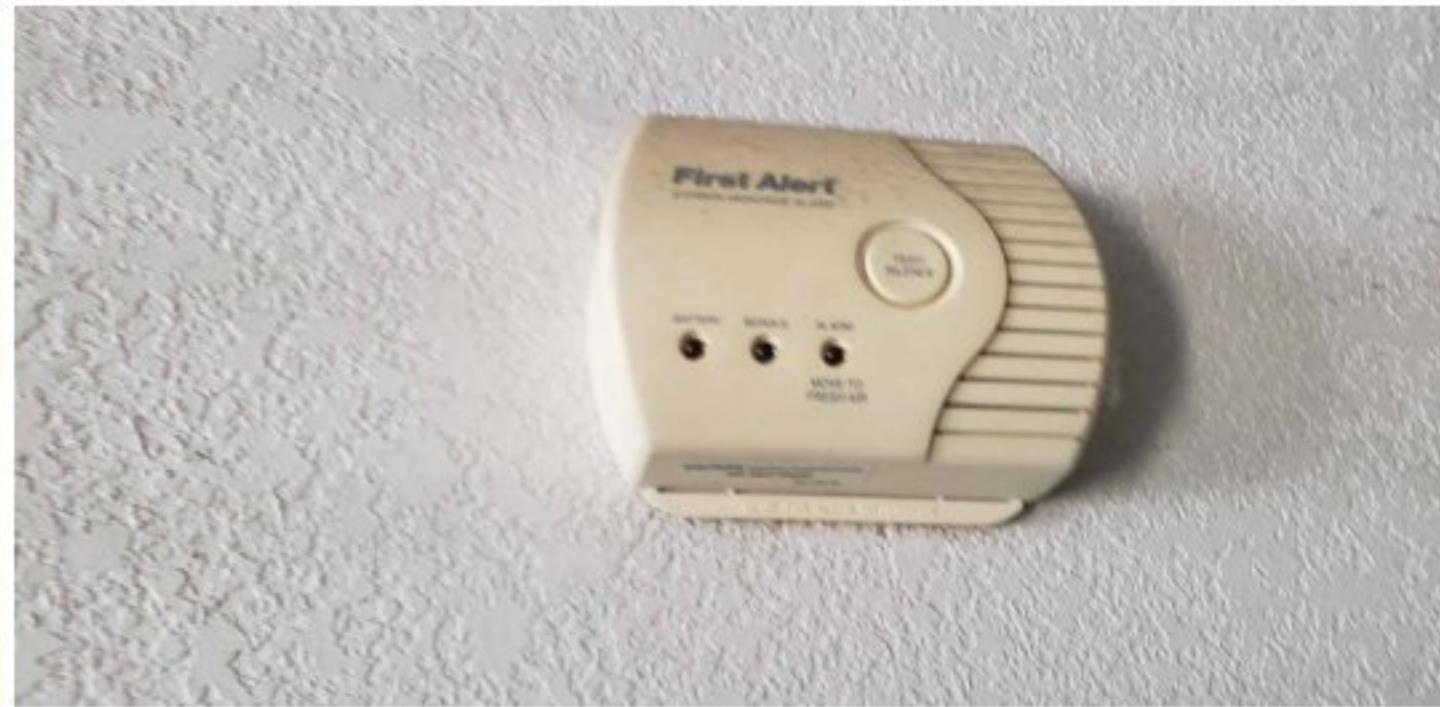
### 17. Living Space Carbon Monoxide Detector:

106, 115, 119: CO detector did not work when tested. Recommend evaluation and repair as needed.

107: CO detector noted to be missing.

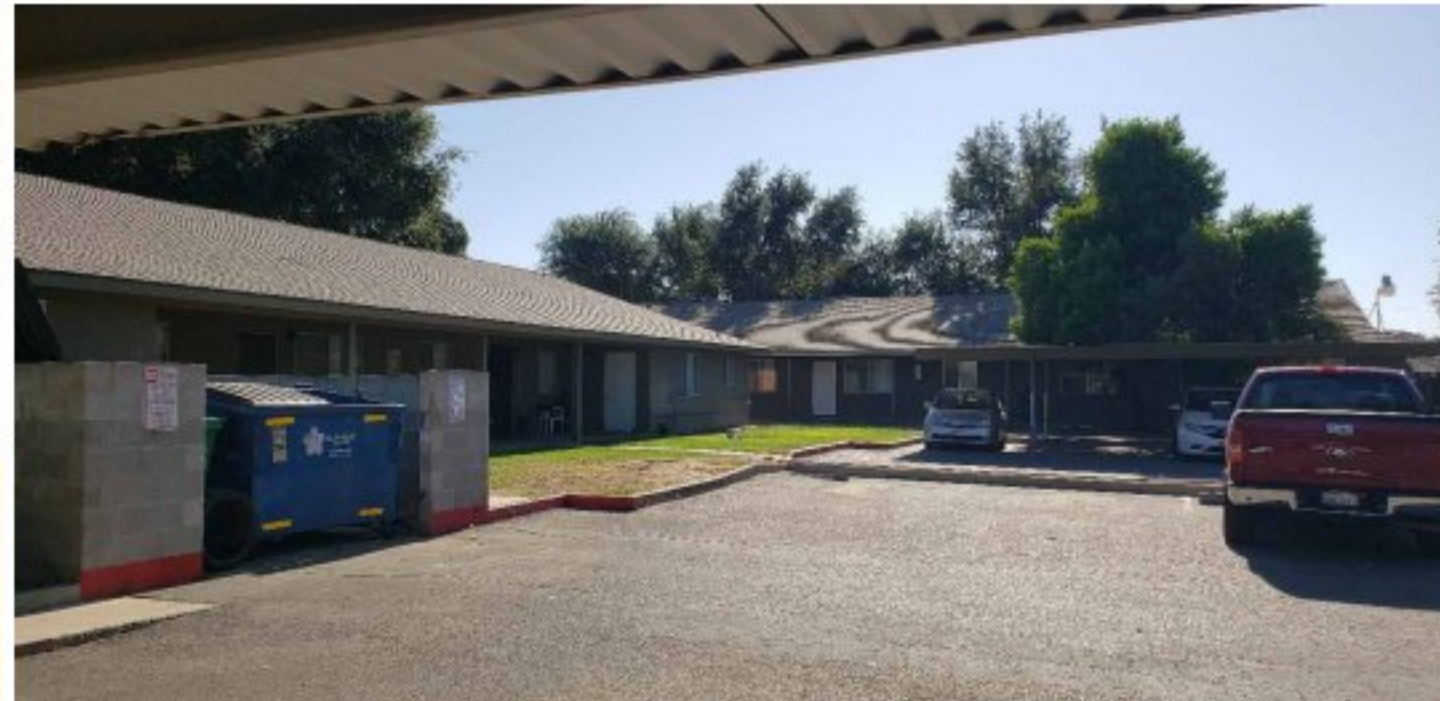
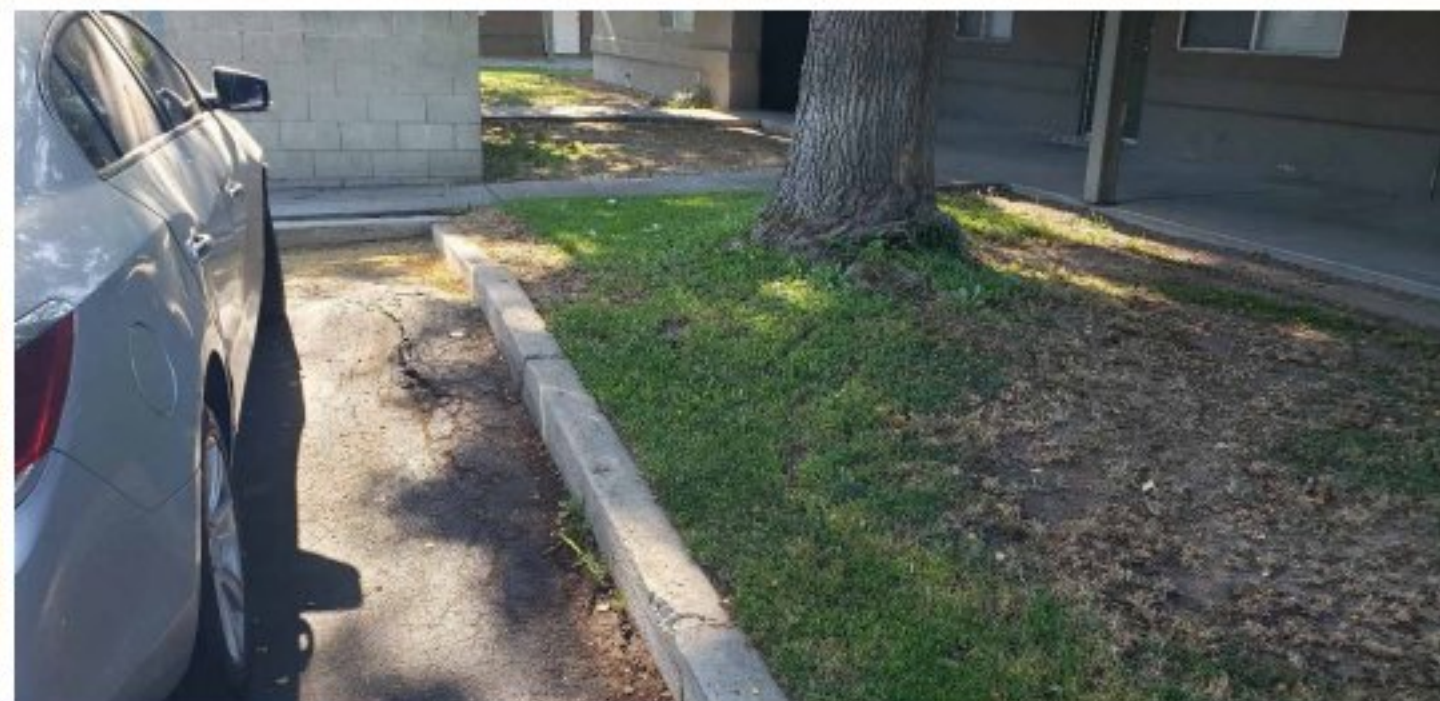
### 18. Driveway: Asphalt -

Tree roots noted to be affecting asphalt in a couple locations. Recommend evaluation and repair as needed.

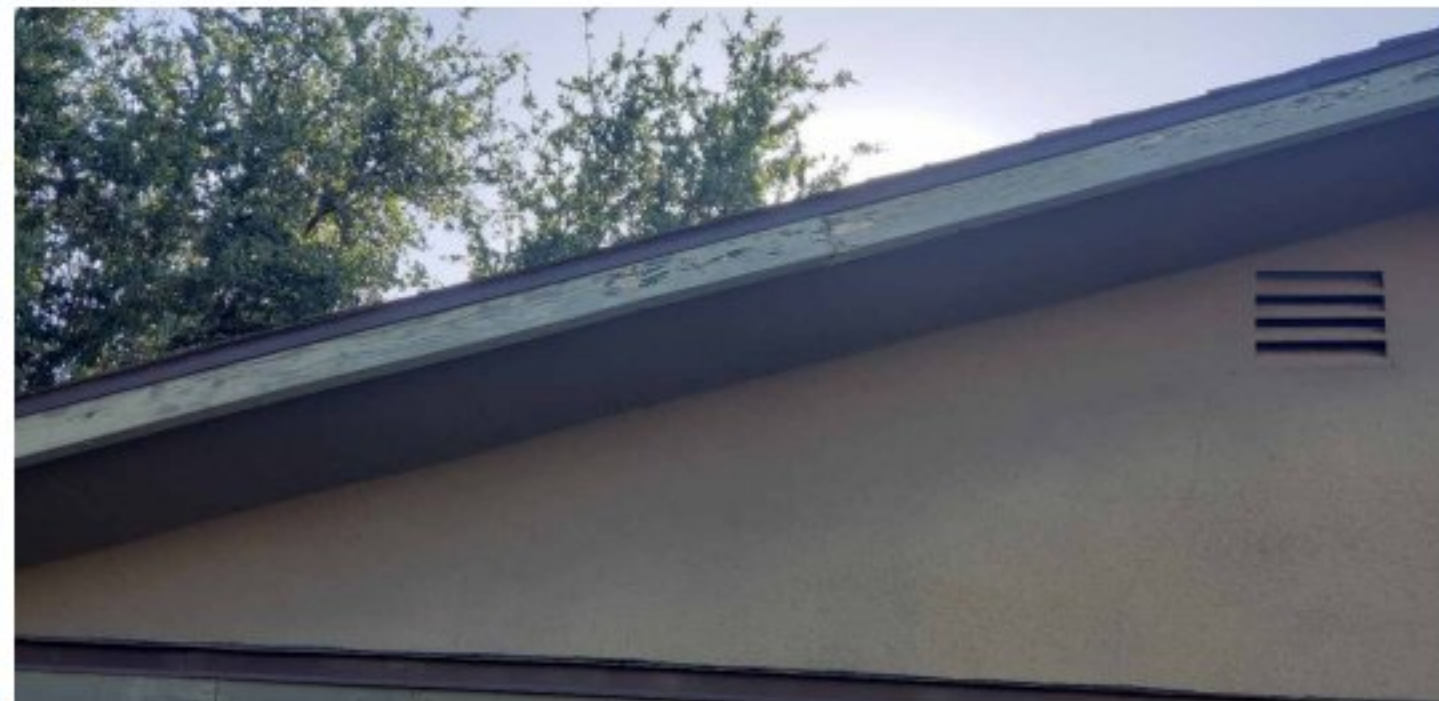
2. **Trim:** Wood -

Chipping/peeling paint noted. Recommend keeping a good coat of paint on all exterior surfaces to prevent premature deterioration.

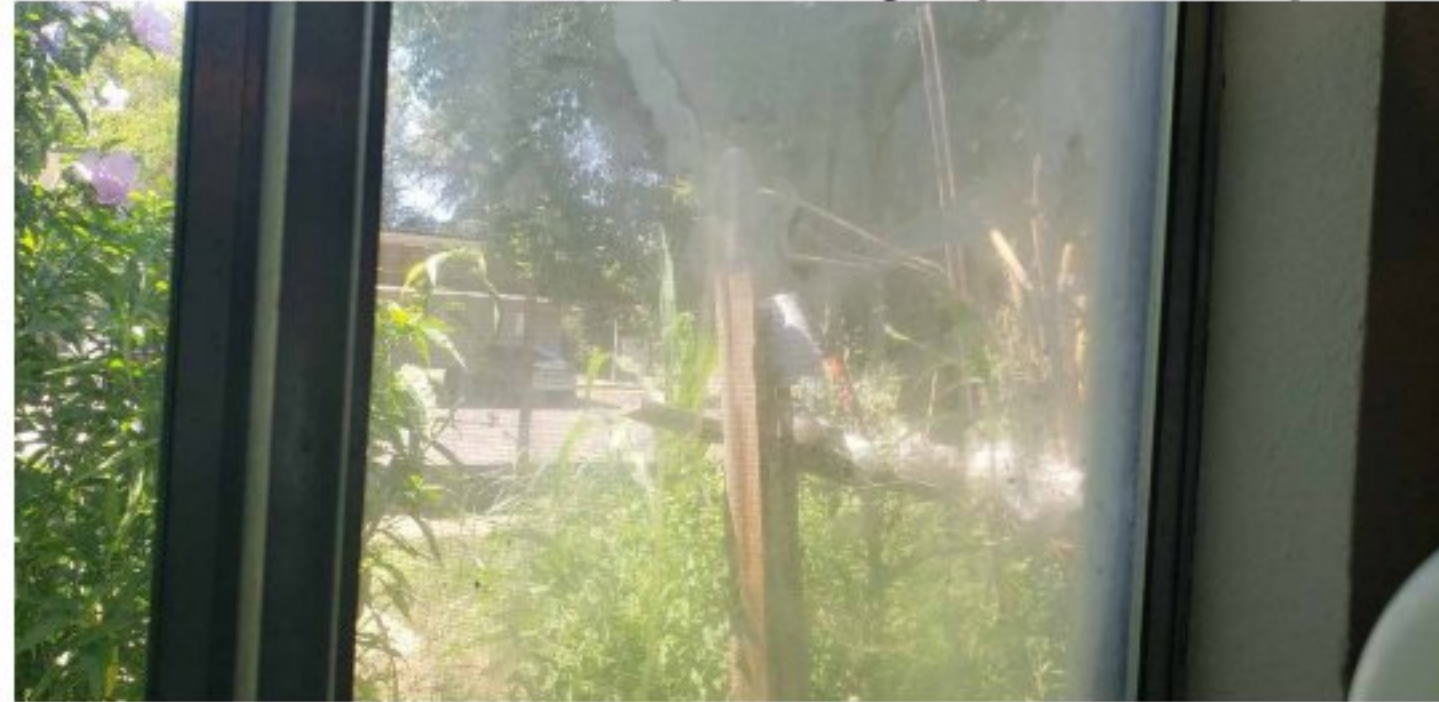
105, 120: Dual pane window noted to be fogged up indicating seal has failed. This not only allows condensation to build up between the panes, but also negates the energy efficiency of the window. Recommend evaluation and repair by qualified professional.

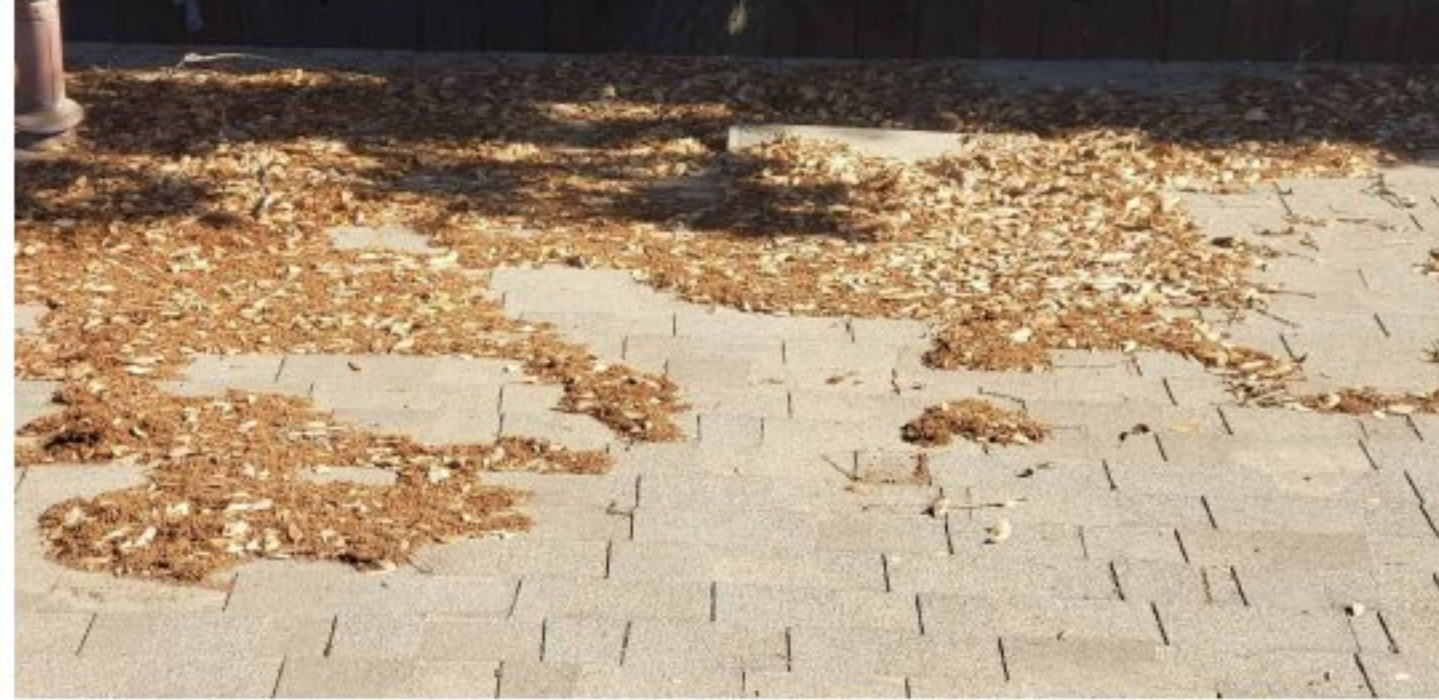
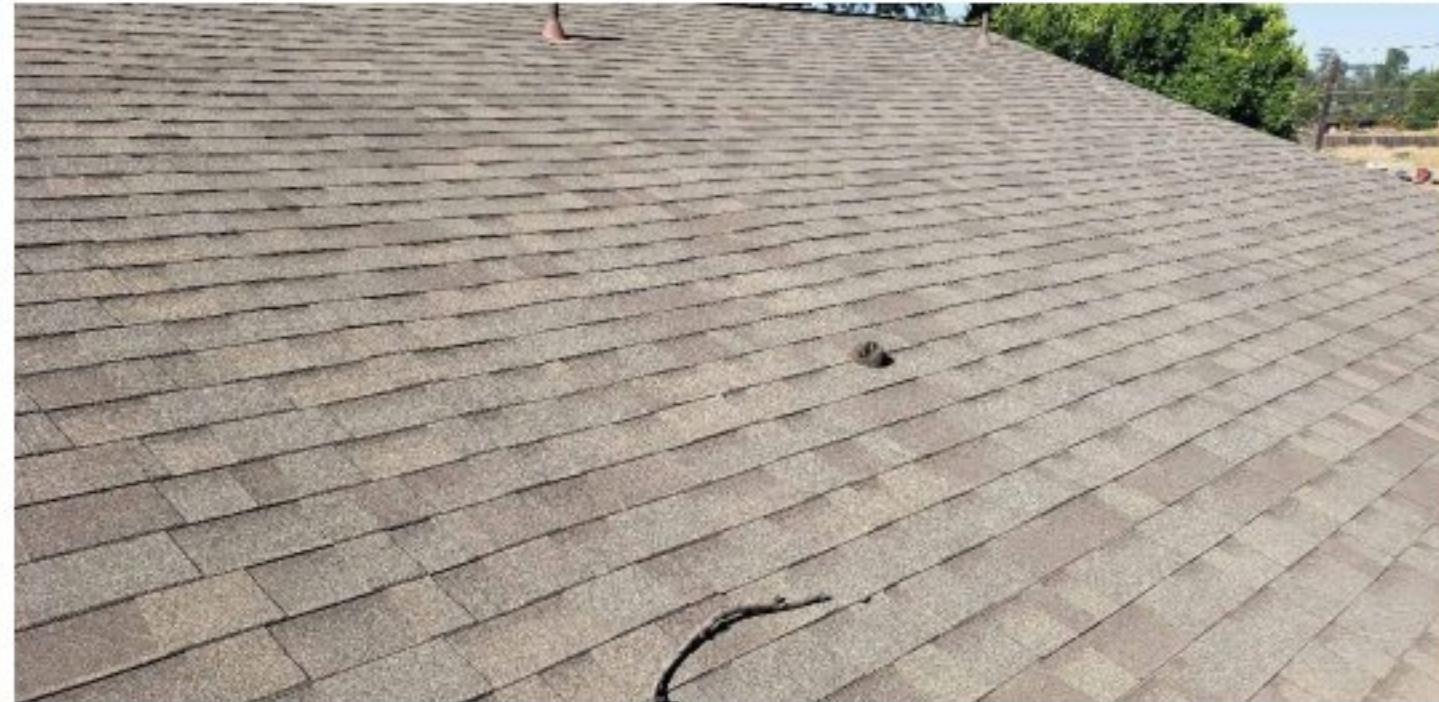
- 1. Material:** Asphalt shingle (Approx. 10-12 yrs. Old) -  
Recommend keeping leaves and debris off of roof materials to prevent premature damage.
