Jonathan Bray Home Inspections  
P.O.Box 3971  
Fresno, CA 93650  
jbrayinspections@yahoo.com

# PROPERTY INSPECTION REPORT

Prepared Especially for Jimmy Cannizzaro  
1262 N. Marks Ave., Fresno 93722  
June 23, 2026

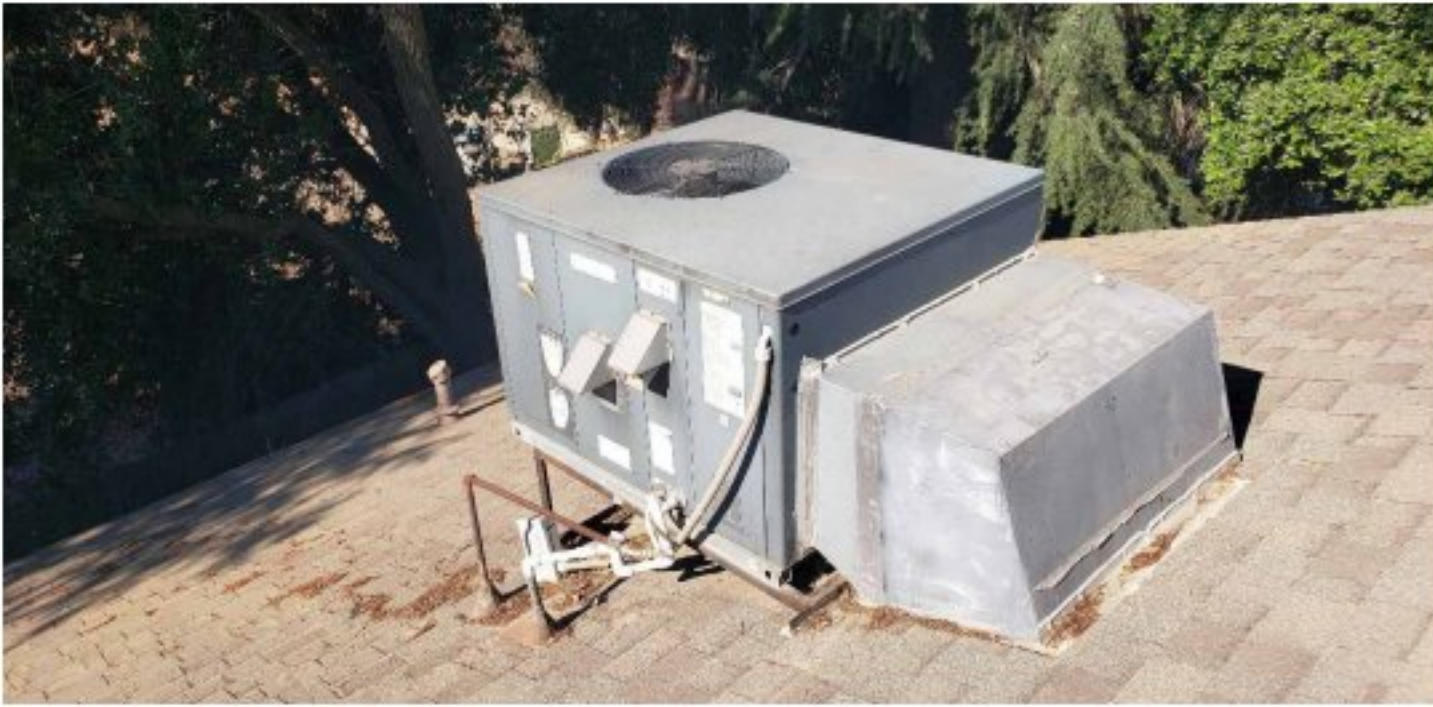
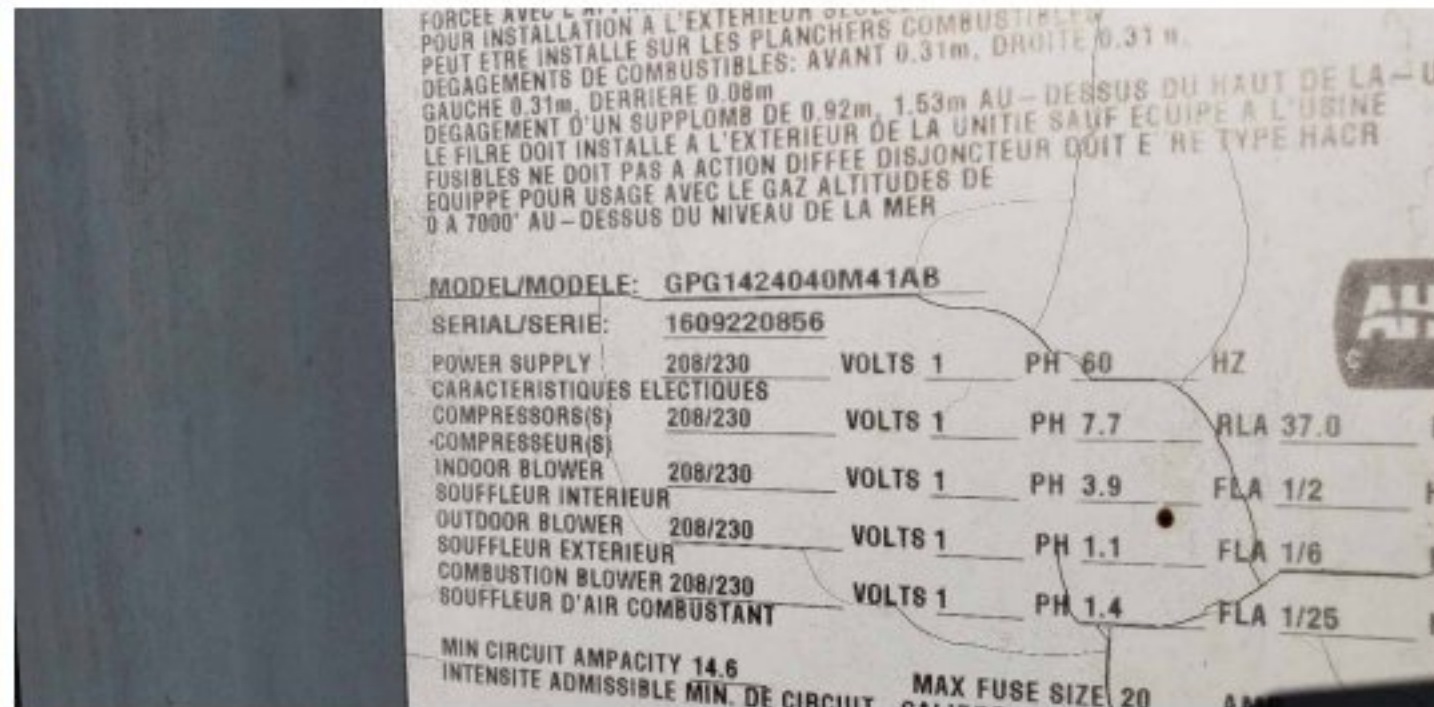
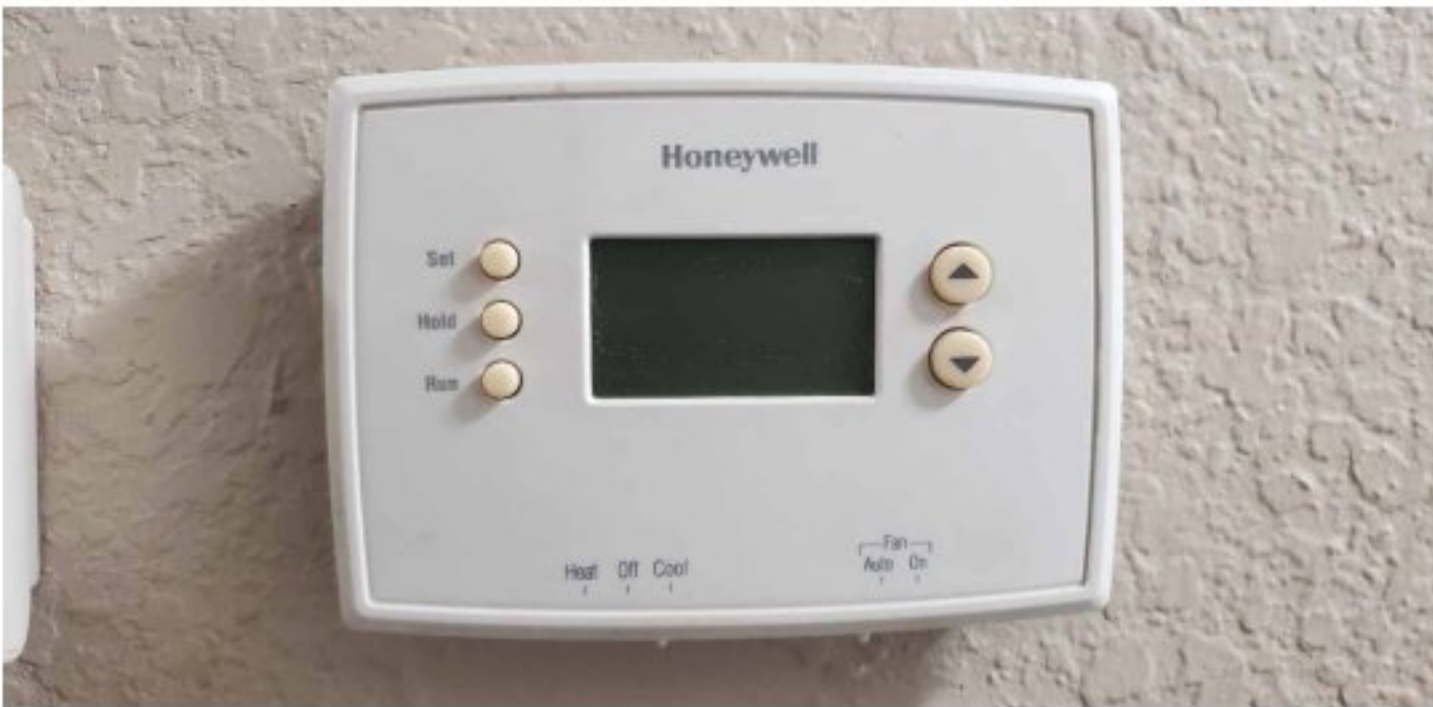
1. **A/C System Operation:** Appears serviceable -  
Unit 101: Thermostat batteries dead. Not able to test.

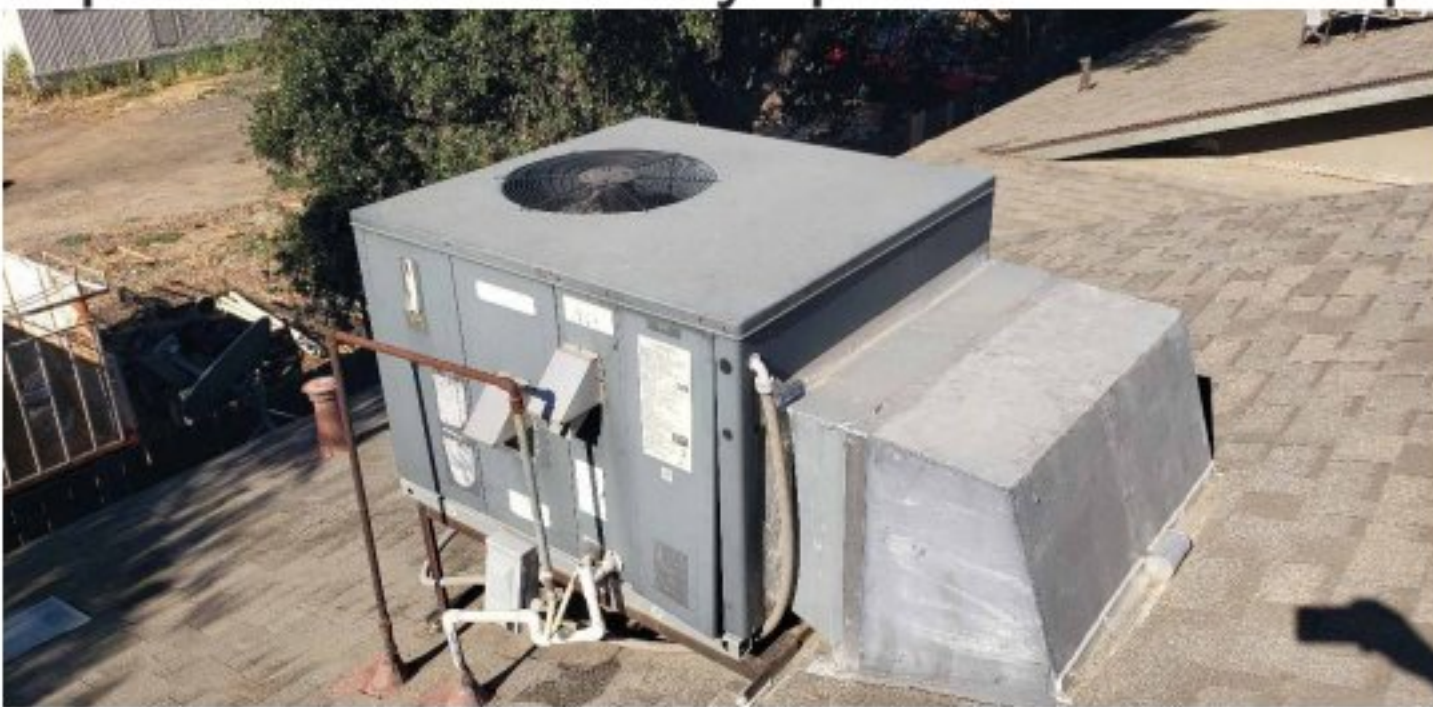
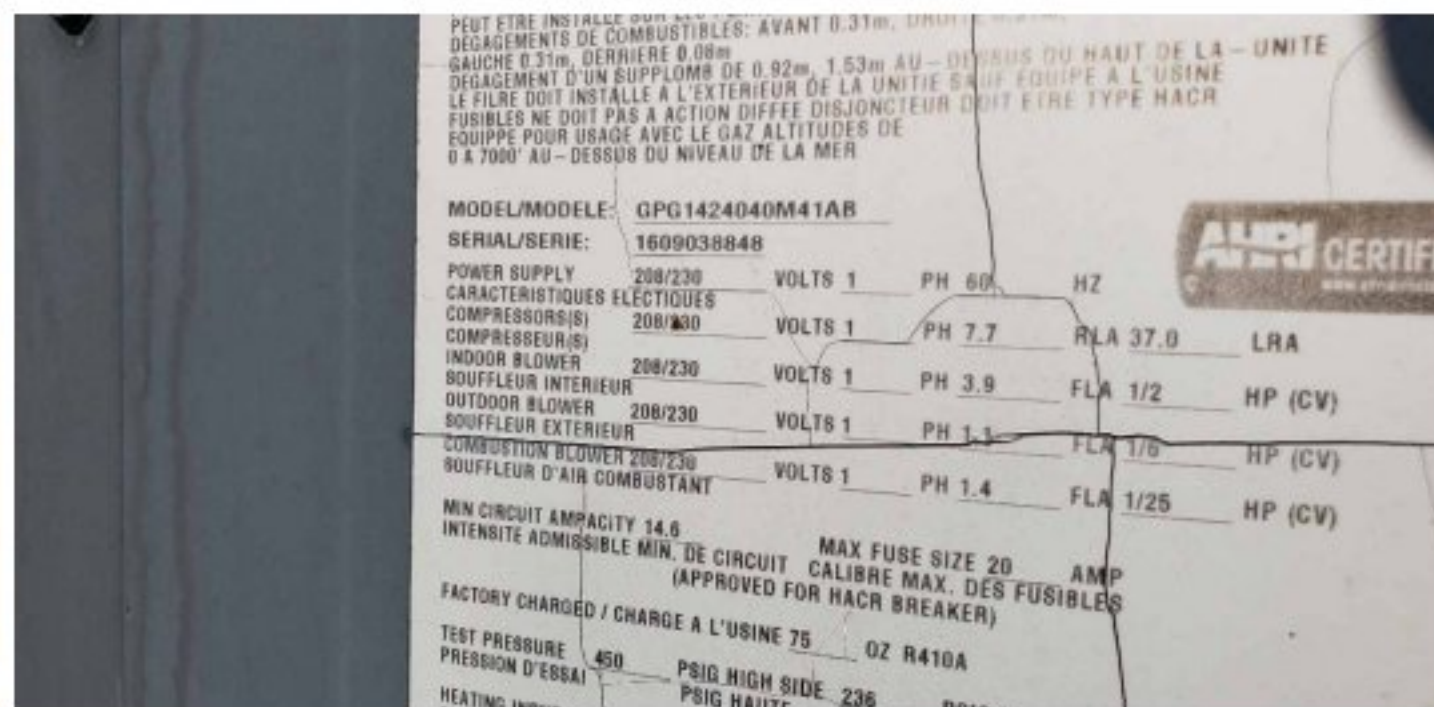
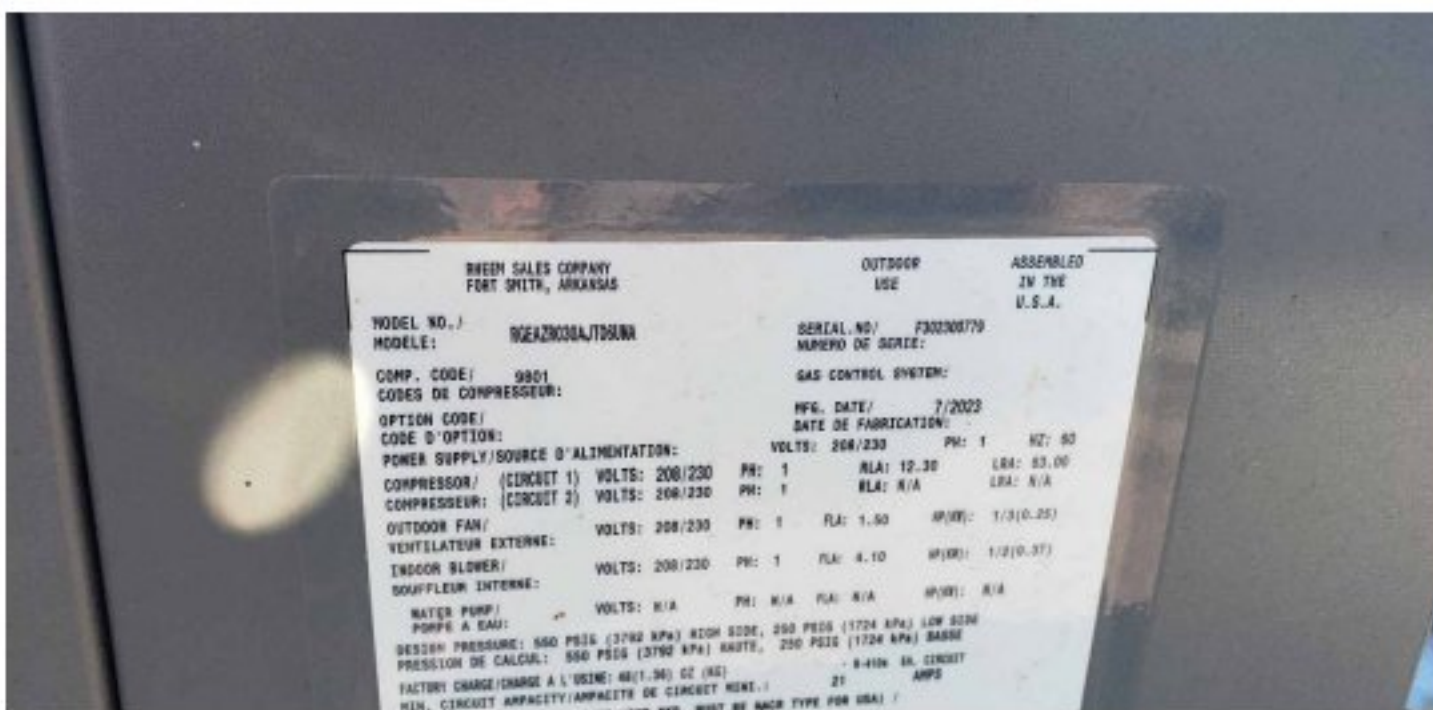
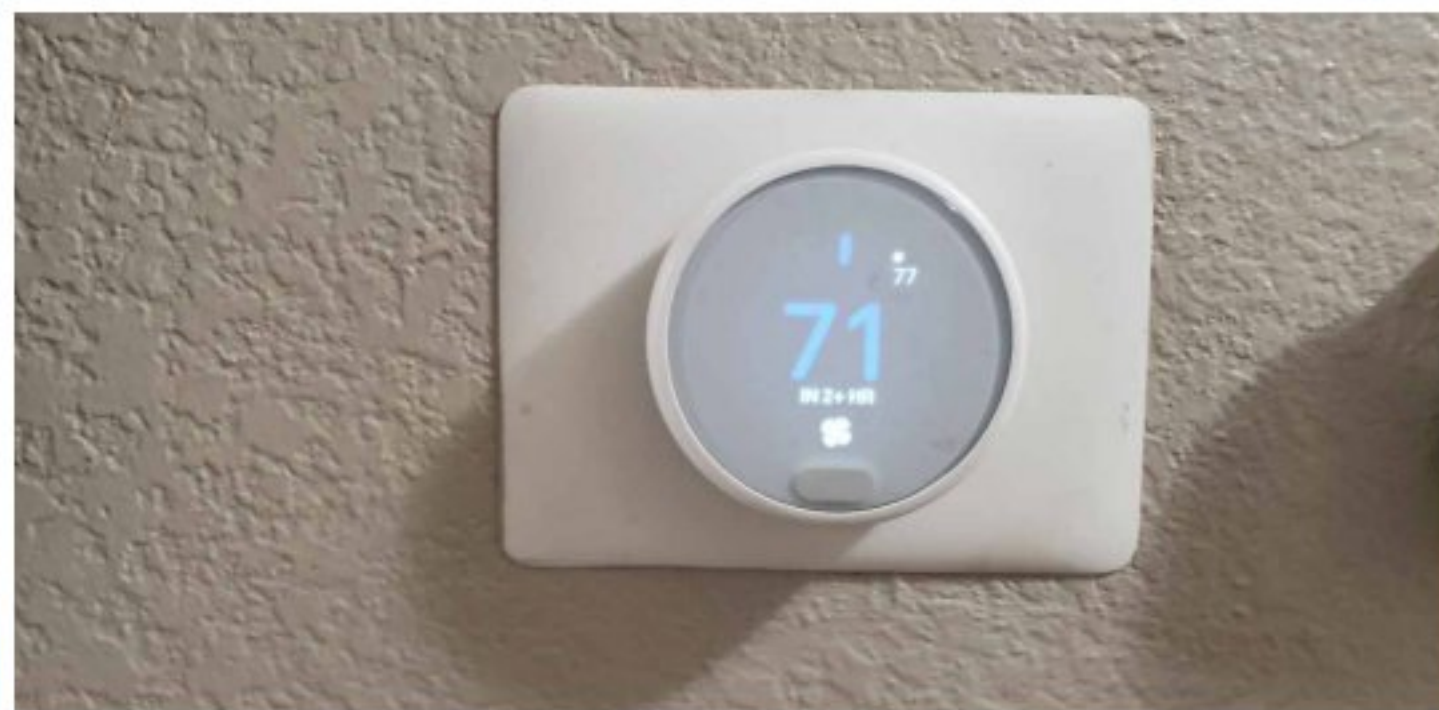
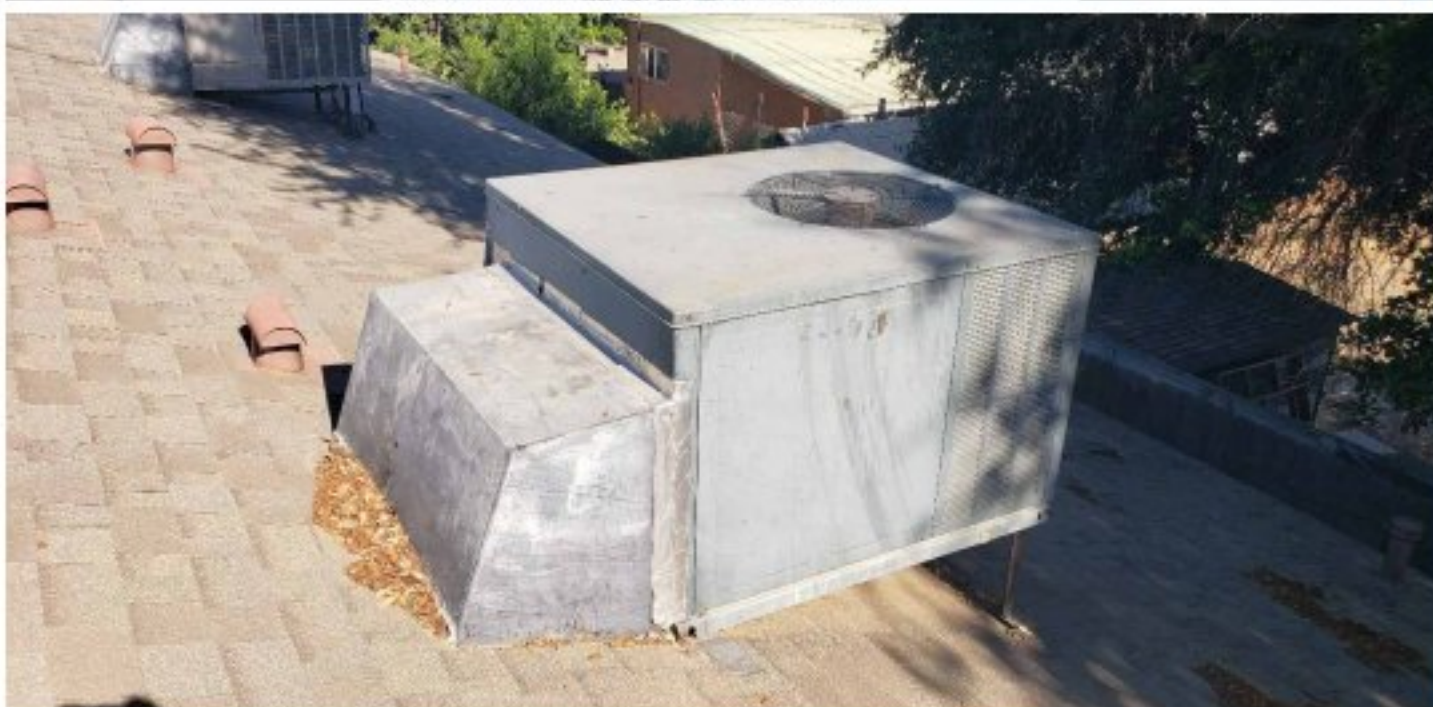
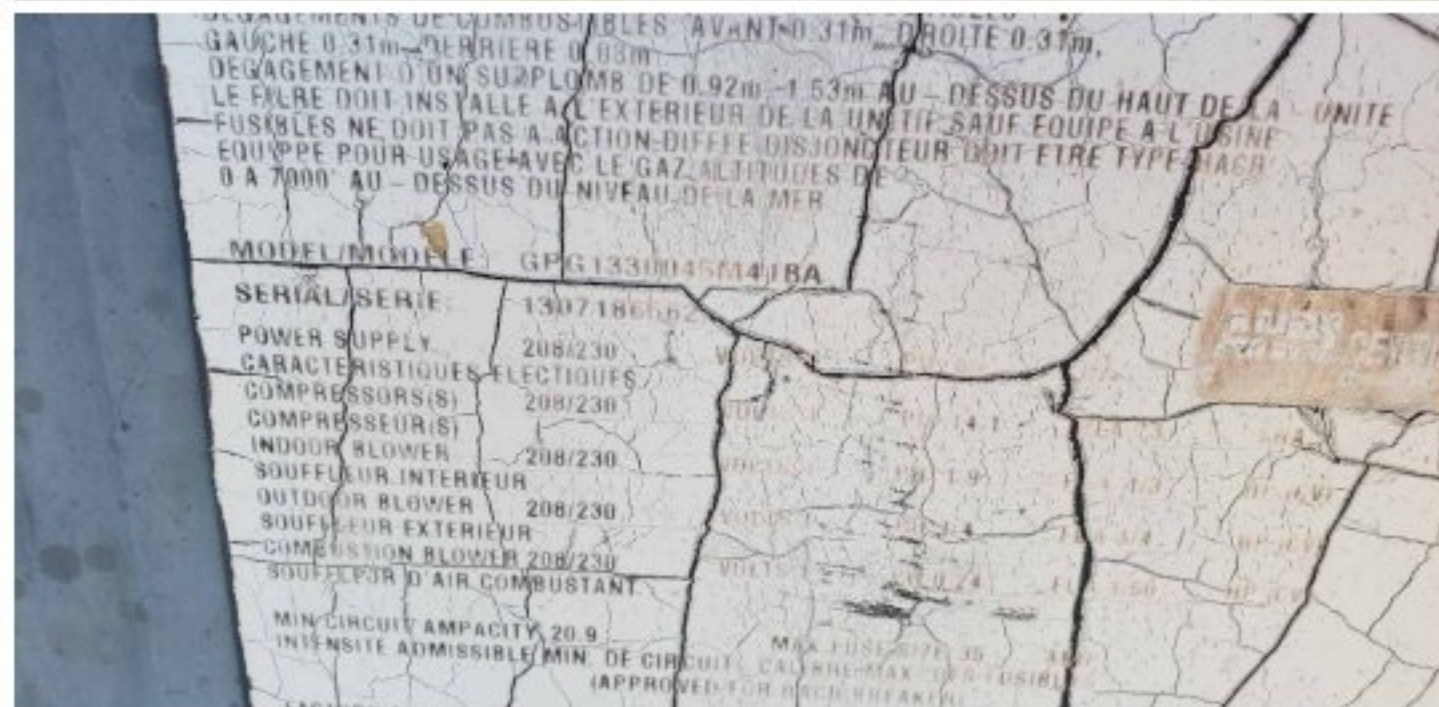
2. **A/C System Operation:** Appears serviceable -  
104, 115, 117: Air coming out of vents was not cooled as expected. Temperature differential did not reach the desired -18 to -25 degree. Recommend evaluation and repair as needed by qualified HVAC professional.

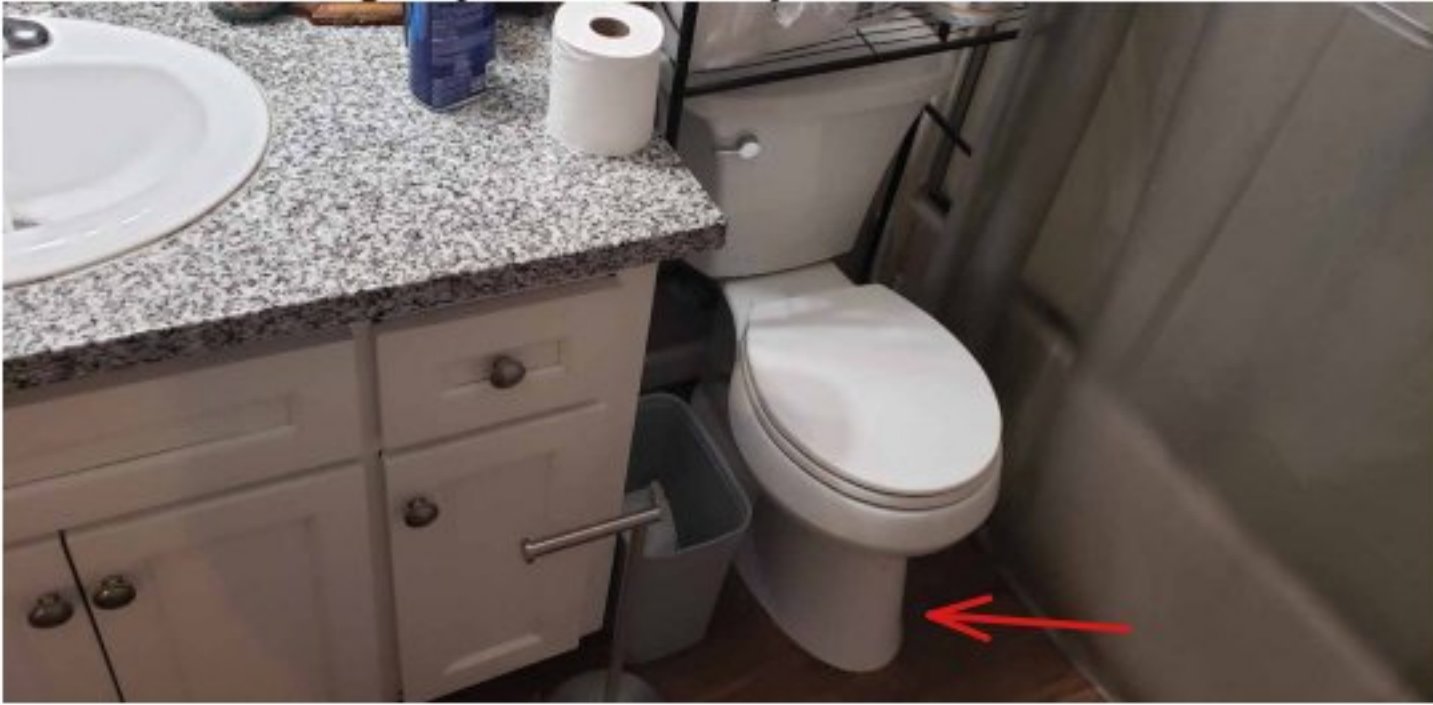
103: Toilet bowl noted to be loose to the floor. Recommend evaluation and repair as needed by qualified professional.

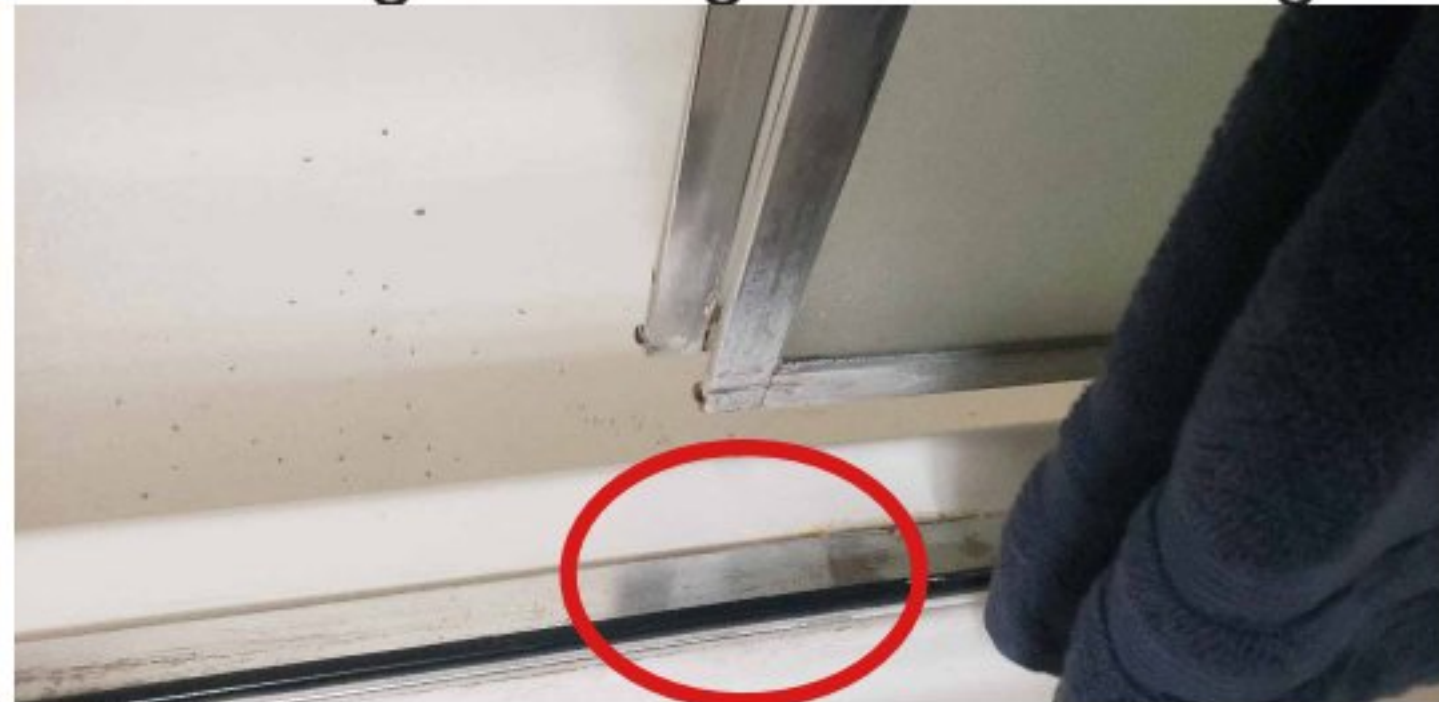
### 9. Tub/Surround:

103, 106: Shower door guide noted to be missing allowing doors to swing inward.

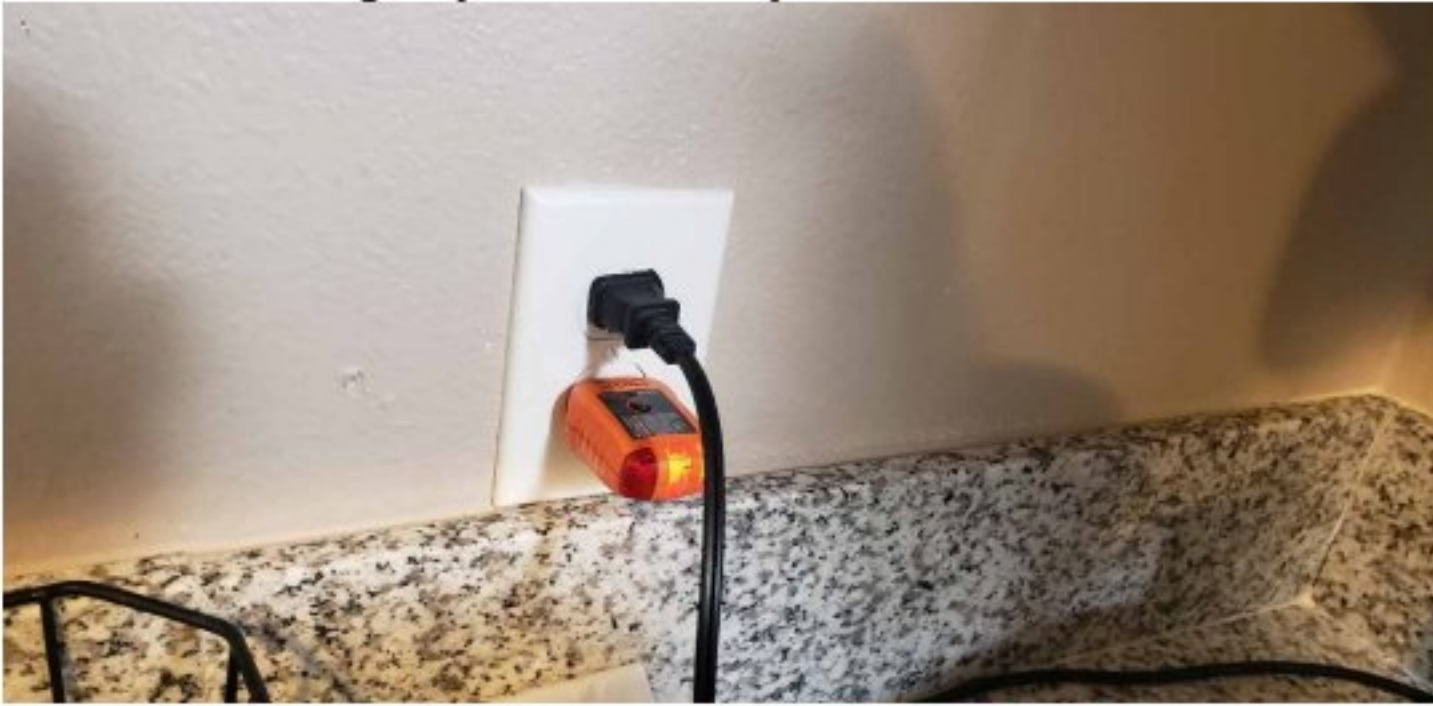
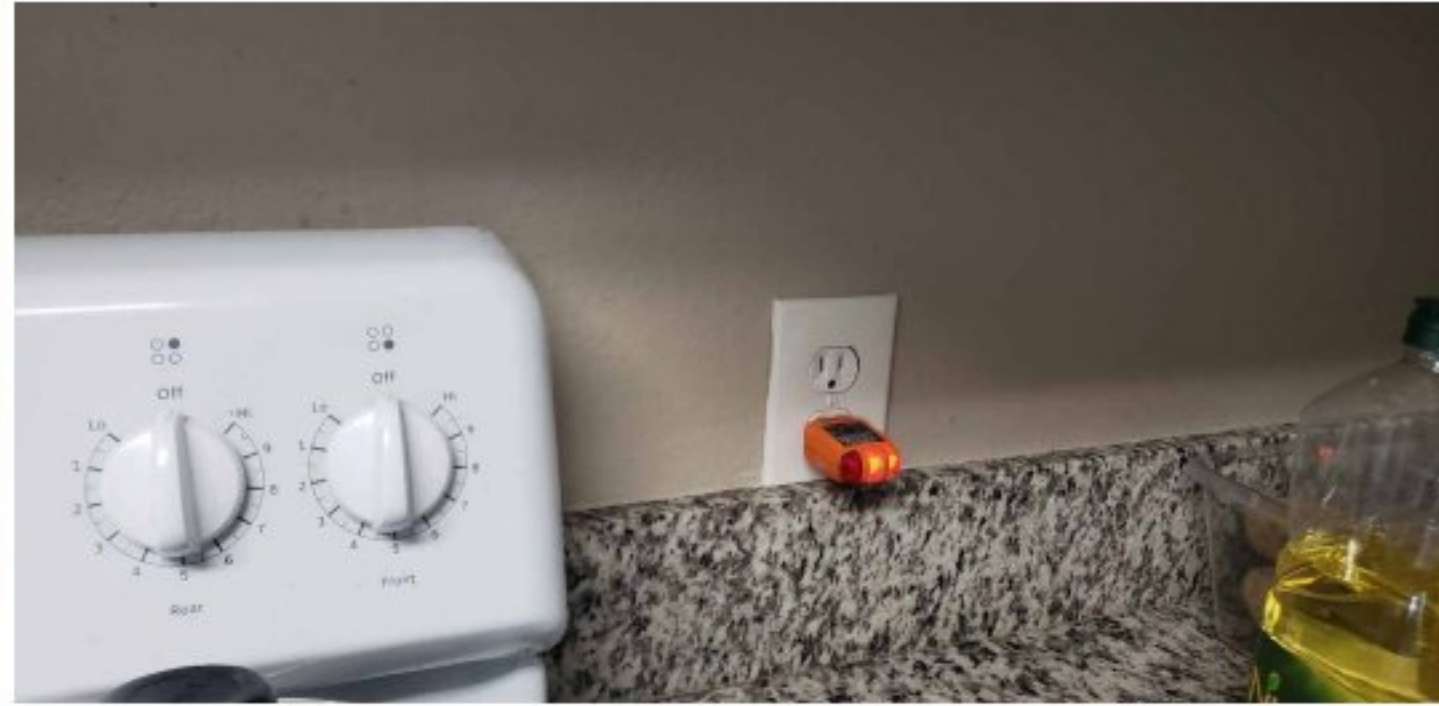
104, 105, 113: Kitchen outlets are recommended to be protected by GFCI outlets. No GFCI protection was detected in kitchen. Recommend evaluation and repair as needed by qualified professional.

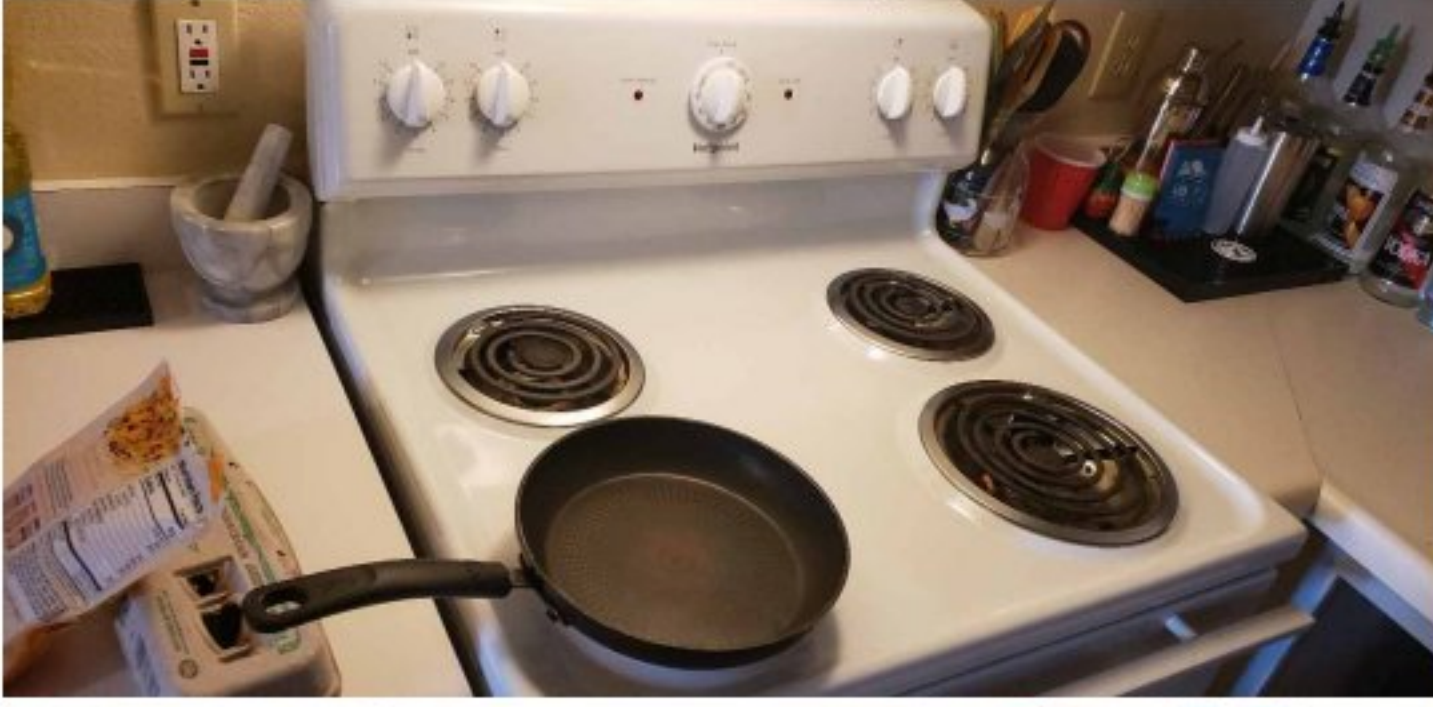
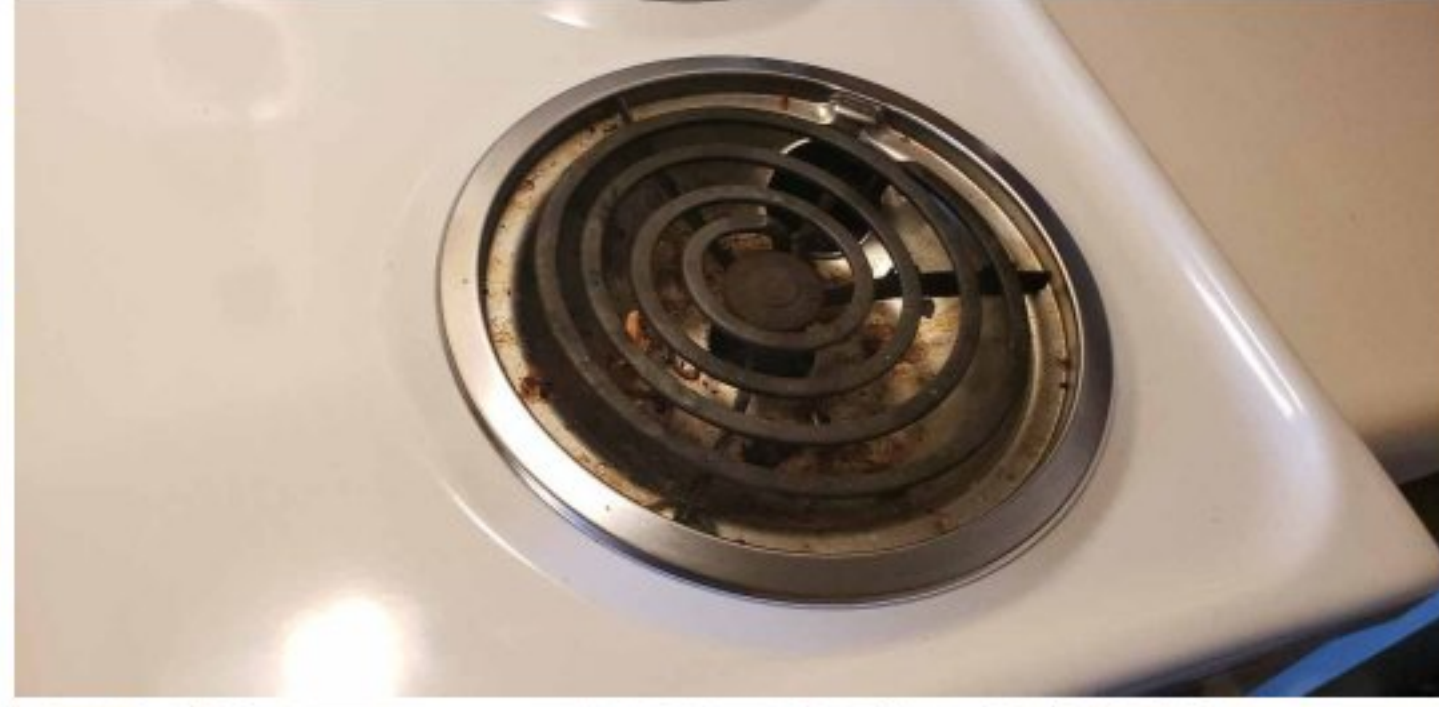
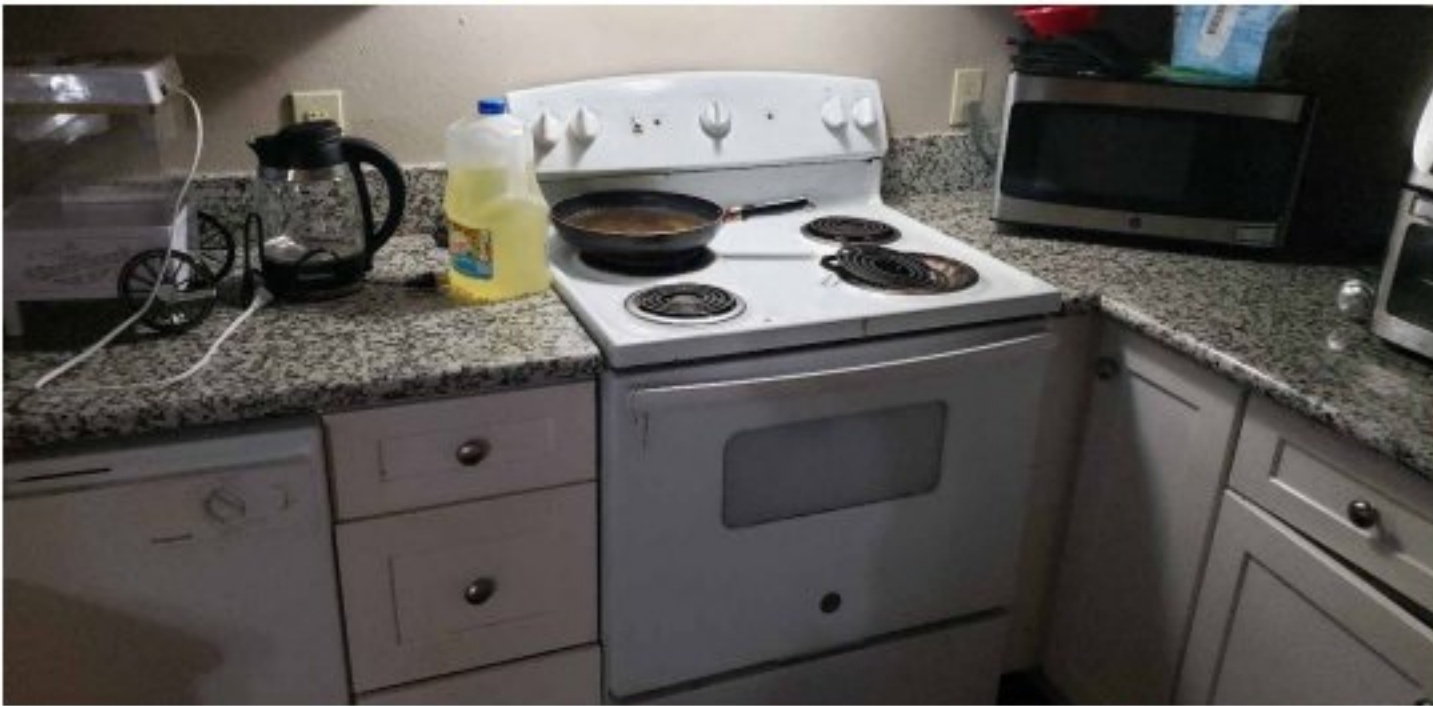
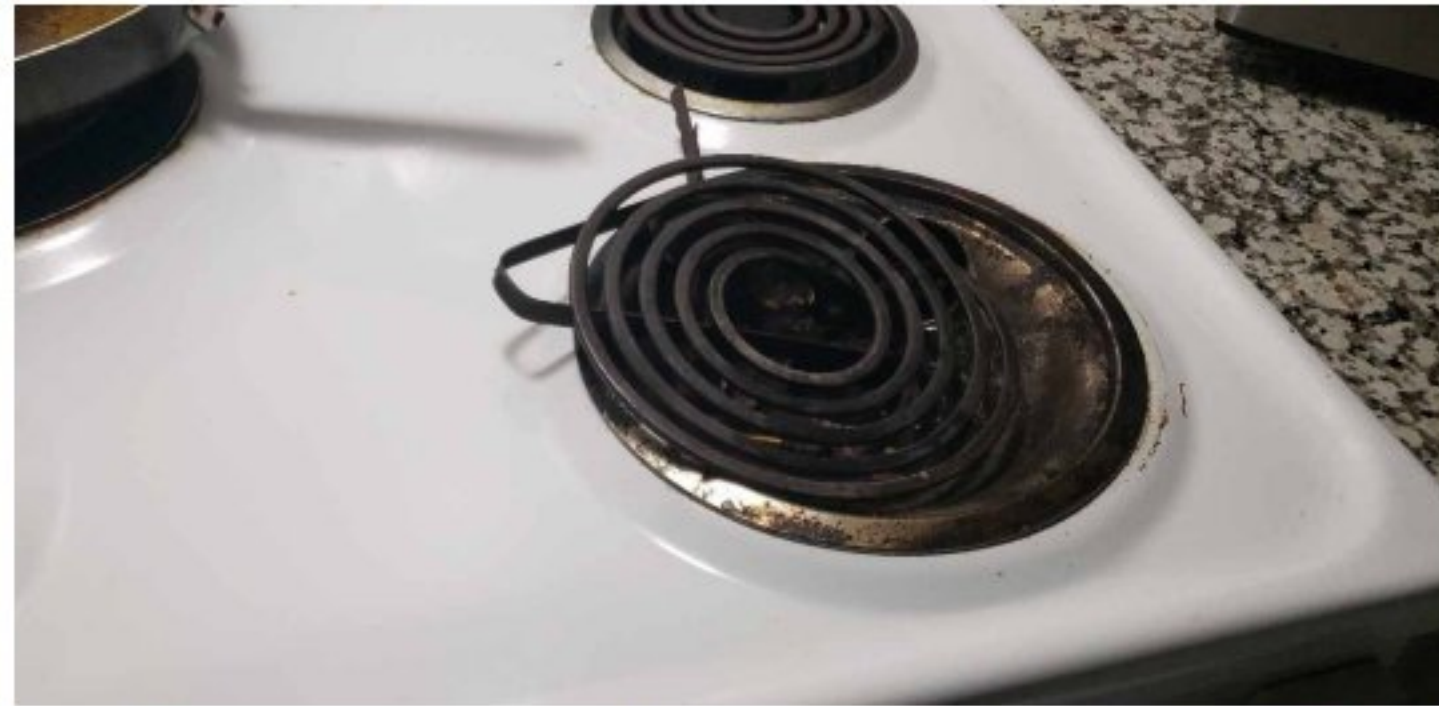
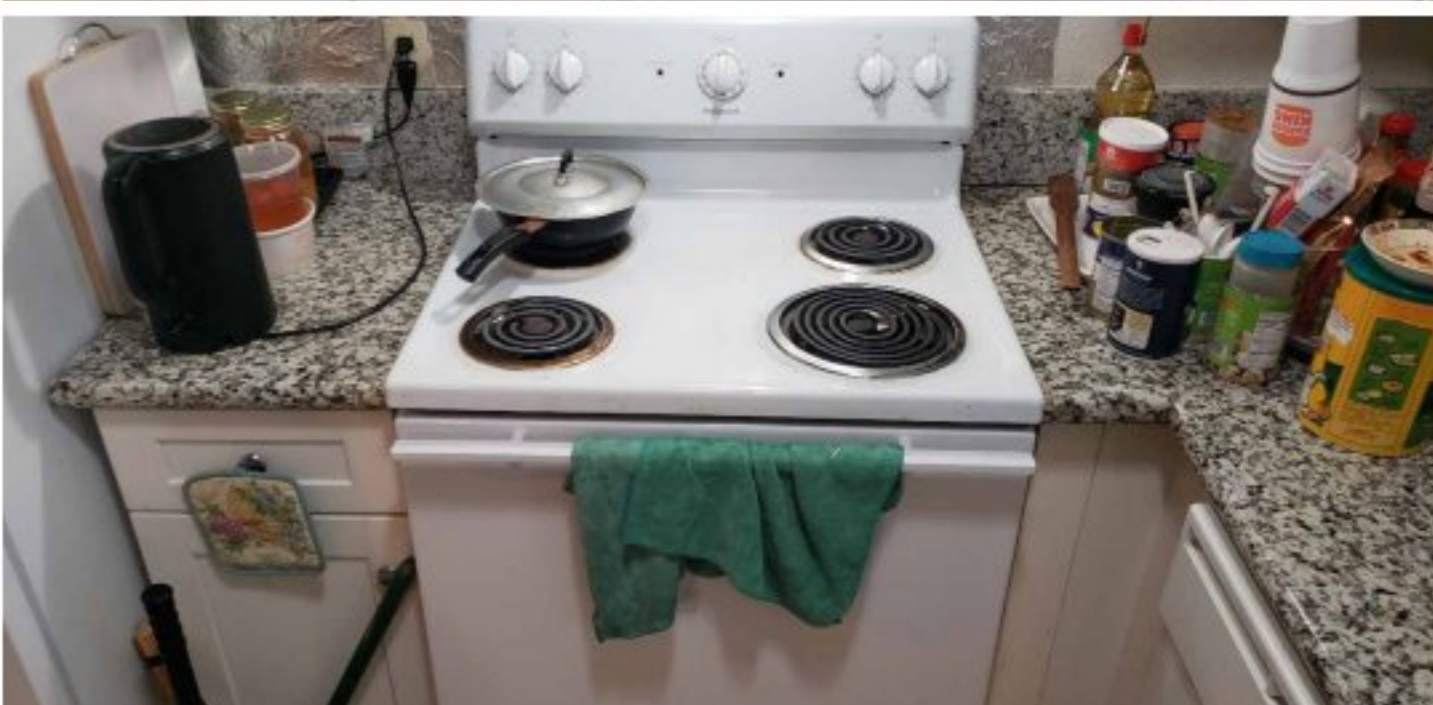
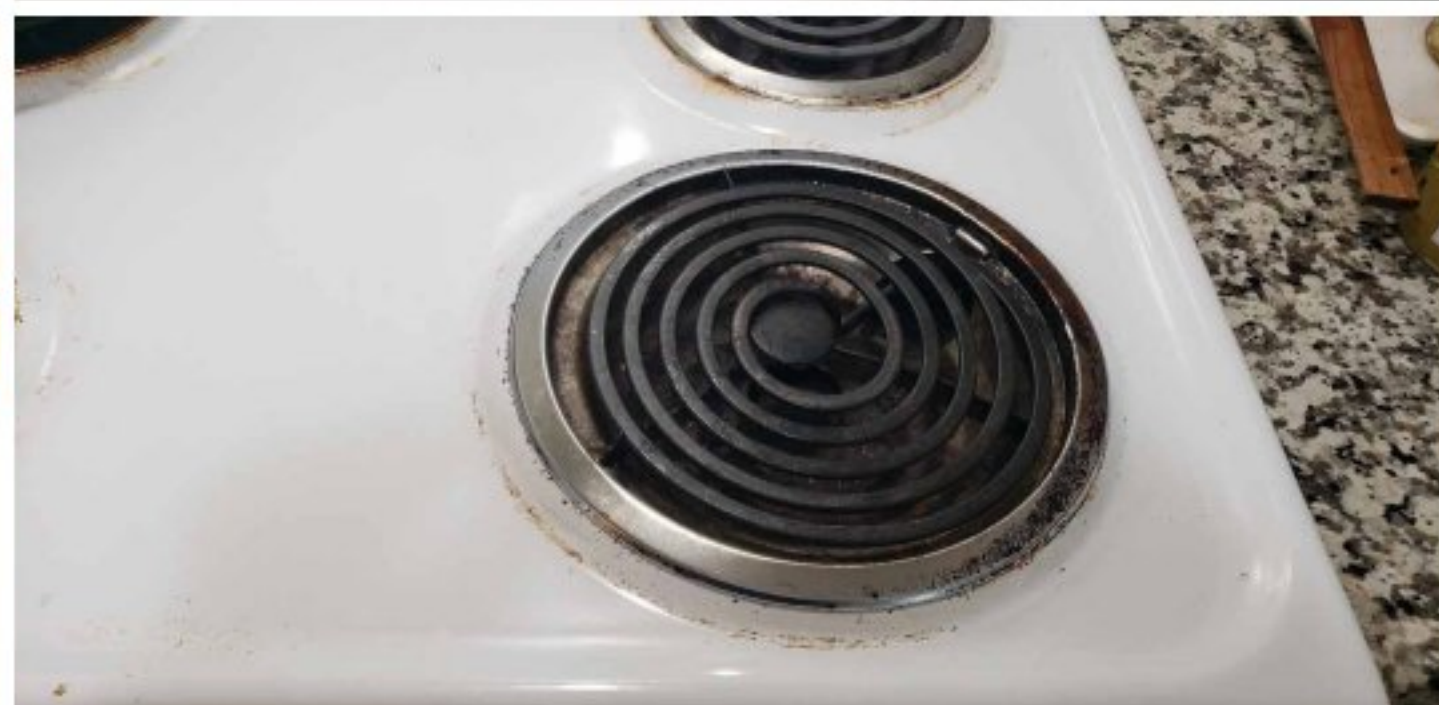
### 4. Oven: Functional -

110, 117, 120: Front right burner did not turn on when tested. Recommend evaluation and repair as needed by qualified professional.

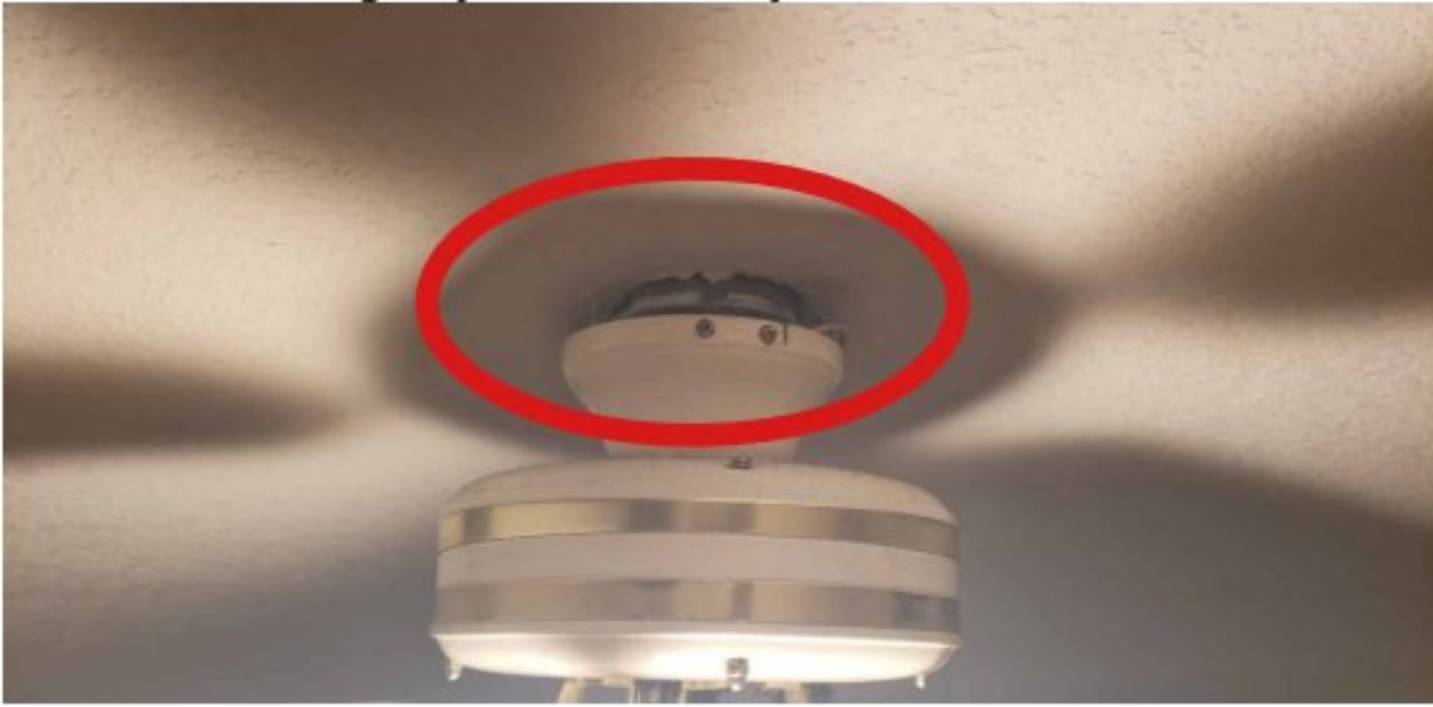
1. **Ceiling:** Texture and paint
2. **Walls:** Texture and paint
3. **Floor:** Laminate flooring, Carpet
4. **Electrical:** 110 VAC outlets and lighting circuits -  
122: Ceiling fan noted to be loose to the ceiling. Recommend evaluation and repair as needed by qualified professional.
