Jonathan Bray Home Inspections  
P.O.Box 3971  
Fresno, CA 93650  
jbrayinspections@yahoo.com

# PROPERTY INSPECTION REPORT

Prepared Especially for Jimmy Cannizzaro  
1262 N. Marks Ave., Fresno 93722  
June 23, 2026

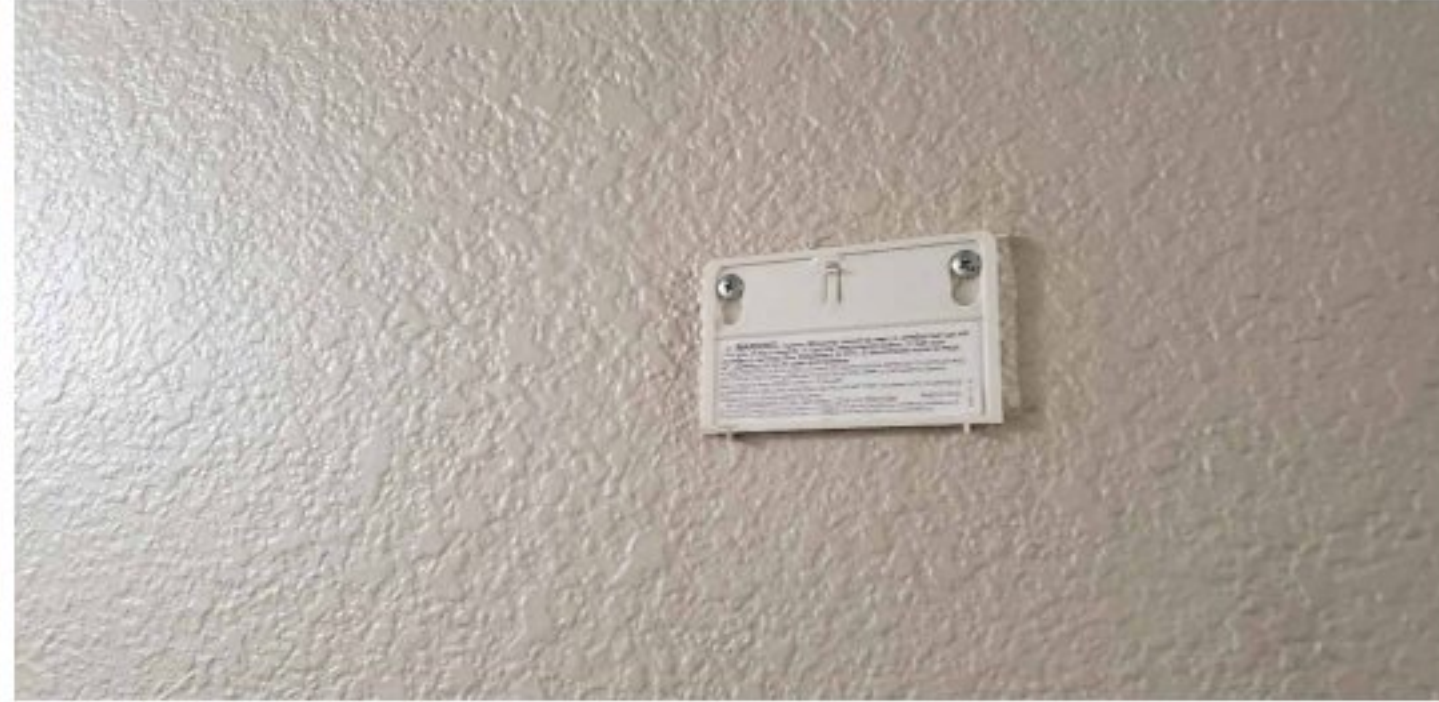
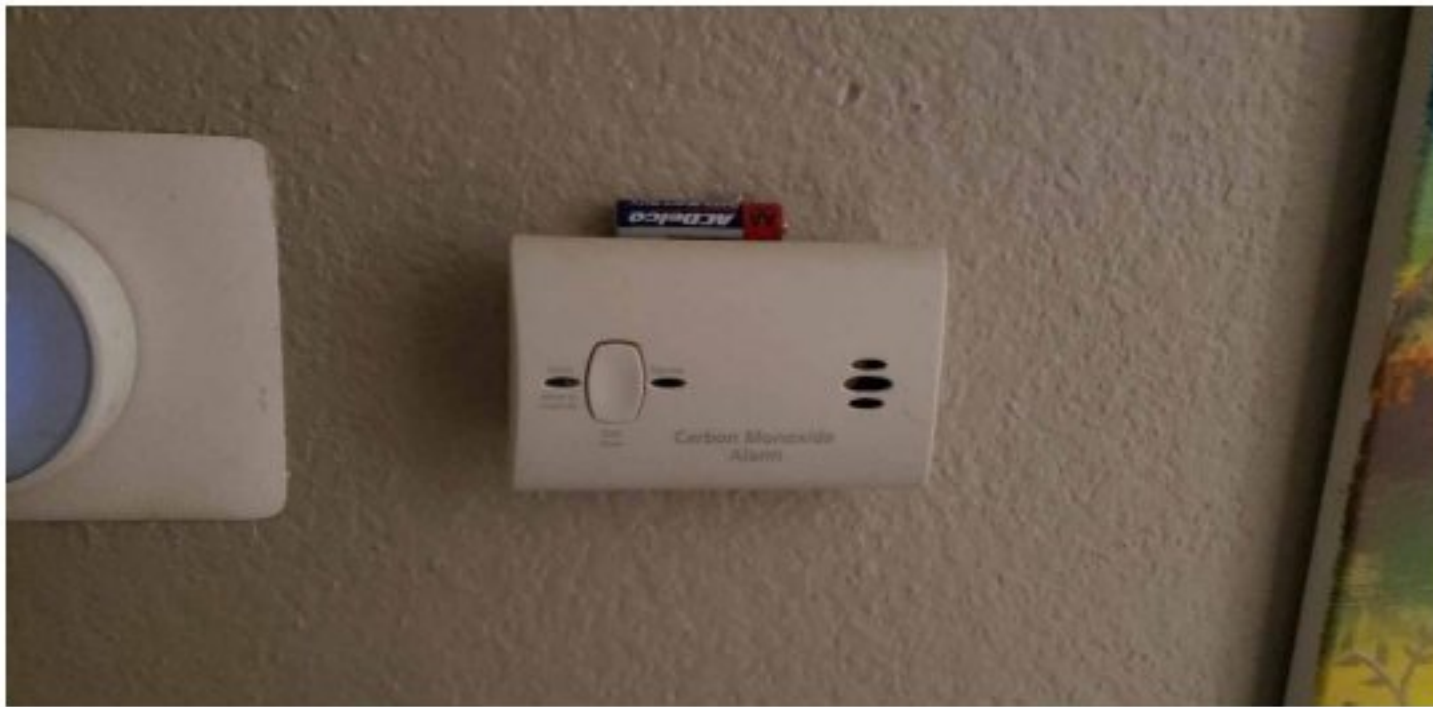
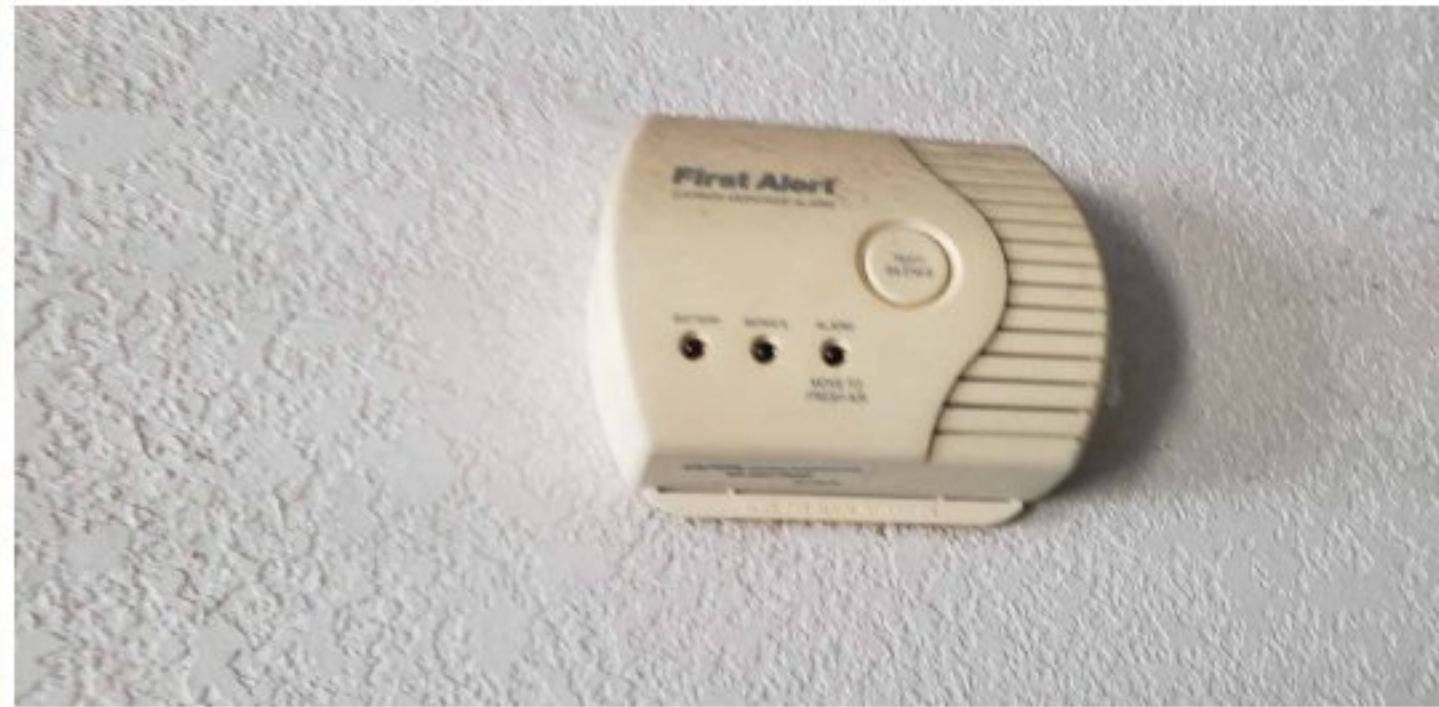
### 6. Carbon Monoxide Detector:

106, 115, 119: CO detector did not work when tested. Recommend evaluation and repair as needed.

107: CO detector noted to be missing.
