May 10, 2020

Paula Tomera
Lander County Convention & Tourism Authority
470 S. Broad St.
Battle Mountain, NV 89820

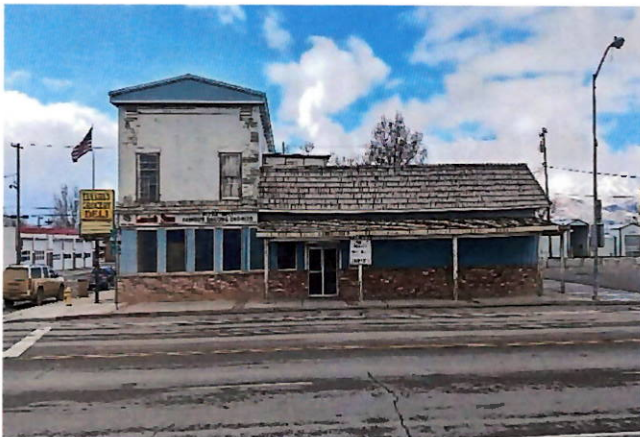
Picture 1 – Exterior Elevation - Current (Front St)

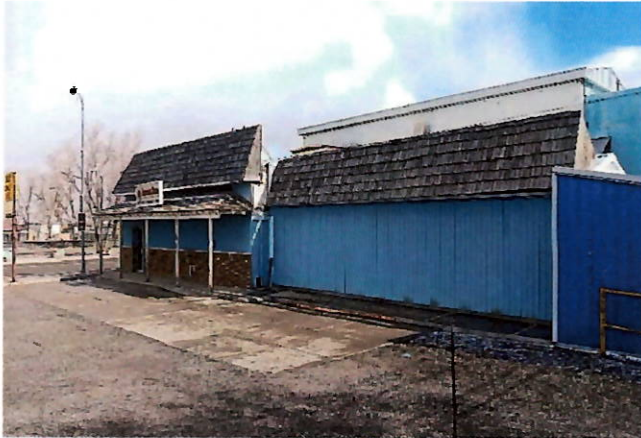
Picture 3 – Exterior Elevation (Looking East)

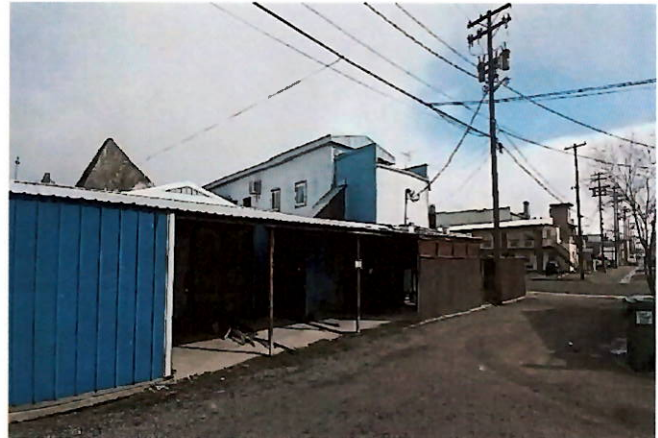
Picture 4 – Exterior Elevation (Looking North)

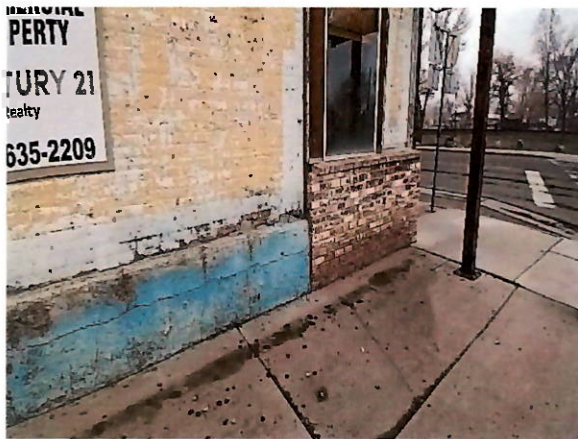
Picture 5 – Exterior Elevation

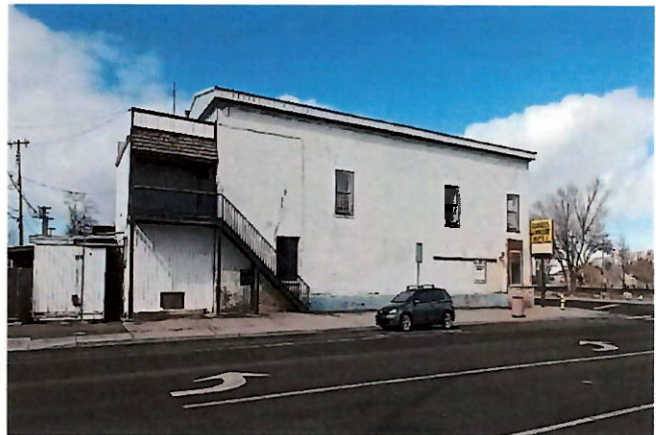
Picture 6 – Exterior Elevation (Broad St).

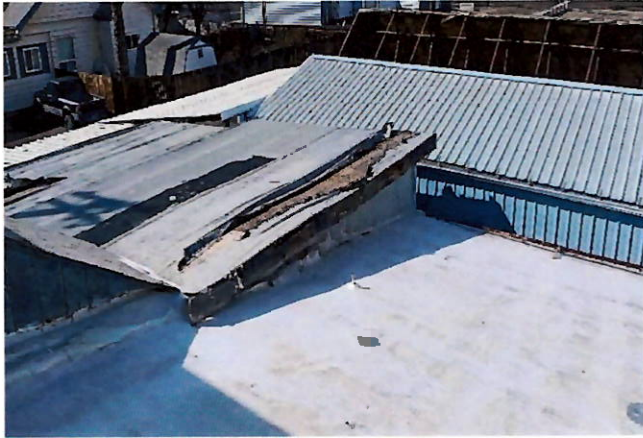
Picture 7 – Damaged Roofing

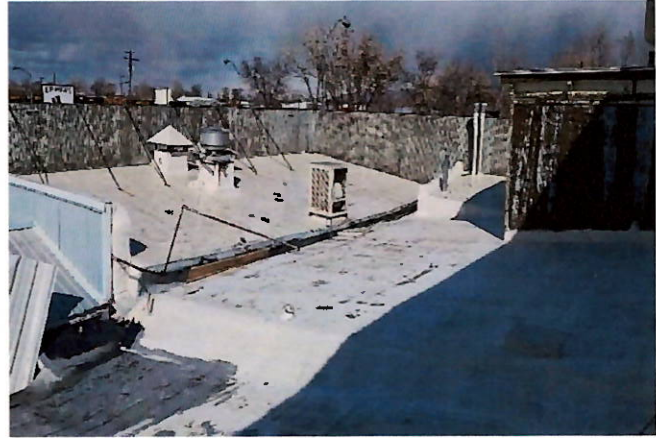
Picture 8 – Roofing with Mechanical

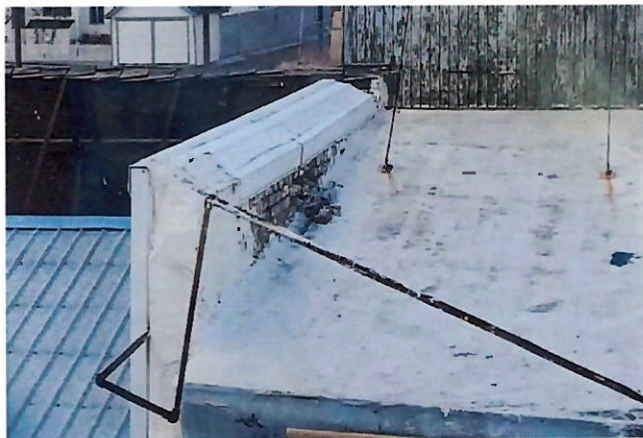
Picture 9 – Parapet Failure and Piping

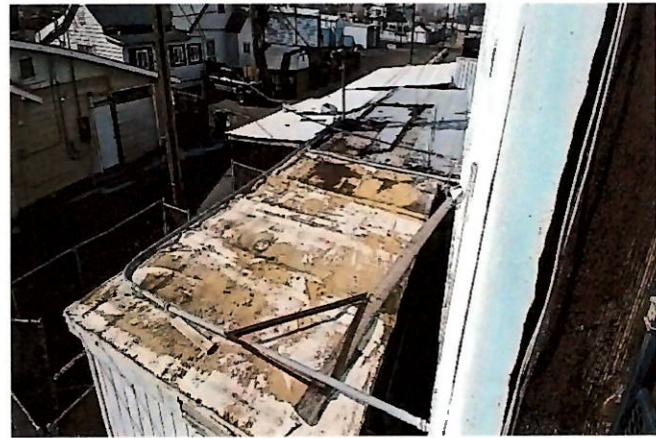
Picture 10 – Roofing Failure

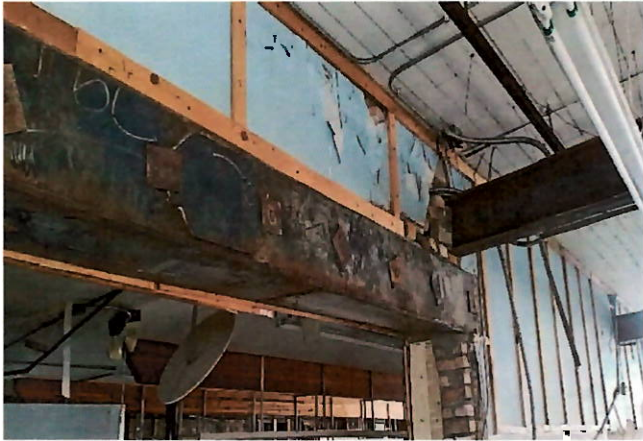
Picture 11 – Retrofitted Header

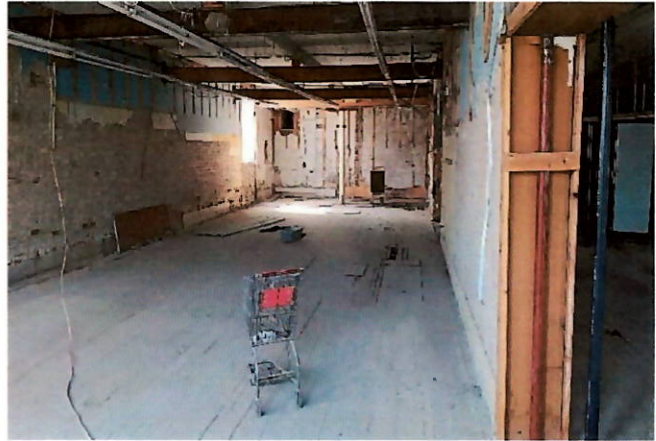
Picture 12 – Interior Framing

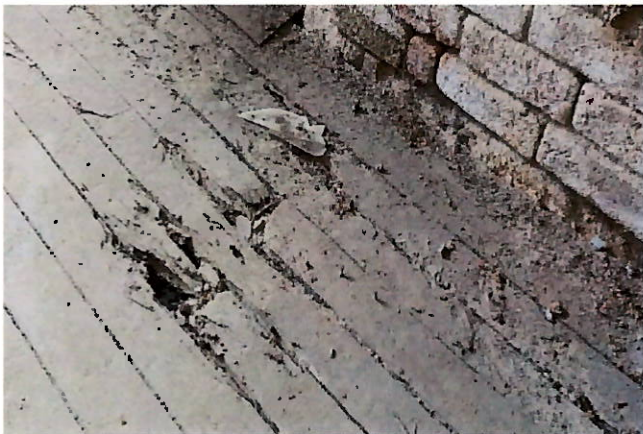
Picture 13 – Flooring Insect Damage

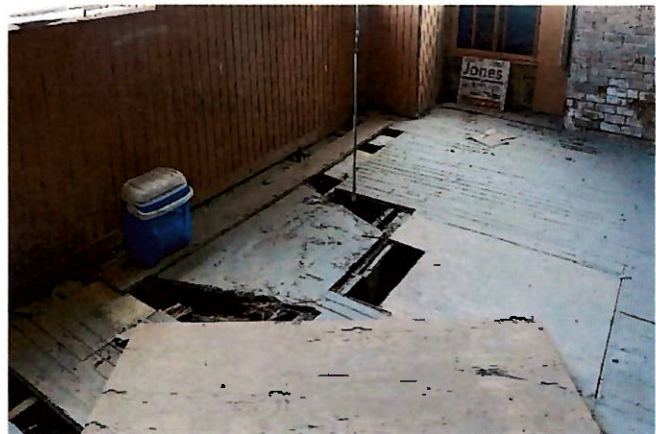
Picture 14 – Flooring Damage

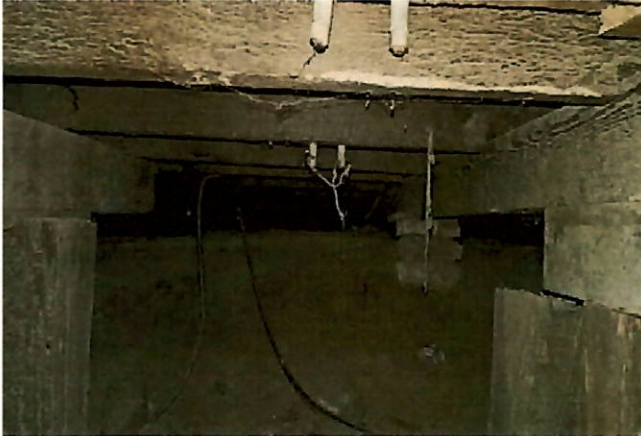
Picture 15 – Existing Floor Joists and Decayed Brick Footings

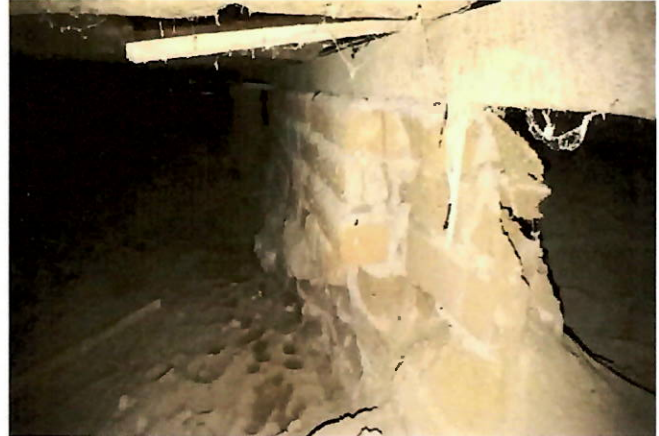
Picture 16 – Existing Floor Joists and Decayed Brick Footings

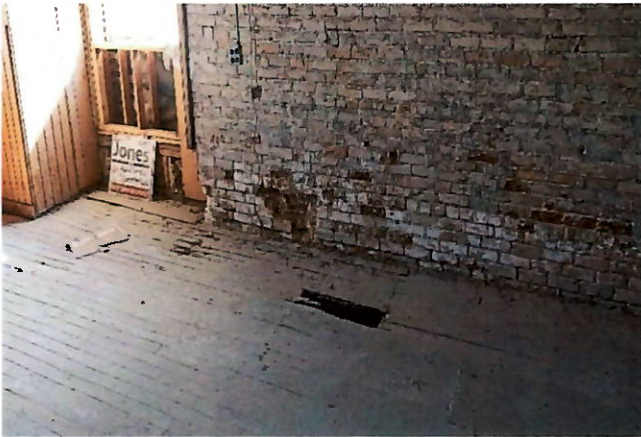
Picture 17 – Decayed Brick – First Floor

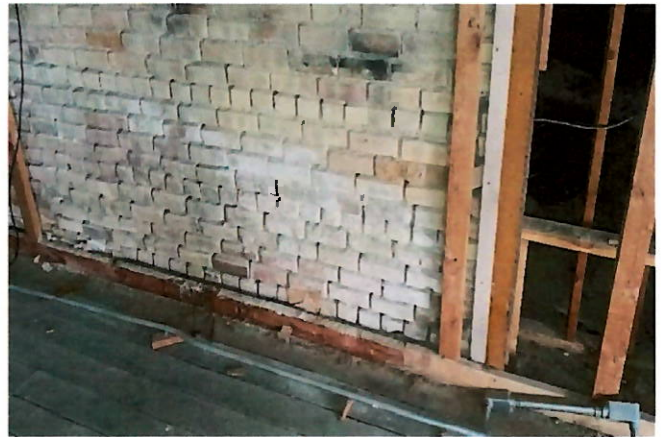
Picture 18 – Decayed Brick – First Floor

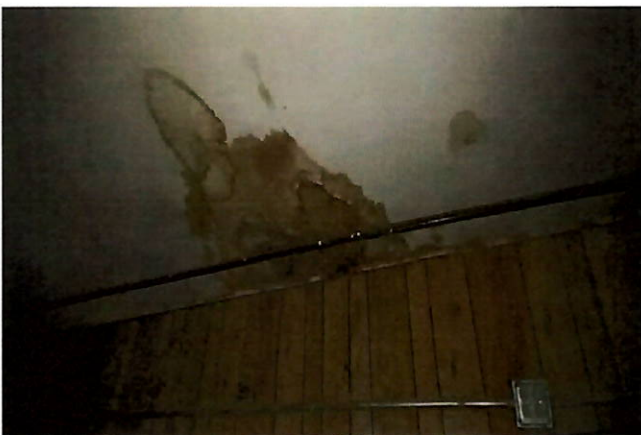
Picture 19 – Water Damage at Ceiling

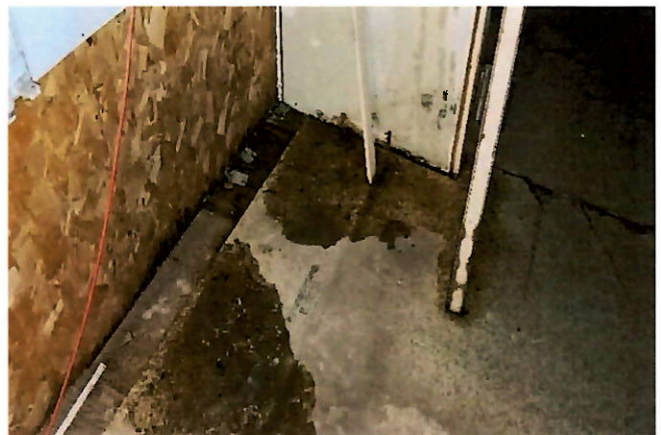
Picture 20 – Water Damage at Floor
