1 West Regent Street, Glasgow

A Post-Occupancy Evaluation

Final Report

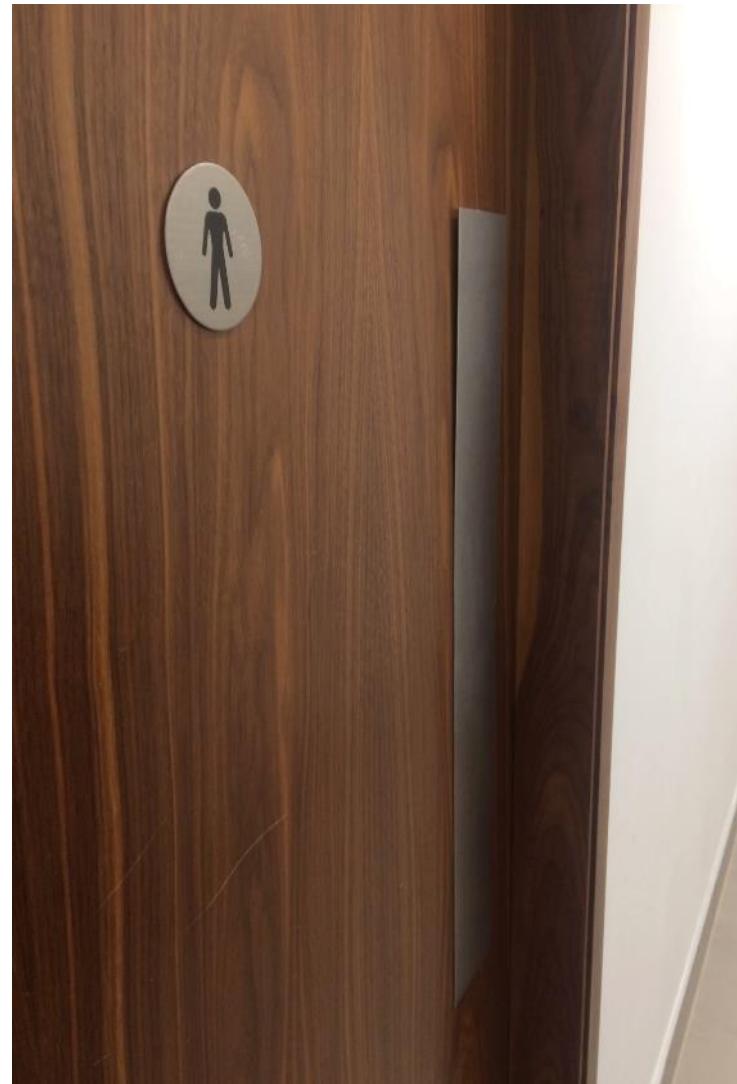
Whilst the screwless finish looked nice, initially, it has aged poorly, quickly. Many are warped and no longer lay flat against the door, and some have been retrofit with screws to help keep them fastened and flat (Figure 2).

Figure 1 – Warped door push plate

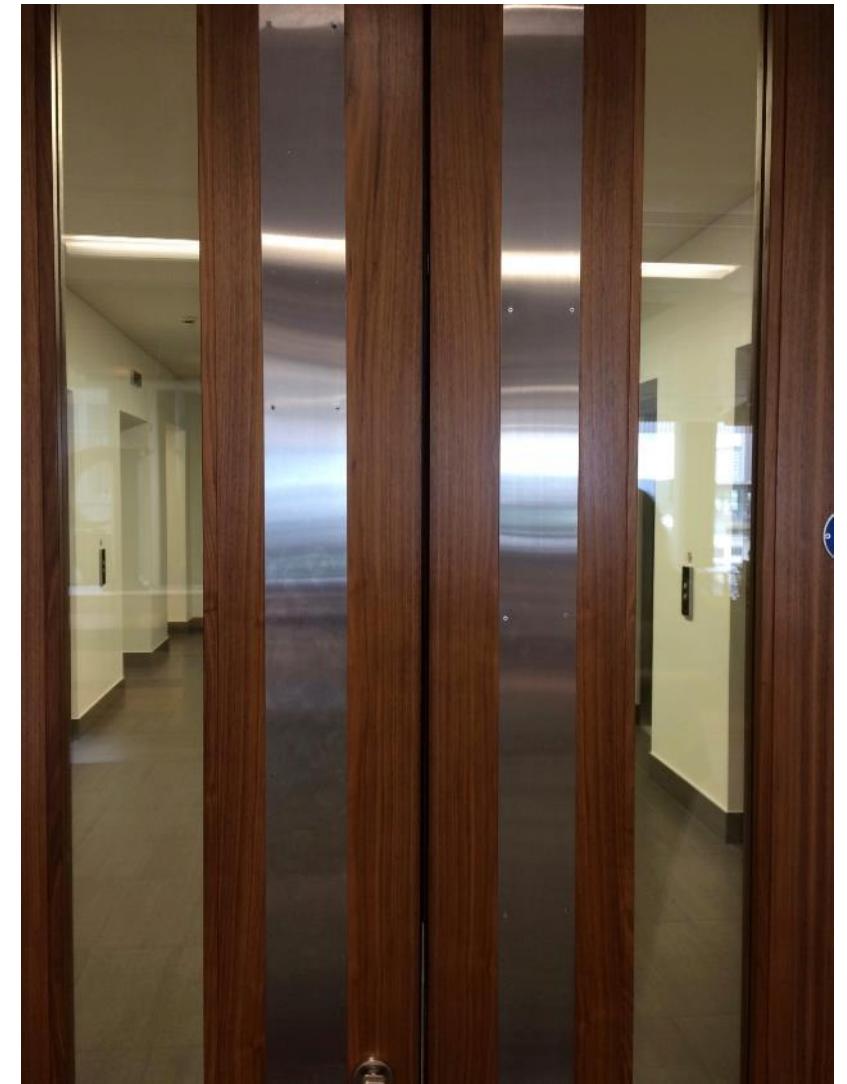
Figure 2 – Screws on door push plates

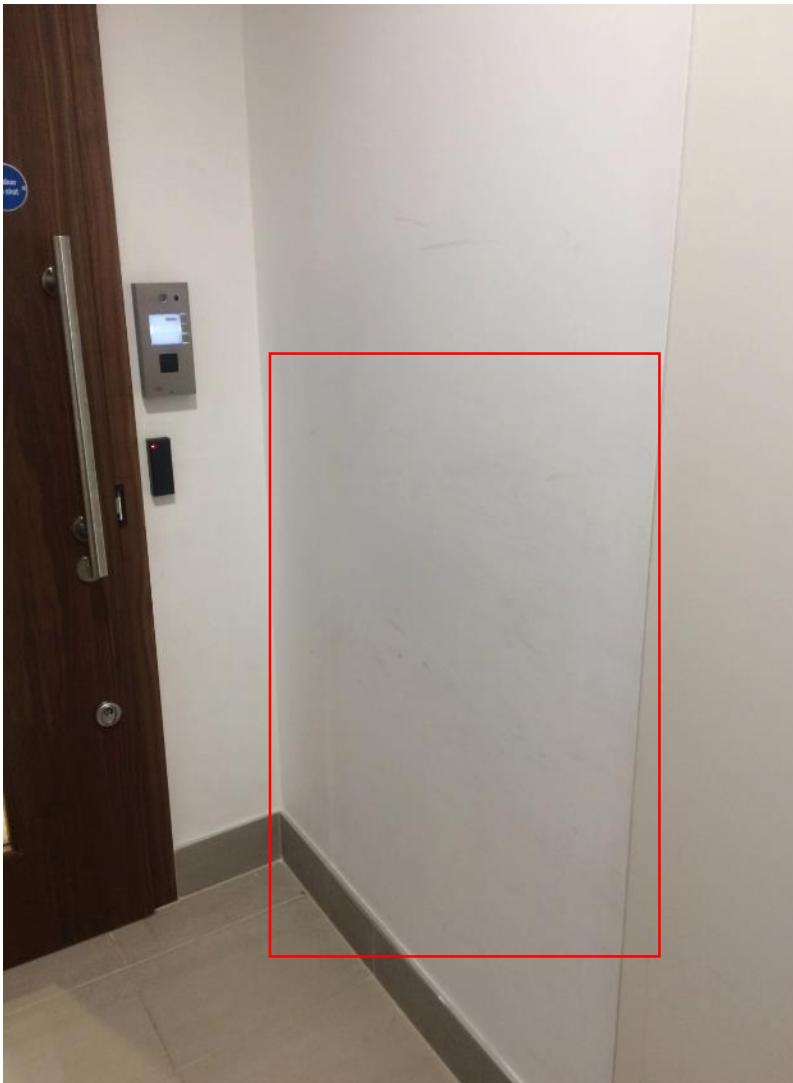
Figure 3 – Heavily marked wall

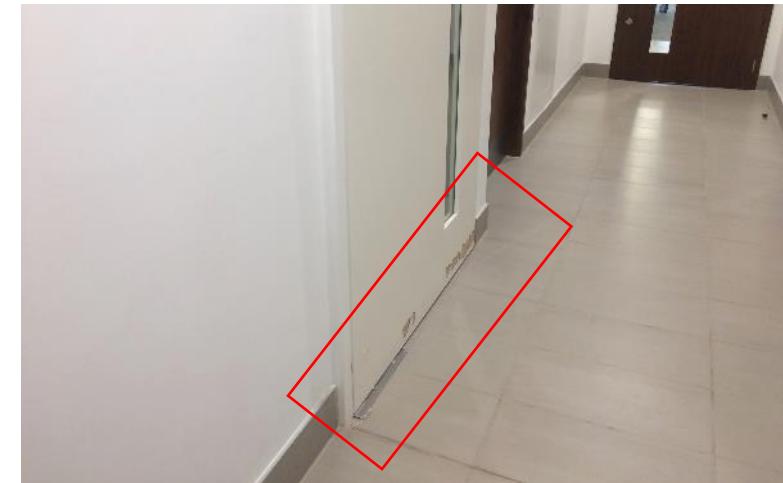
Figure 4 – Missing kick plate

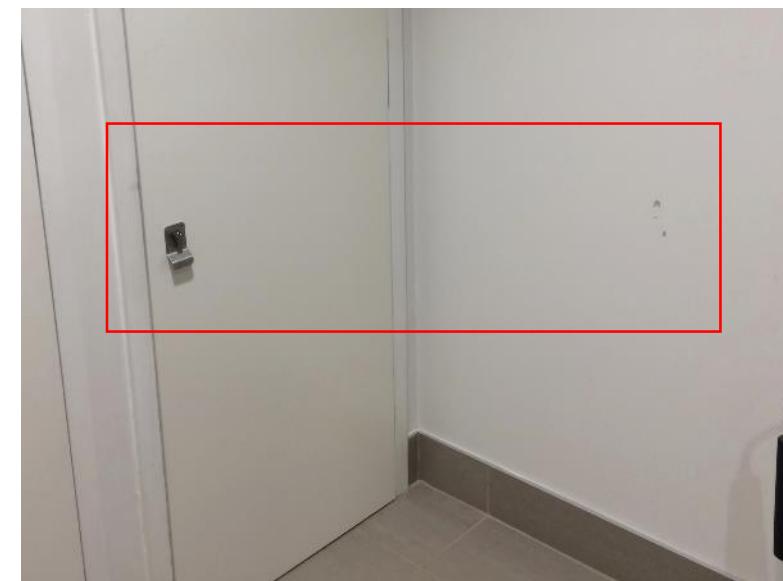
Figure 5 – Damaged wall from lack of stopper

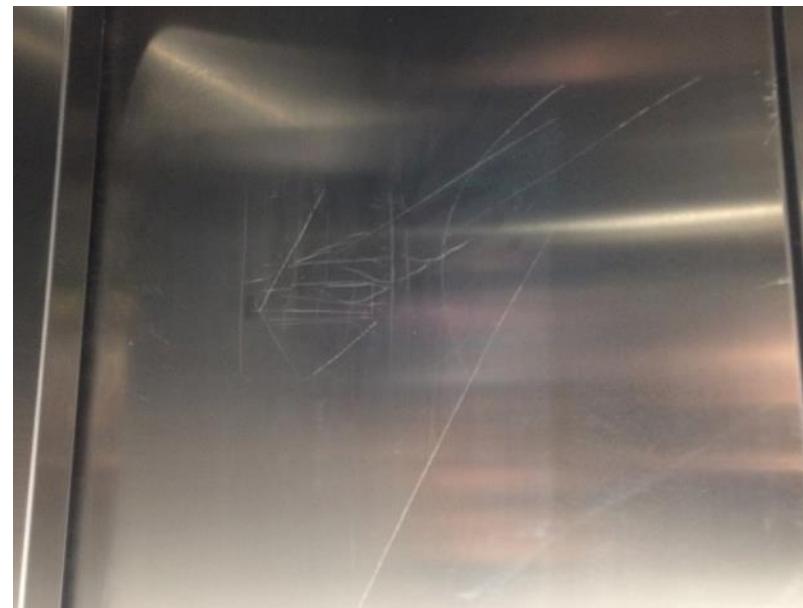
The surfaces of lift panels were scratched. One panel in particular was noted to be vandalism, but there were scratches on other panels which were due to people's bags in the lift, etc. Tenants felt that it made the lifts look scruffy and a more durable finish may have been more effective.

Figure 6 – Vandalism inside one of the lift doors

It might be useful in the future to ‘bench test’ finishes in high use areas such as lifts, for example by scratching at them a little with a set of keys, etc., to see how well they tolerate use and potential abuse.

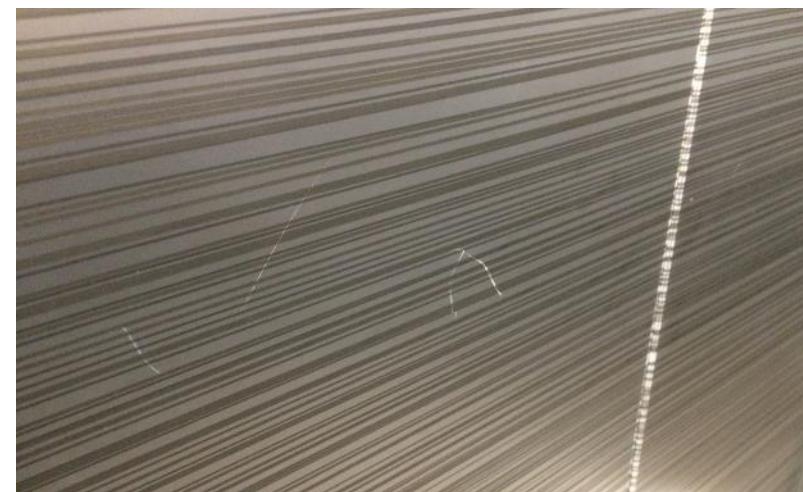
Figure 7 – Scratched screen-printed stainless lift panels

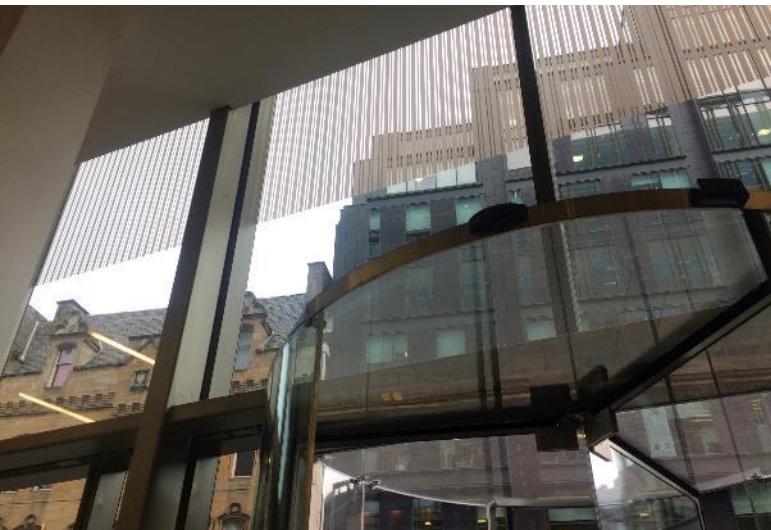
Figure 8 – 3 layers of glass visible, including the flat roof, partitions and upper wall

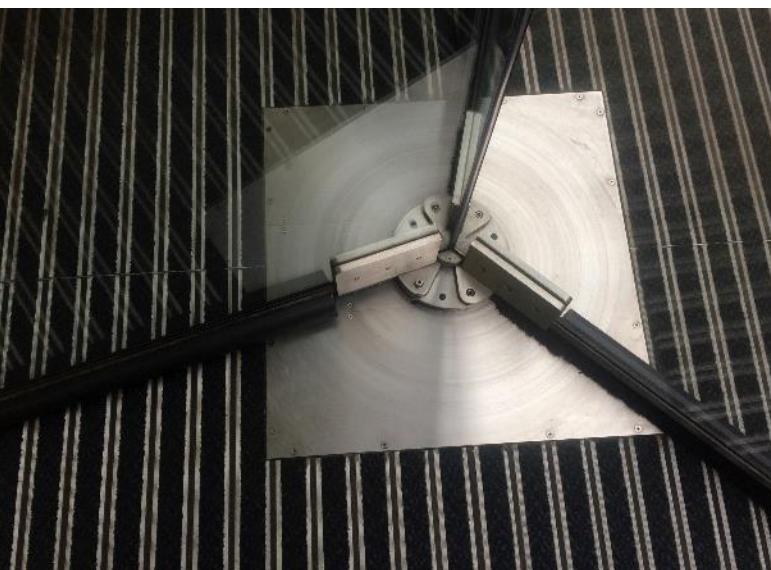
Figure 9 – Marked stainless fixing plate

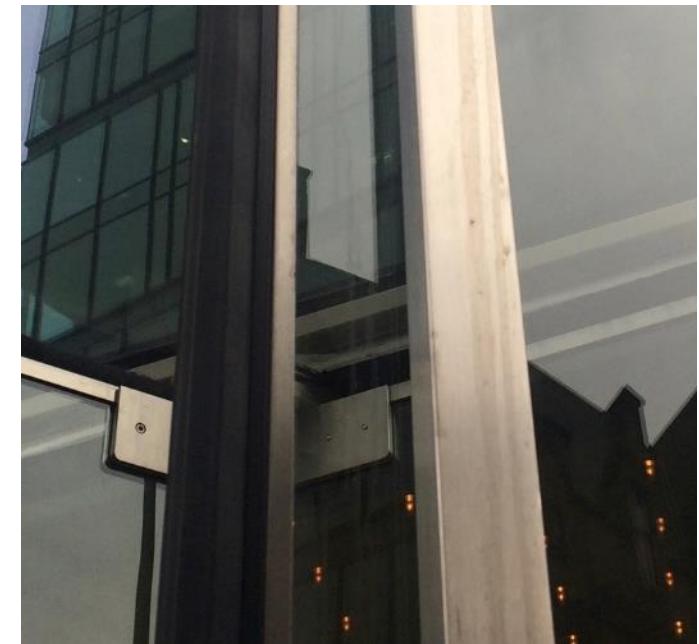
Figure 10 – Marked stainless, from rain runoff

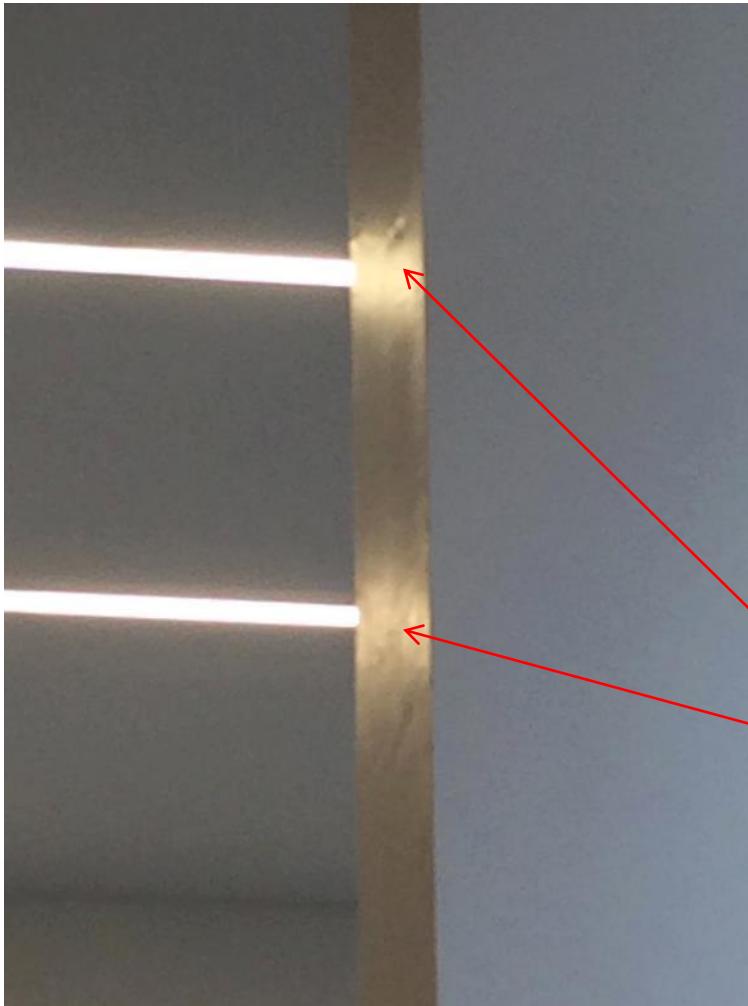
Polished plaster was a finish requested by the client). The plaster finish does not look either smooth, nor intentionally distressed, but rather uneven. As a result, the surface was skimmed and painted over, but some unevenness remains.

Figure 12 – Polished plaster (reception column), with light reflecting off

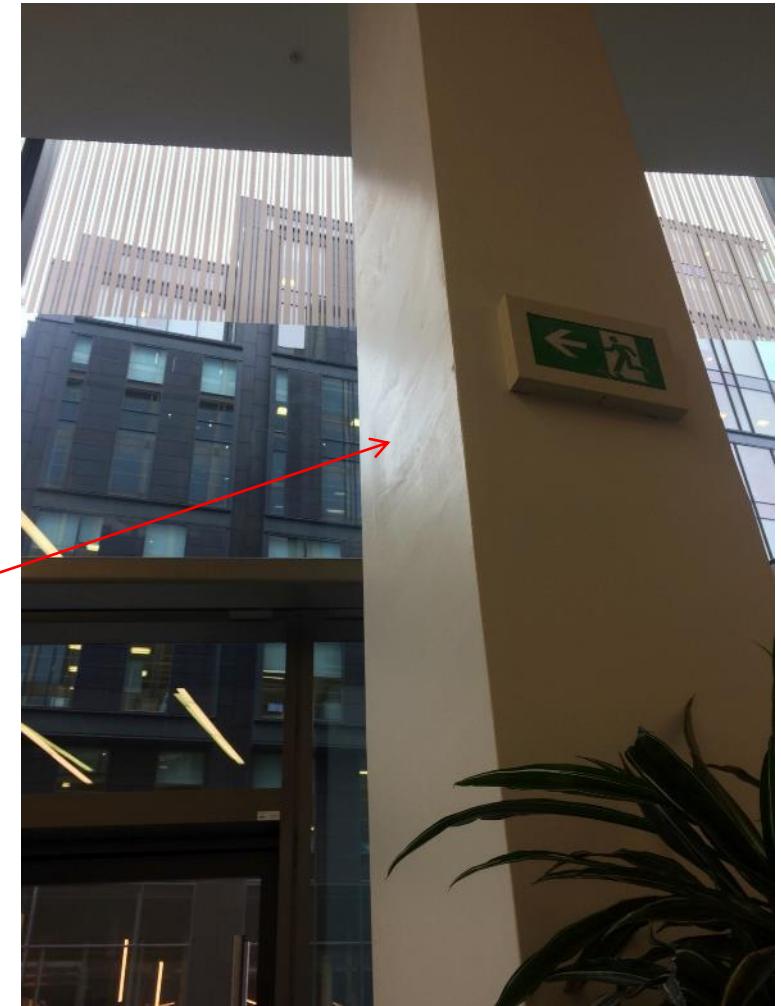
Figure 13 – Polished plaster (reception column)
