Home Inspection Report

137 S. Sheperd St. , Sonora, CA 95370

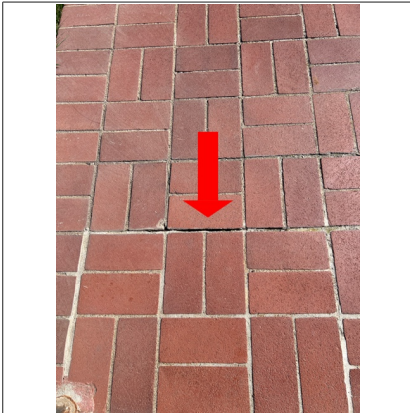
ITEM: 1:1. There is mortar missing at a small section of the front walkway

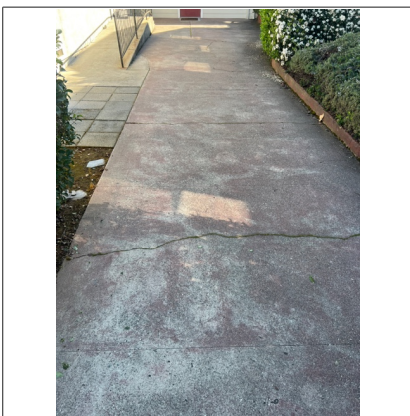
There are typical cracks present in the driveway

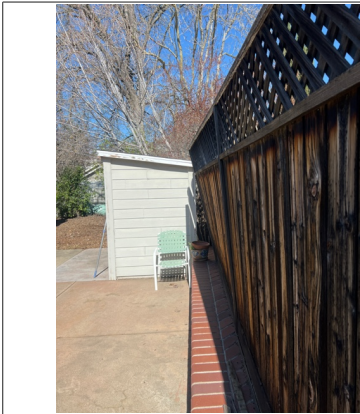
ITEM: 1:2. As with any fence that is built directly in the ground, there are damaged, worn, weathered and loose wood members present at various areas

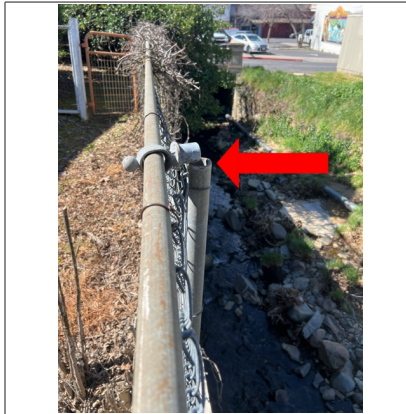
ITEM: 1:2. As with any fence that is built directly in the ground, there are damaged, worn, weathered and loose wood members present at various areas

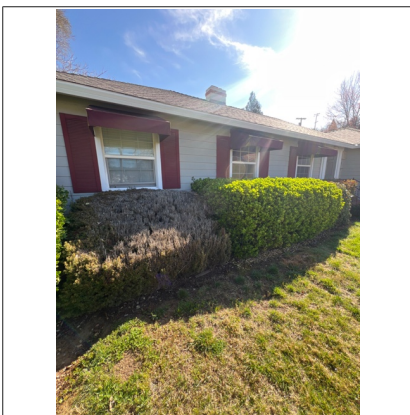
ITEM: 1:3. There are planted shrubs at the exterior which are slightly in contact with the structure

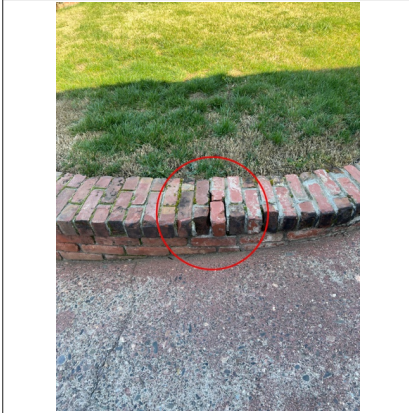
ITEM: 1:4. There is a small damaged section of retaining wall adjacent to the driveway

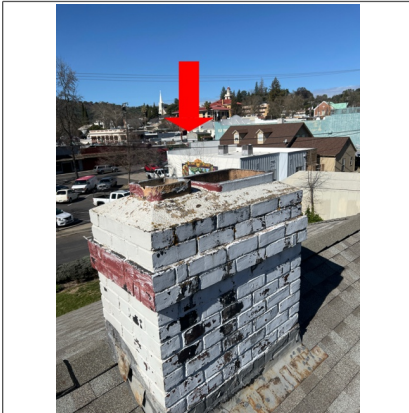
ITEM: 2:1. There was no rain cap installed at the top the chimney

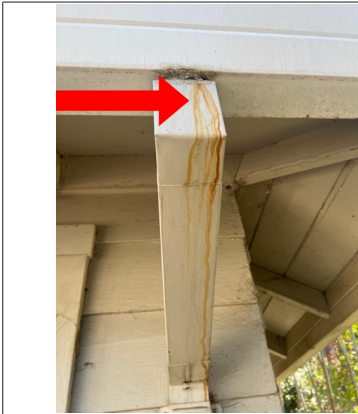
ITEM: 2:2. One or more of the gutter downspouts are stained indicating a possible leak

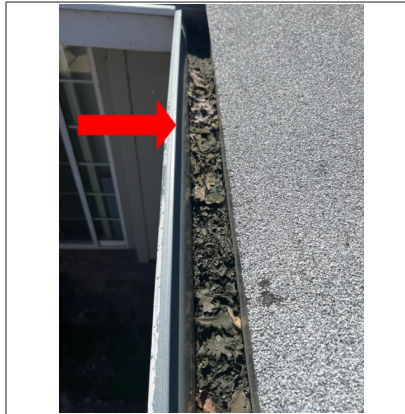
ITEM: 2:3. Portions of the insides of the gutters are full of debris and grass

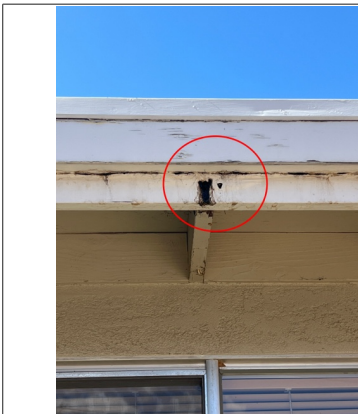
ITEM: 2:4. There is dry rot damage present at the back fascia board

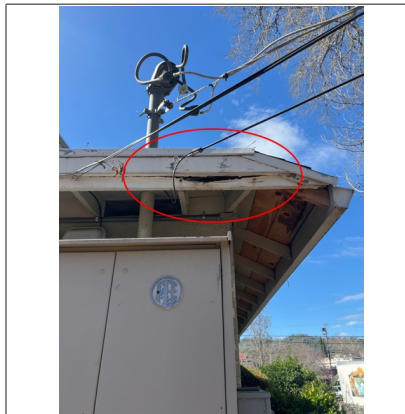
ITEM: 2:4. There is dry rot damage present at the back fascia board

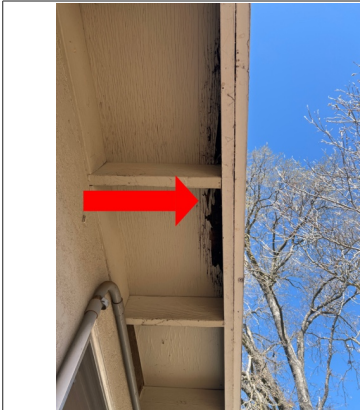
ITEM: 2:5. There is dry rot damage present at the back roof sheathing

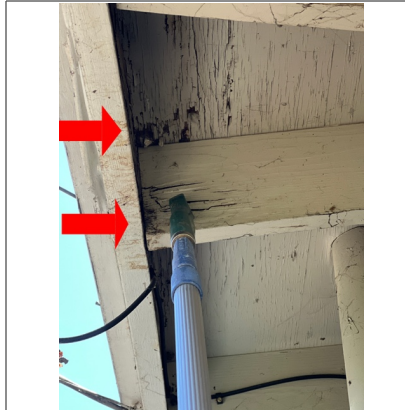
ITEM: 2:5. There is dry rot damage present at the back roof sheathing and rafter tails

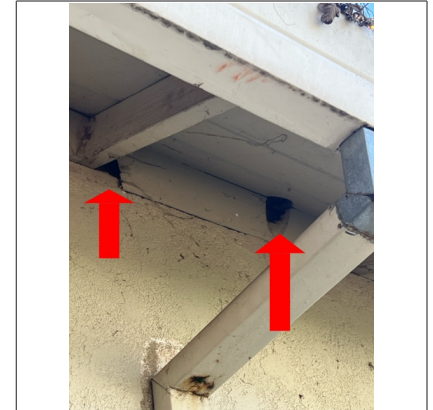
ITEM: 2:6. There are holes in the eaves at the back left corner of the structure

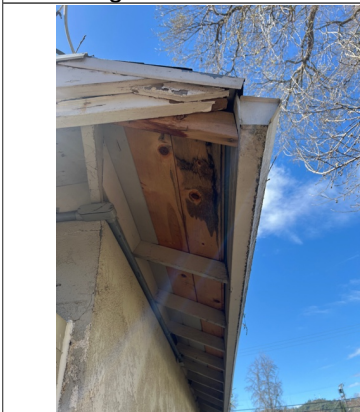
ITEM: 2:7. There are water stains noted at the wood members in the eaves which may indicate a possible roof leak

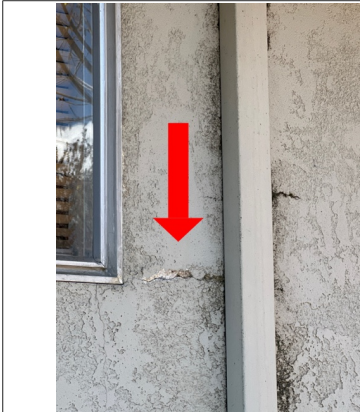
ITEM: 2:8. There are cracks noted in the stucco at various locations

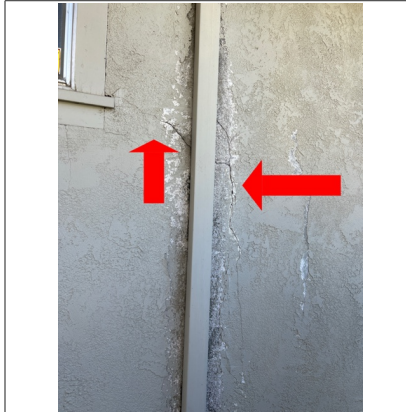
ITEM: 2:8. There are cracks noted in the stucco at various locations

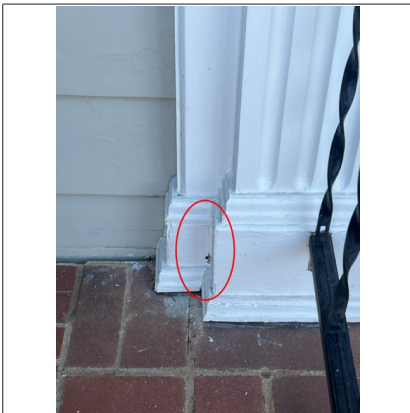
ITEM: 2:9. There is dry rot damage present of the front porch cover trim

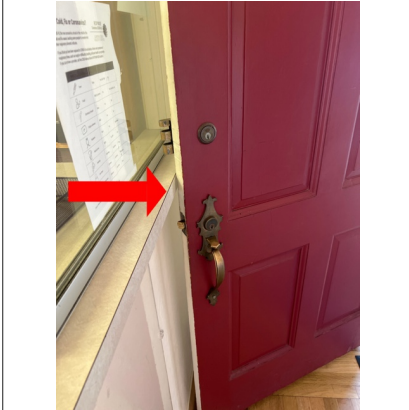
ITEM: 2:10. There is no door stop present at the front entrance door

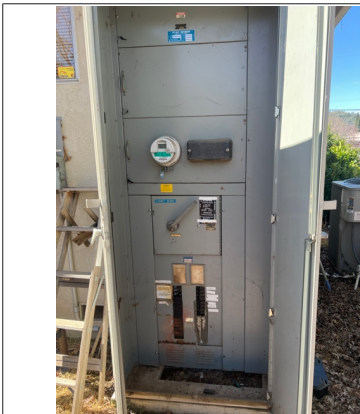
Image of the electrical service panel

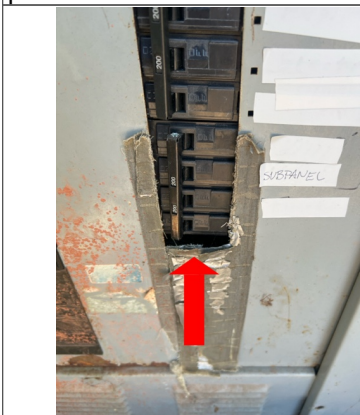
ITEM: 2:11. The dead head Cover at the main electrical service entry panel is loose and there is one or more missing circuit breaker blank cover plates

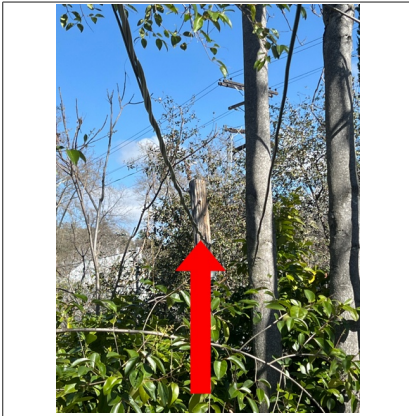
ITEM: 2:12. The electrical service entry wires are lower than 12 feet from the ground and are slightly in contact with some tree limbs

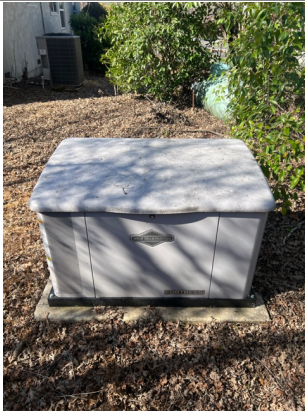
Image of the generator

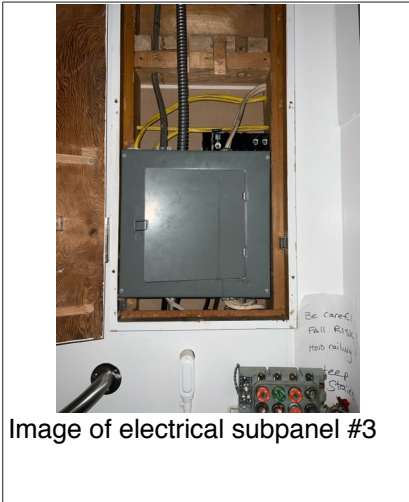
Image of electrical subpanel #3

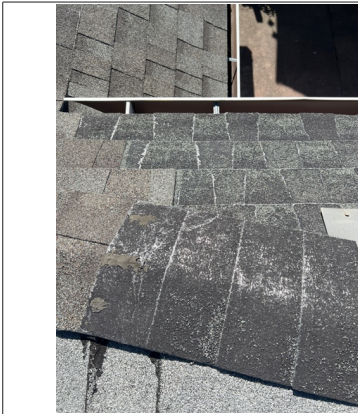
ITEM: 4:1. Several of the roof and ridge shingles at the roof appeared to have lost their granules and are worn

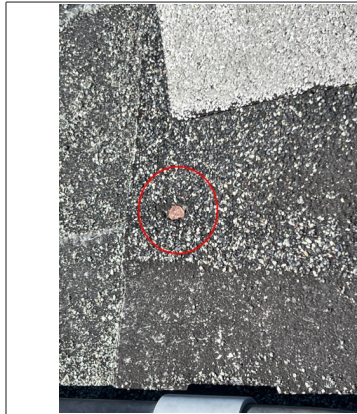
ITEM: 4:2. There are exposed and loose nails at the roofing material at one or more areas

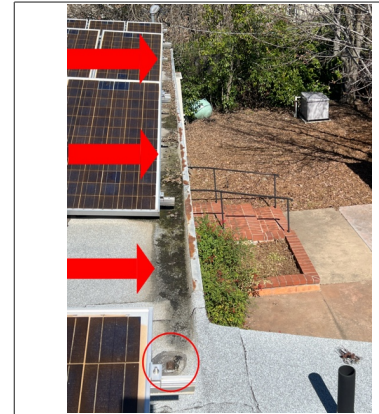
ITEM: 4:3. There is debris present on the roofing at the backside of the structure which appears to be obstructing the flow of water

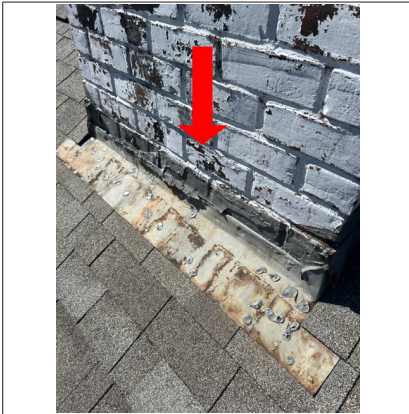
ITEM: 4:4. A section of the counter flashing at the chimney is missing

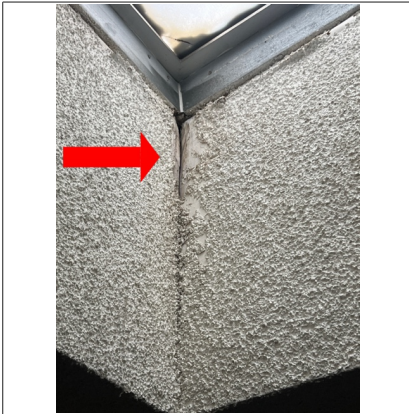
ITEM: 4:5. There is water damage visible at the back skylight area as viewed from the interior of the structure

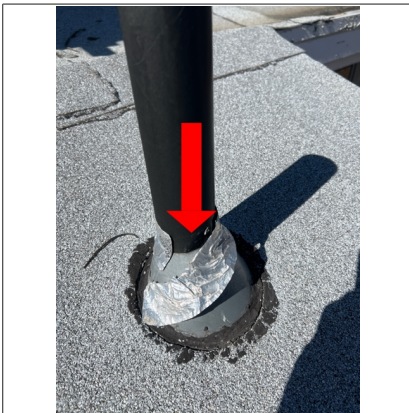
ITEM: 4:6. The sealant that was used around the back plumbing stack or vent at the roof is coming loose

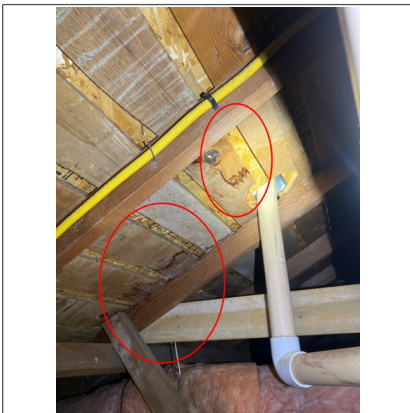
ITEM: 5:1. There are moisture stains on the roof sheathing as viewed from within the attic area

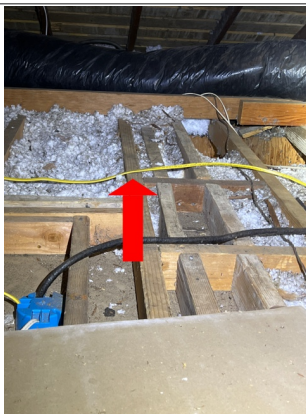
ITEM: 5:2. Portions of the wiring in the attic are loose and improperly terminated

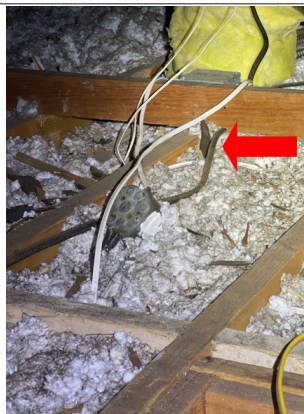
ITEM: 5:2. Portions of the wiring in the attic are loose and improperly terminated

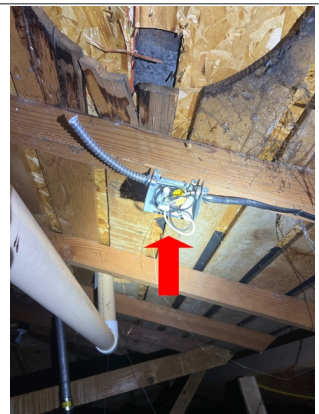
ITEM: 5:3. There are missing cover plates at one or more of the electrical junction boxes in the attic

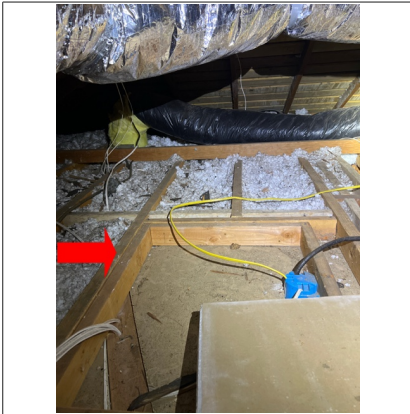
ITEM: 5:4. The attic insulation does not appear to be of adequate depth or properly installed

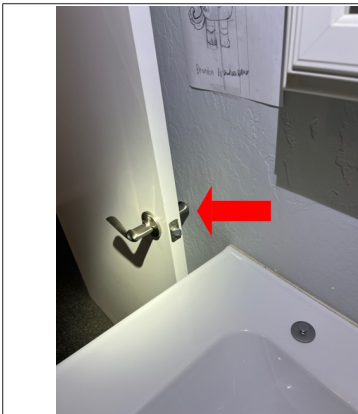
ITEM: 6:1. There are missing doorstops at one or more of the interior doors

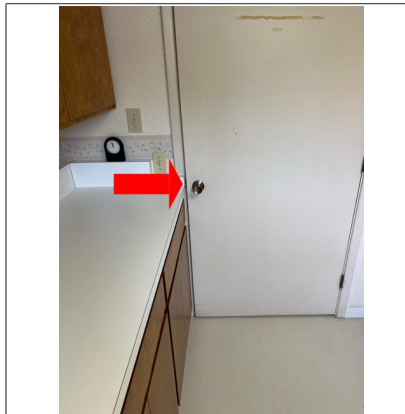
ITEM: 6:2. The entry door to exam room #1 does not properly latch

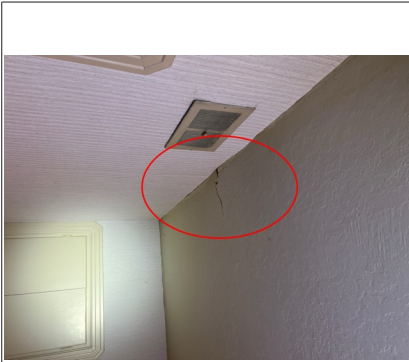
ITEM: 6:4. There are damaged and cracked sections of drywall throughout the structure

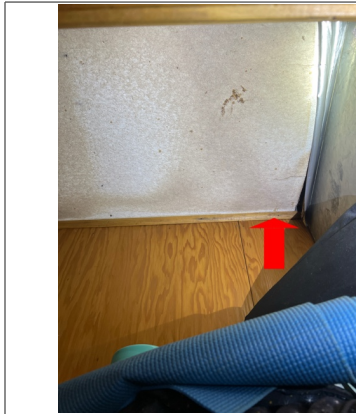
ITEM: 6:4. There are damaged and cracked sections of drywall throughout the structure

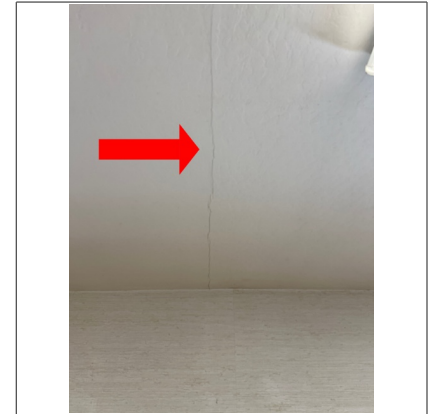
ITEM: 6:4. There are damaged and cracked sections of drywall throughout the structure

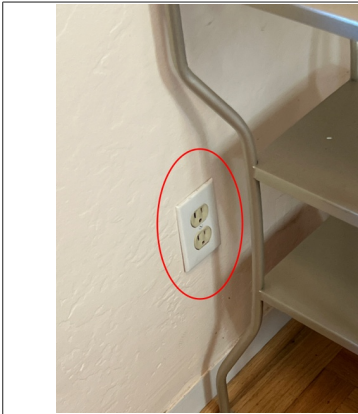
ITEM: 6:5. One or more receptacles throughout the structure have an open ground

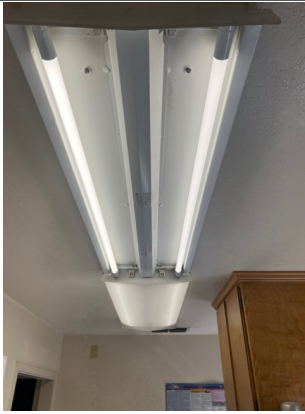
ITEM: 6:8. There are missing light lenses in one or more areas throughout the structure

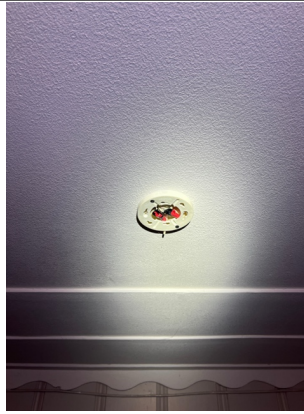
ITEM: 6:9. There is a missing cover plate with exposed electrical wires present in the ceiling of the exam room at the left center portion of the structure

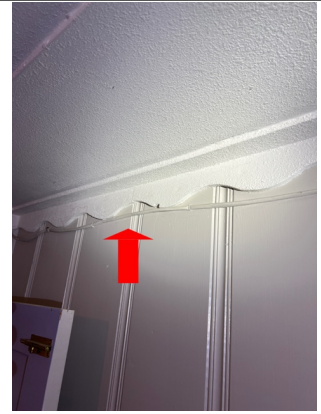
ITEM: 6:10. There is a surface mounted electrical wire present downstairs in the bedroom

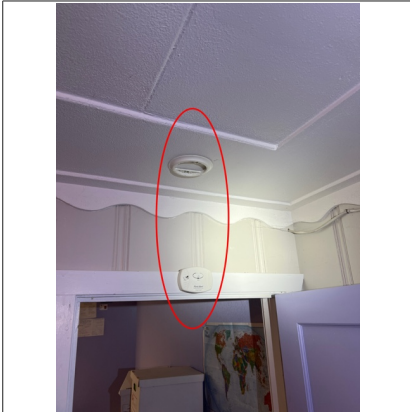
ITEM: 6:11. The smoke detector is missing and the carbon monoxide detector is not operable in the downstairs bedroom

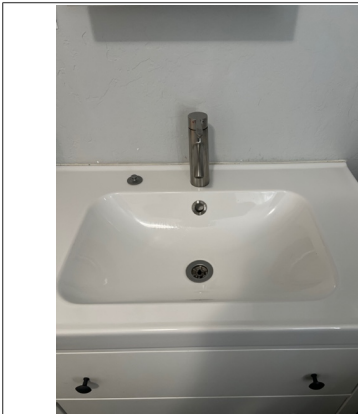
ITEM: 6:12. There is no running hot water at either of the front to left exam room sinks

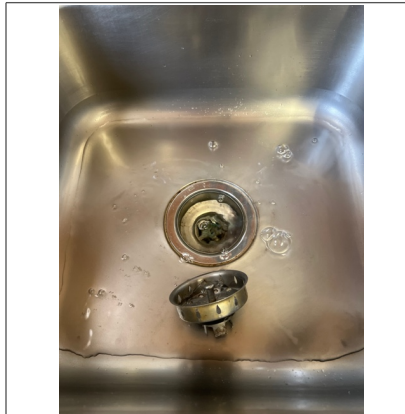
ITEM: 6:13. The drain at the sink is showing signs of backup (see photo). Having the sink drain evaluated and repaired as needed by a licensed plumbing contractor is recommended.

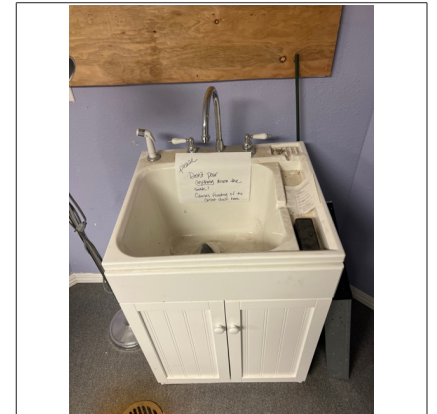
ITEM: 6:14. The sink in the basement area was not tested but appears to be loose

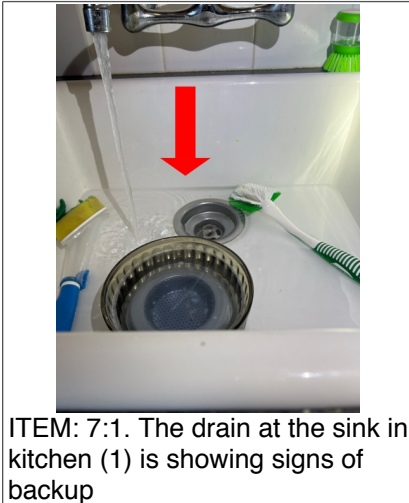
ITEM: 7:1. The drain at the sink in kitchen (1) is showing signs of backup

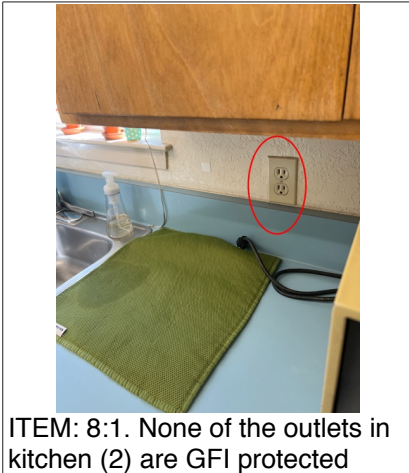
ITEM: 8:1. None of the outlets in kitchen (2) are GFI protected

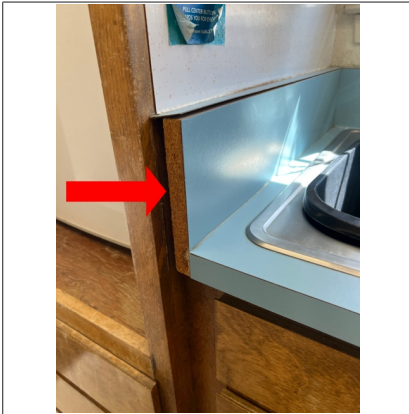
ITEM: 8:2. The edge piece at the Formica countertop in kitchen (2) is missing

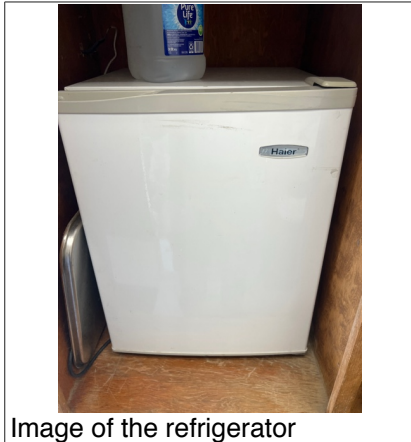
Image of the refrigerator

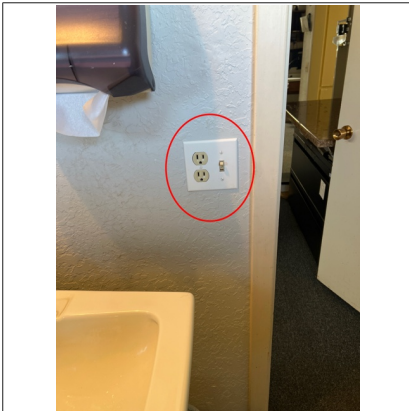
ITEM: 9:1. None of the outlets in the office and private bathrooms are GFI protected

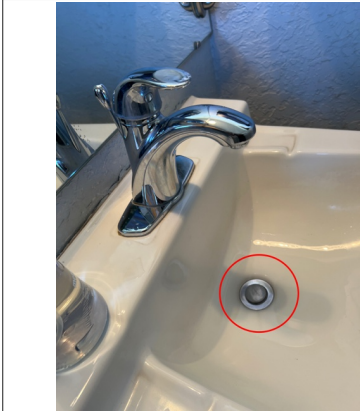
ITEM: 9:2. The stoppers at the back left and private bathroom sinks are not operable

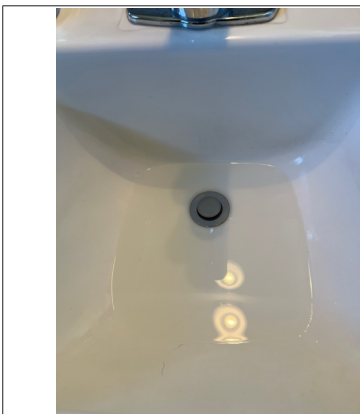
ITEM: 9:3. The water at the back left bathroom sink was draining slowly indicating a possible clog

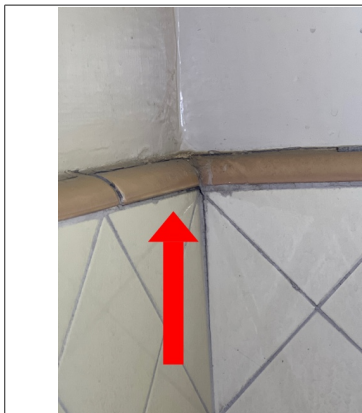
ITEM: 9:5. There are loose and cracked tiles at the private bathroom shower stall

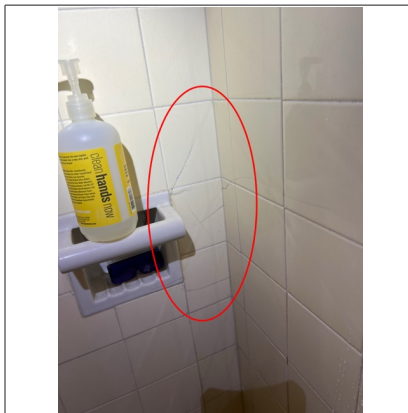
ITEM: 9:5. There are loose and cracked tiles at the private bathroom shower stall

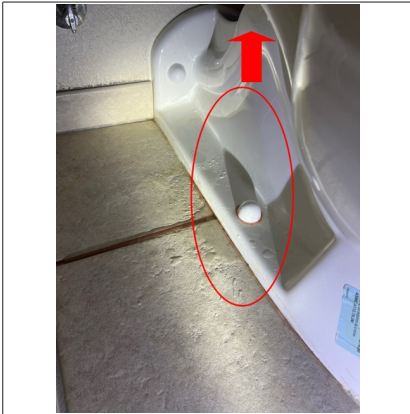
ITEM: 9:6. The commode at the exercise studio is leaking

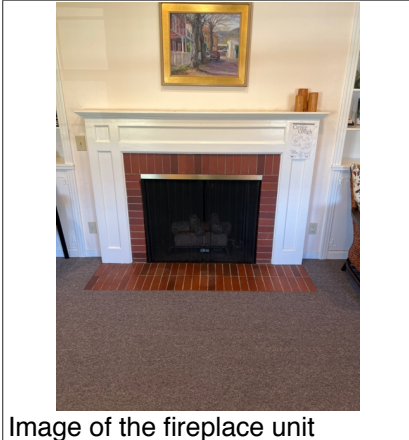
Image of the fireplace unit

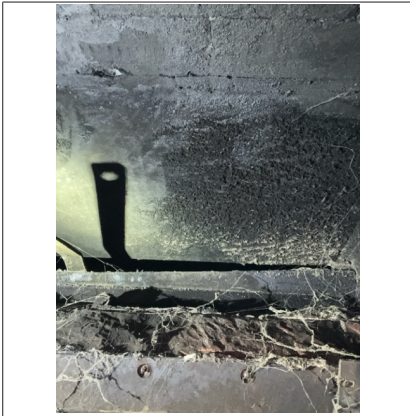
ITEM: 10:1. The interior of the fire box area of the fireplace has a build up of creosote

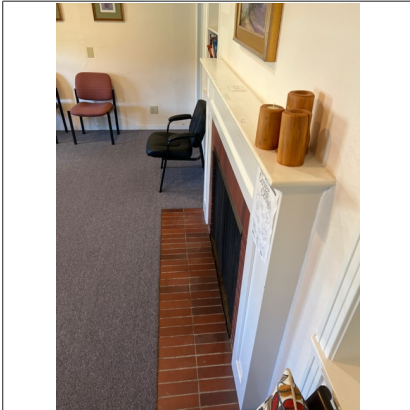
Image of the hearth and mantle

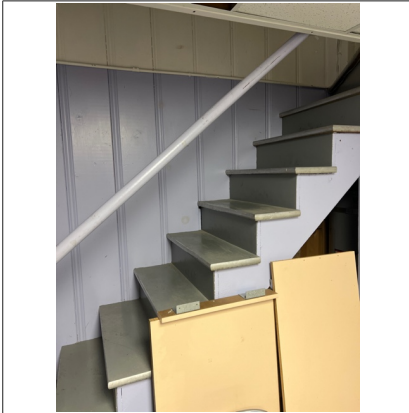
ITEM: 11:1. There are no balusters or horizontal railing installed at the stair railing

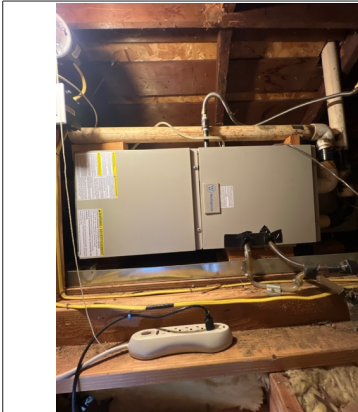
Image of furnace unit #1

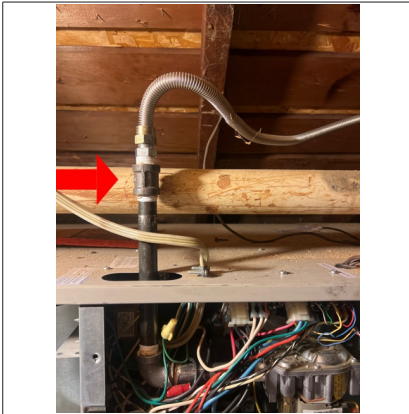
ITEM: 12:1. The gas supply line at furnace unit #2 contained no drip leg

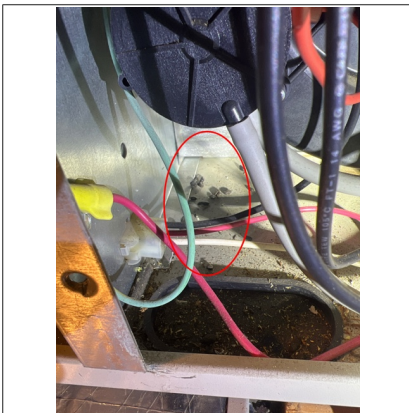
ITEM: 12:2. Evidence of rodents was present in and around the HVAC units

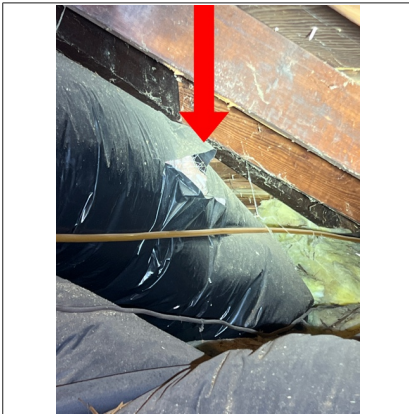
ITEM: 12:3. The plastic covering installed over the heating and air conditioning ducts over the exercise room is torn in one or more areas

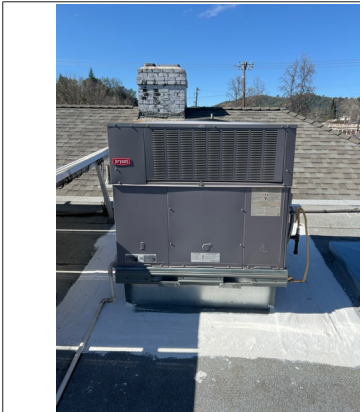
Image of the heat pump

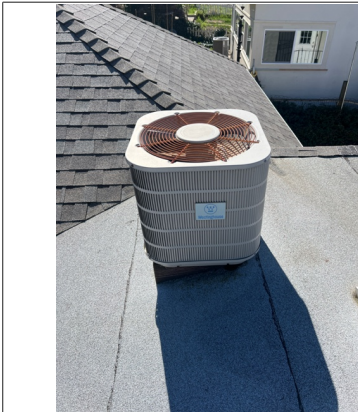
Image of AC condensing unit #1

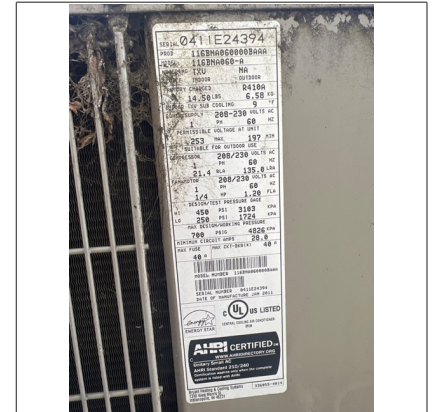
Image of the data plate at unit #2

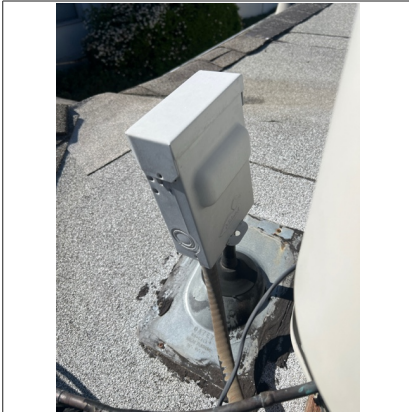
Image of the disconnect AC unit #1

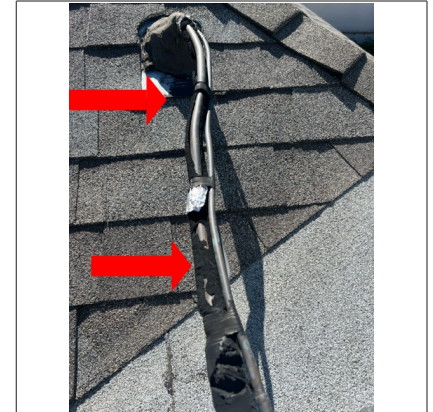
ITEM: 12:4. Sections of the insulation at the line set at both of the AC condensing units are torn and damaged

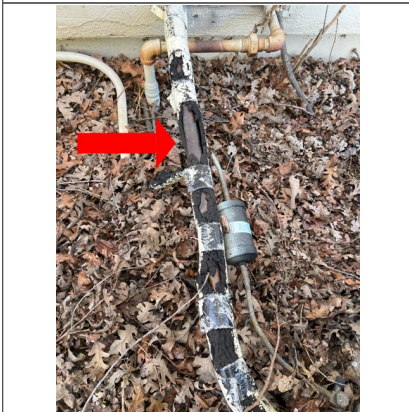
ITEM: 12:4. Sections of the insulation at the line set at both of the AC condensing units are torn and damaged

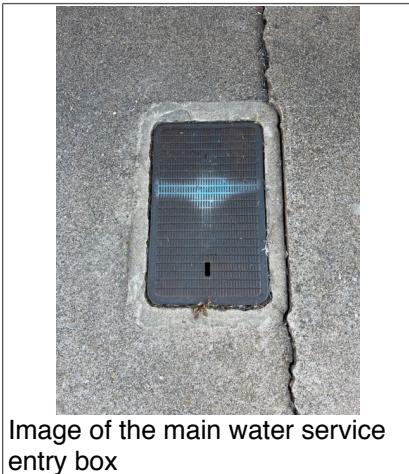
Image of the main water service entry box

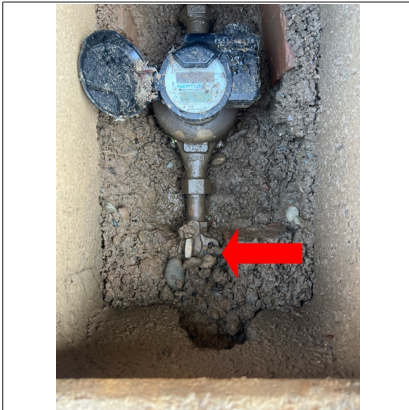
Image of the main water shut off valve in the service entry box

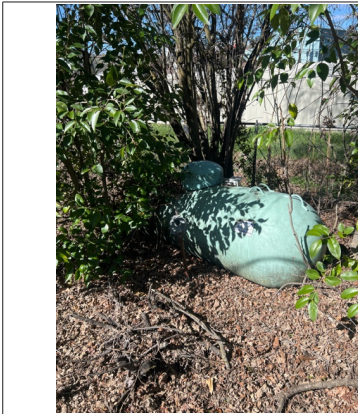
Image of the propane tank

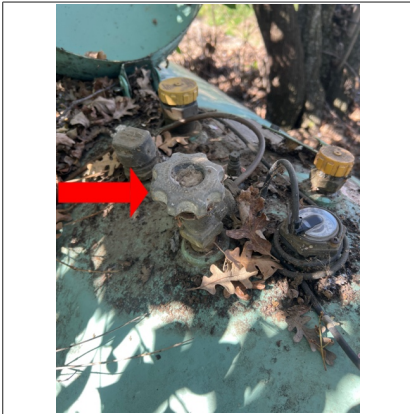
Image of the gas shut off valve on top of the tank

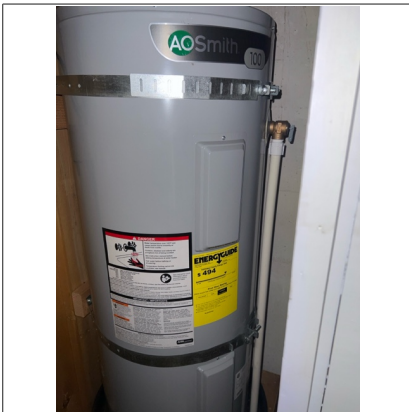
Image of the water heater

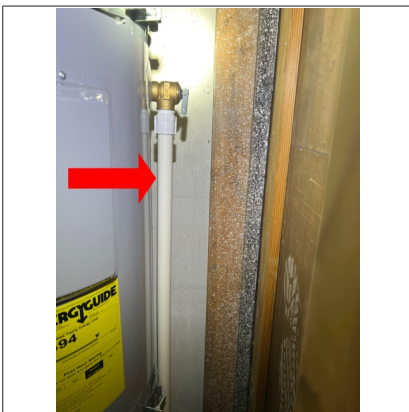
ITEM: 13:1. The material used for the discharge at the TPR valve at the water heater is insufficient

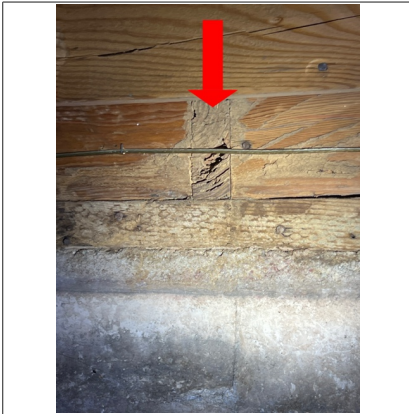
ITEM: 14:2. There is evidence of a wood pest infestation at the rim and floor joists

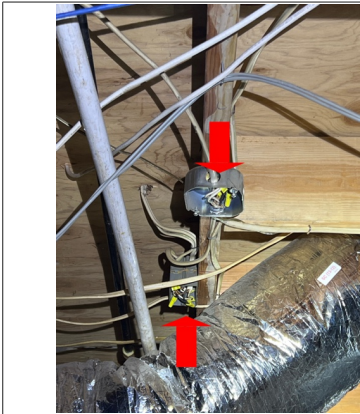
ITEM: 14:3. There are missing cover plates at one or more electrical junction boxes with exposed wires in the subarea

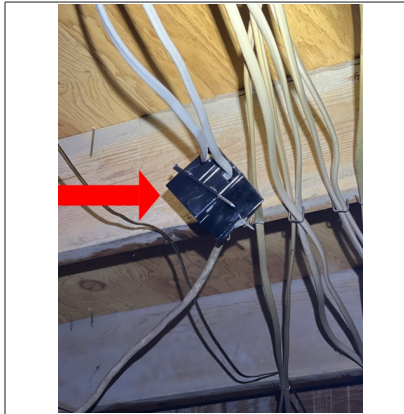
ITEM: 14:4. There is a loose and hanging electrical junction box in the sub area

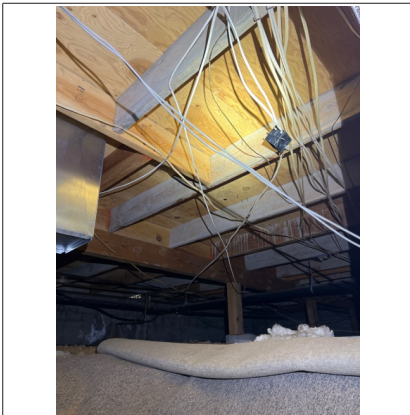
ITEM: 14:5. There is currently no insulation installed in the subarea
