Property Condition Assessment Report

711 Keller Parkway

EBI Project No. 1122002191

April 05, 2022

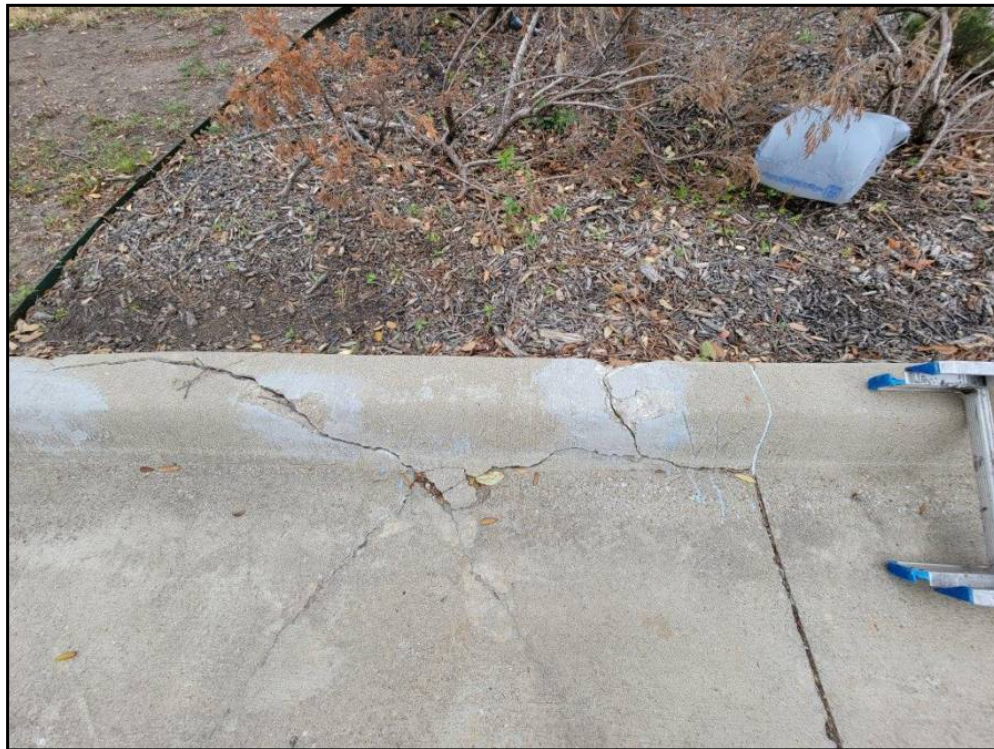
9 : Damaged curbing at southeastern corner of site.

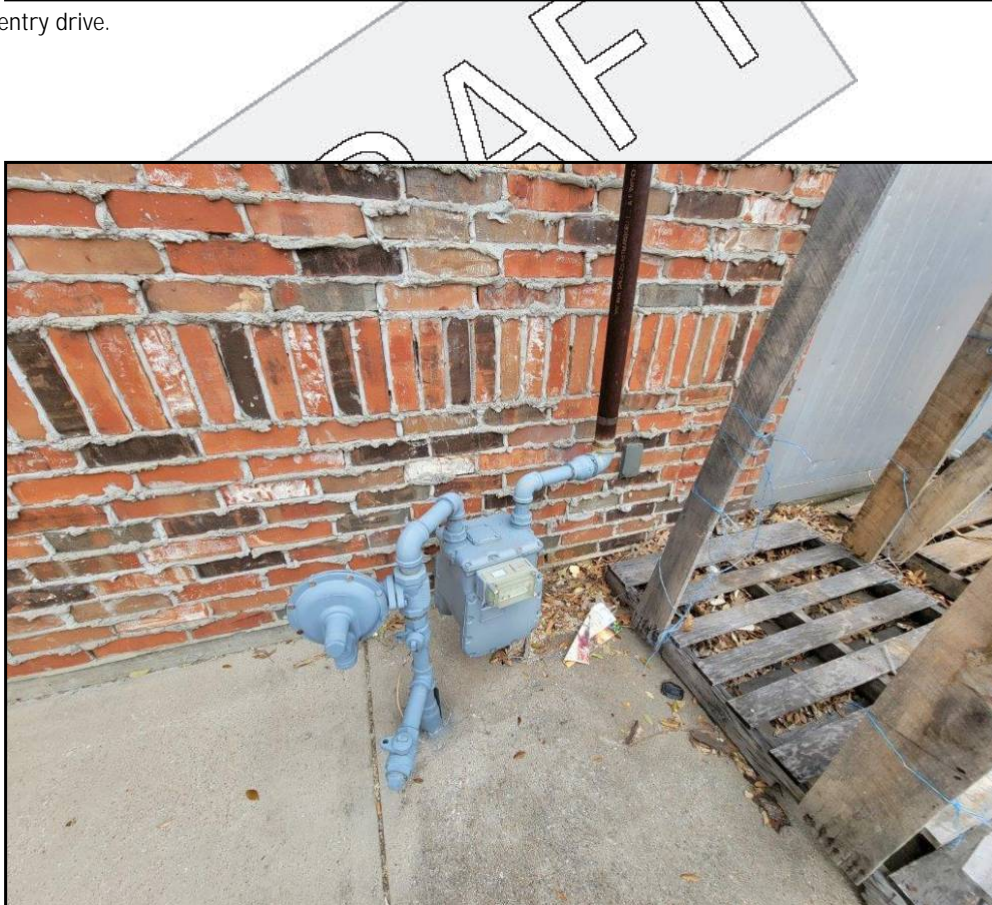
There were no reported or observed problems with the Subject Property gas connections, systems, sizes, or capacities. The utility appears to be configured and operated in a manner consistent with its intended use, adequate for the use type, and appears to be in good condition.

12 : Gas connections.

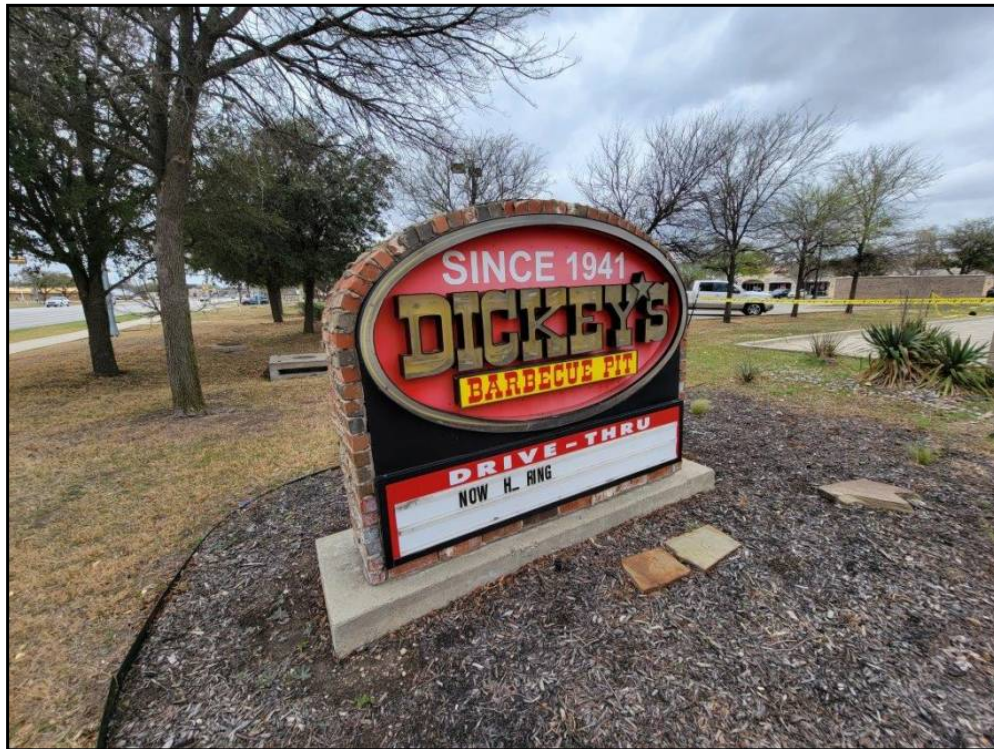
The property signage appears to be in good condition.

13 : Property signage in SWC of Property.

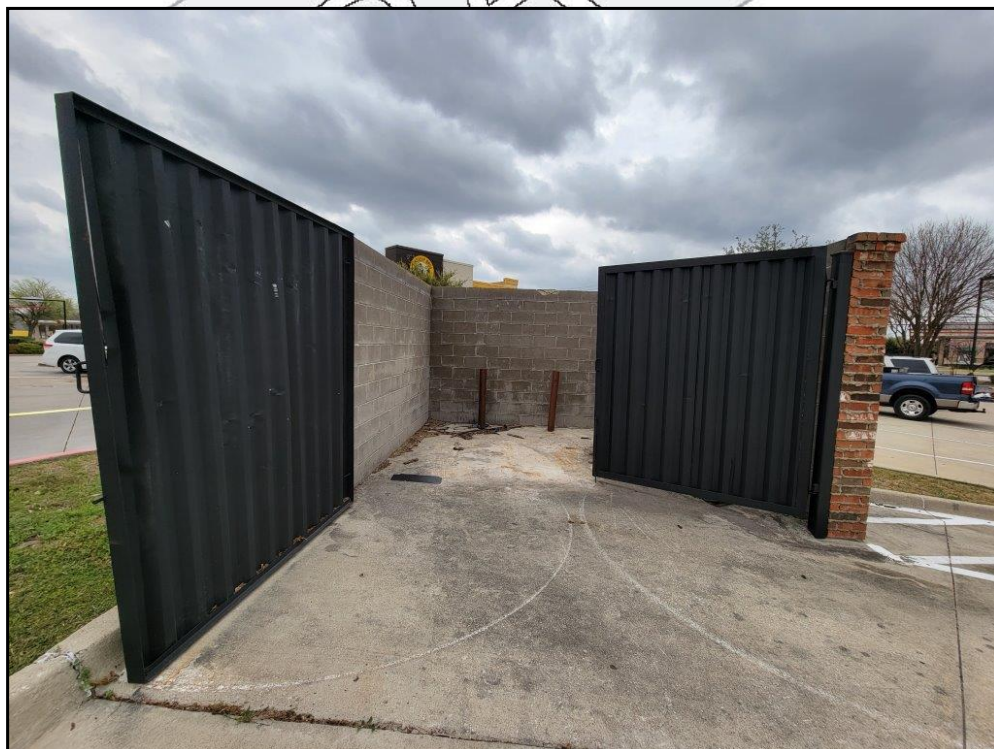
The dumpster enclosure appears to be in good condition.

14 : Dumpster enclosure.

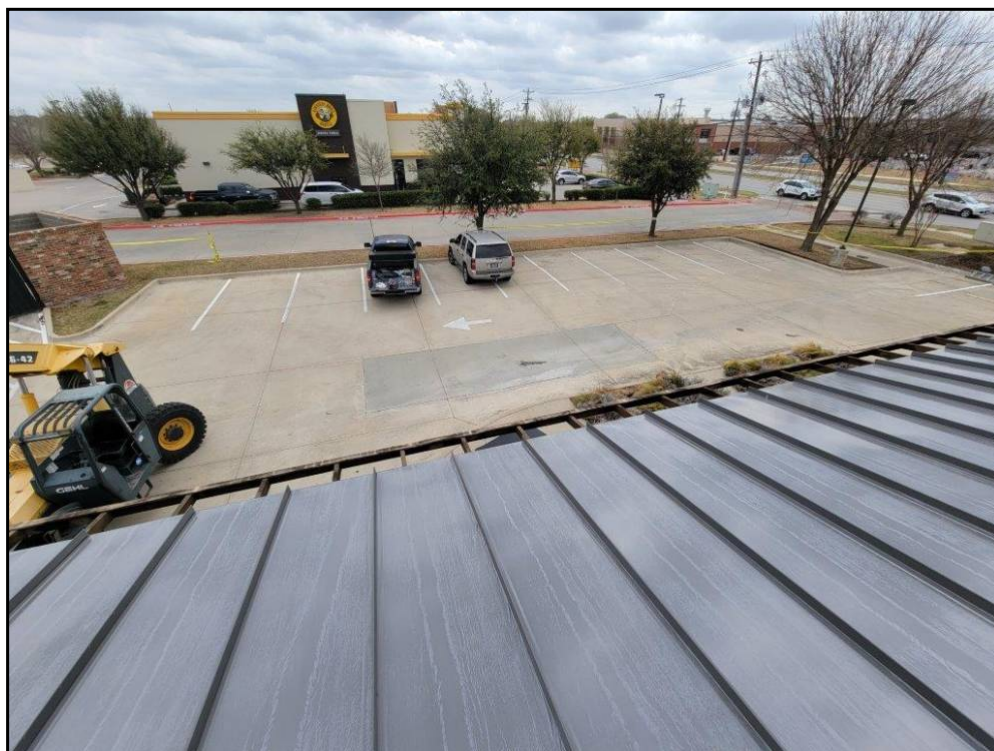
The TPO-membrane and metal shed roofs appear to be in good overall condition. Roofs of this type typically have an average, effective useful life of approximately 20 (TPO-membrane) to 50 years (metal shed roofs), depending on the property's location, material type and quality, quality of installation, roof maintenance and exposure, amount of roof traffic, and regional climatic conditions. Based on their reported ages, current conditions, and expected useful lives, the roofs are expected to reach their life expectancy after the analysis term.

15 : Shed metal roof.

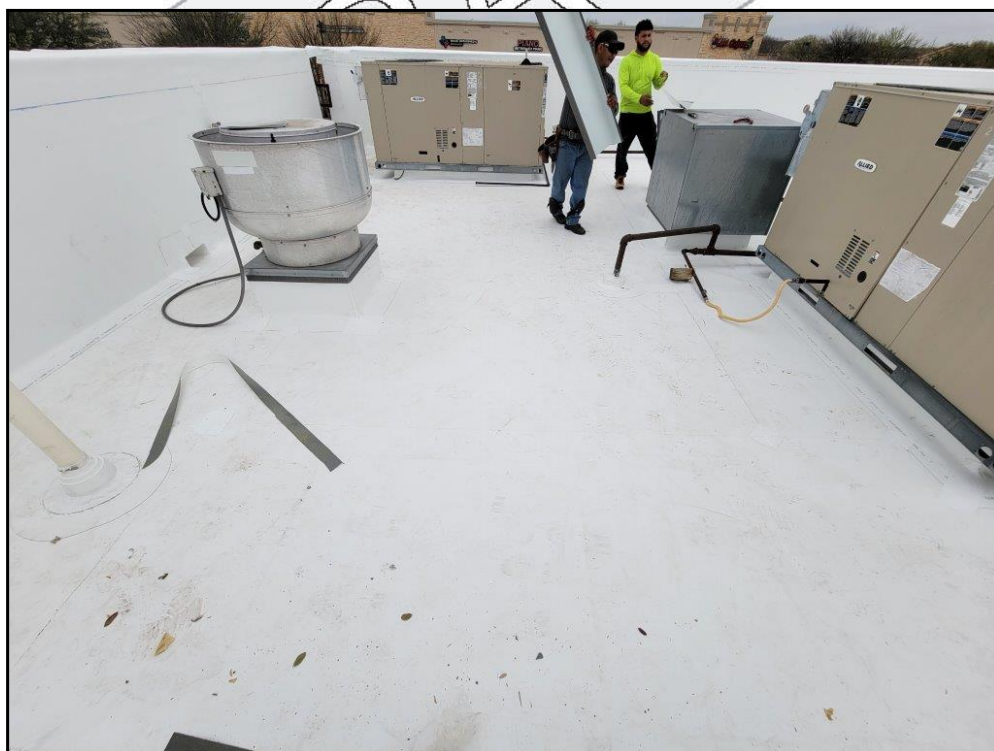
16 : TPO-membrane roofing.

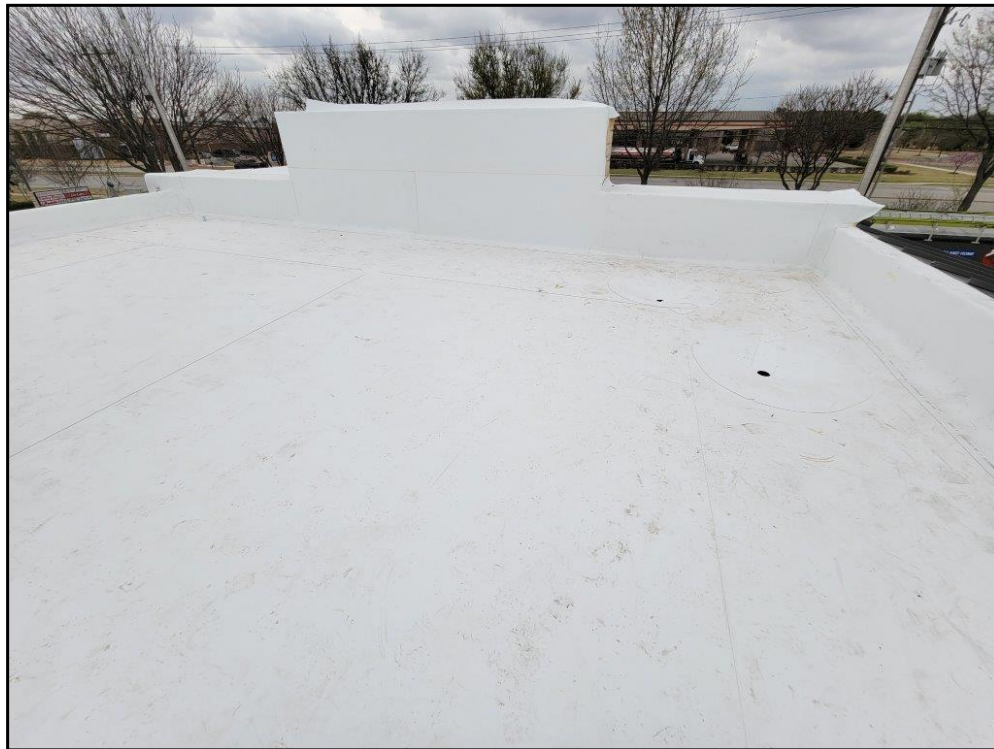
17 : TPO-membrane roofing.

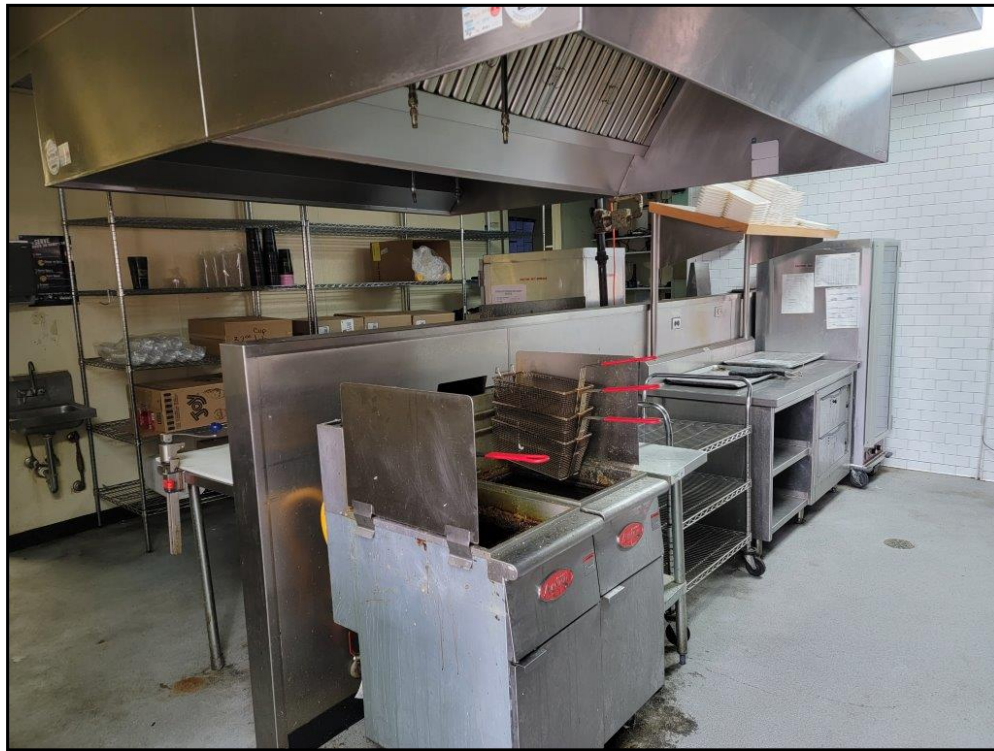
The restaurant/retail spaces, commercial kitchen, storage areas, and offices are in good condition. Some of the interior finishes observed were worn, and interior refurbishment is recommended during the analysis term. New tenant refurbishment is not calculated in this Report as reserves for this work are typically carried elsewhere during underwriting.

31 : Kitchen area. (3)

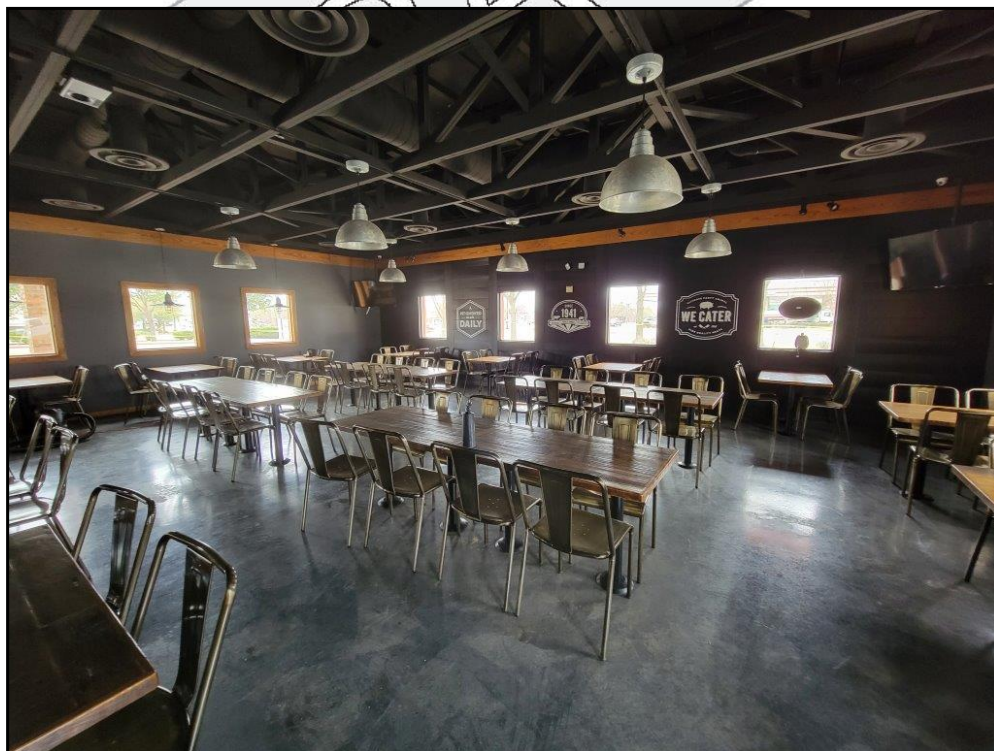
32 : Dining area.
