## On-Site Sewage Disposal System Inspection Report

Address: 20835 Nanticoke Road

City: Bivalve

Blue Wave Environmental Consulting, LLC  
bluwaveenvironmentalconsulting.com

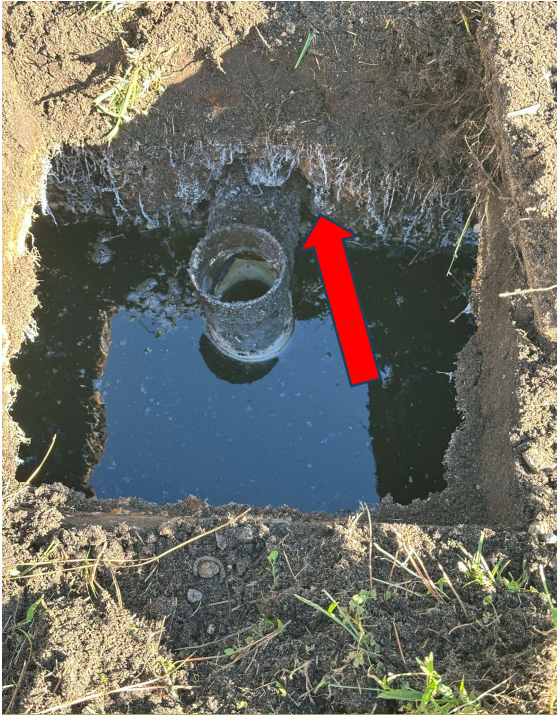
Septic tank outlet

Comments: There is a void forming around the outlet pipe allowing dirt and roots to enter.

| Summary/Conclusions | | |
|---|---|---|
| Septic Tank | <input type="checkbox"/> Satisfactory<br><input type="checkbox"/> Unsatisfactory<br><input checked="" type="checkbox"/> Satisfactory with Concerns | |

| Summary/Conclusions | | |
|---|---|---|
| <b>Explain:</b> Seal void around outlet pipe. Replace lid on distribution box. | | |

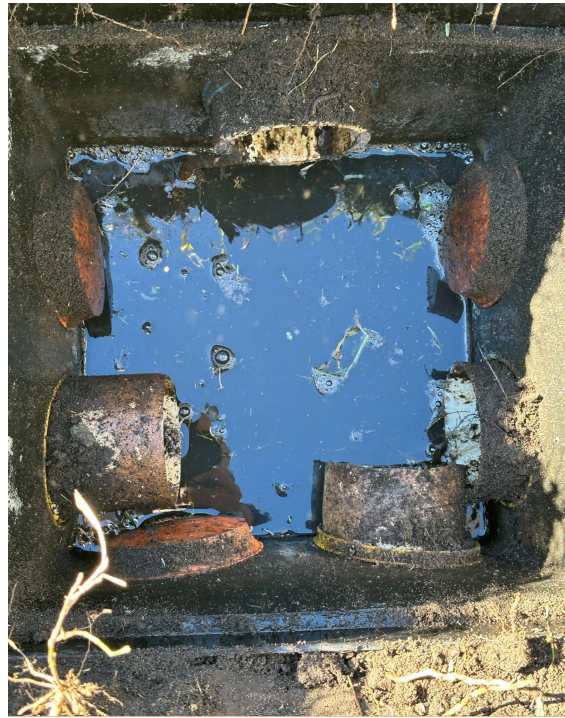
Distribution box

Comments: The box is plastic and structurally sound. The lid is cracked.

| Summary/Conclusions | | |
|---|---|---|
| Distribution Box | <input type="checkbox"/> Satisfactory<br><input type="checkbox"/> Unsatisfactory<br><input checked="" type="checkbox"/> Satisfactory with Concerns | |
