235 W. Travis Street | La Grange, Texas | July 09, 2021

**EXISTING CONDITIONS**

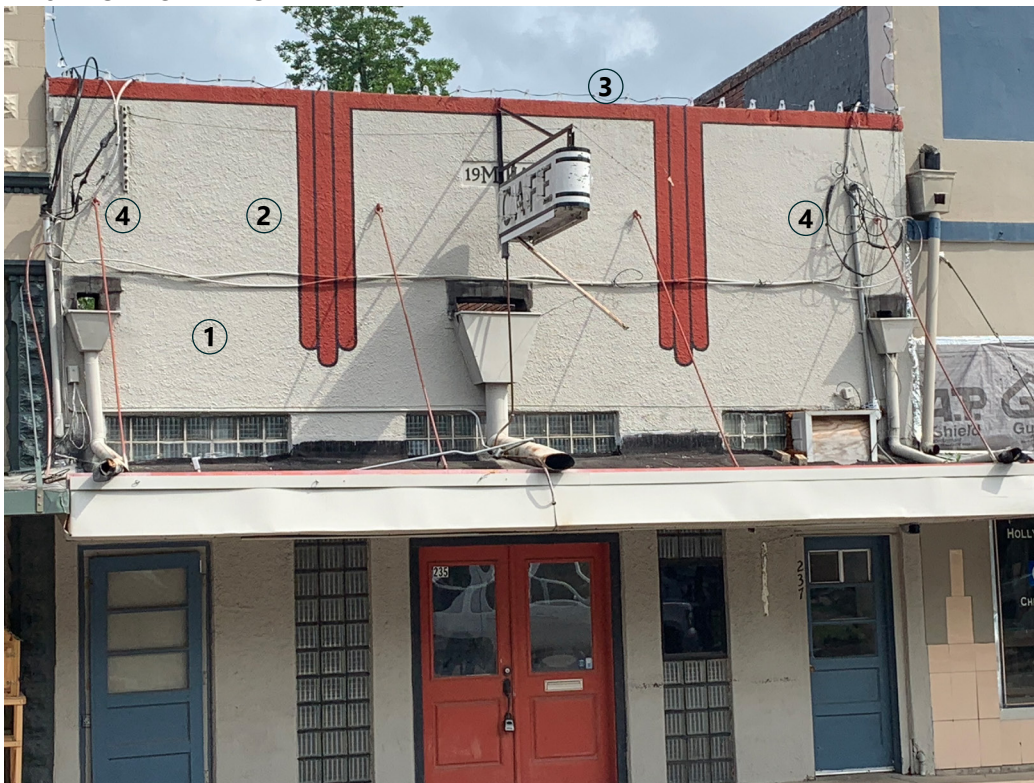
#### EXISTING FRONT FACADE

1. **Stucco.** The exterior wall appears to be stucco finished on brick according to photos and field observation by the Main Street Manager. The three existing water outlets should be closed, patched and repaired using the same wall material. The wall repairs should match existing wall material and texture. The exterior wall should be cleaned and repainted. Refer to: [Preservation Brief #22 "Preservation and Repair of Historic Stucco"](#)

3. **Parapet walls.** The top of the exterior front and back walls need weather protection. Stucco appears applied over the top of the exposed facade wall. The back wall has a roofing material not adhered to the wall. It could lead to potential damage due to moisture infiltration. In both cases, consider the installation of a metal wall cap & drip edge to protect the top of the wall from water and moisture.

4. **Electrical.** Existing exposed electrical wires at the upper exterior wall are a hazard. Exposed light fixtures and wires should be re-routed and concealed if possible. It is important to consult with a licensed electrician to remove and re-route electrical wires. Any damage to structural and historical features should be avoided or minimized. It is also recommended to consult with local code officials early in the rehabilitation process.

2. **Paint.** Before painting, the wall should be prepared by cleaning and washing with low-pressure water, supplemented by scrubbing with soft natural bristle brushes. It is important to prepare the surface using low-pressure water to remove dirt and loose paint, then repair any areas that are chipped or cracked with stucco mortar before applying two coats of primer and a finish paint coat. Organic plant material, such as algae, mold and metal stains should be removed with appropriate solvents. Refer to: [Preservation Brief #1 "Assessing Cleaning and Water Repellent Treatments for Historic Buildings"](#). It should be necessary to conceal any repairs and imperfections of the wall by painting the entire front facade of the building.

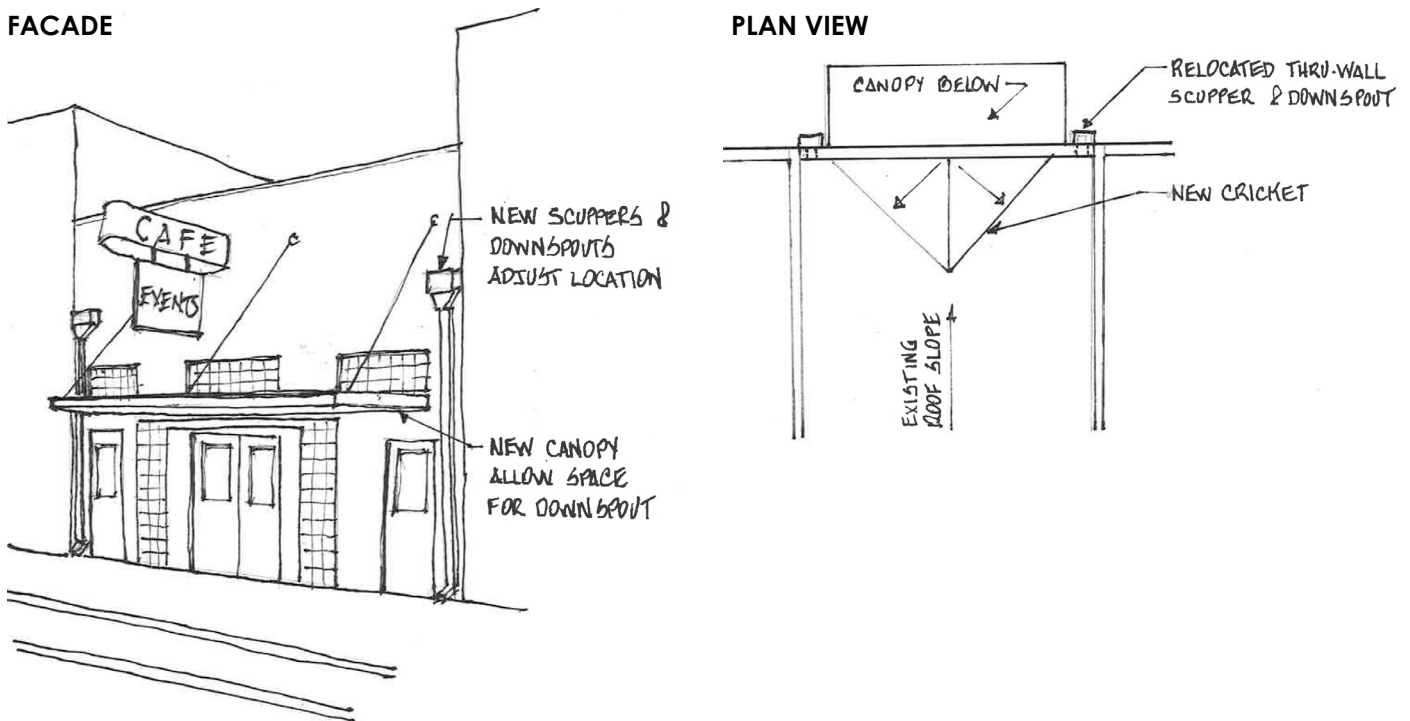
**Roof Option 1.** This option is the least invasive and more cost effective. Maintain exterior drainage at front facade, adjusting the location of scuppers and downspouts and eliminating the drain at the center of the building. In this option the new canopy's width needs to be adjusted to allow space for vertical downspouts.

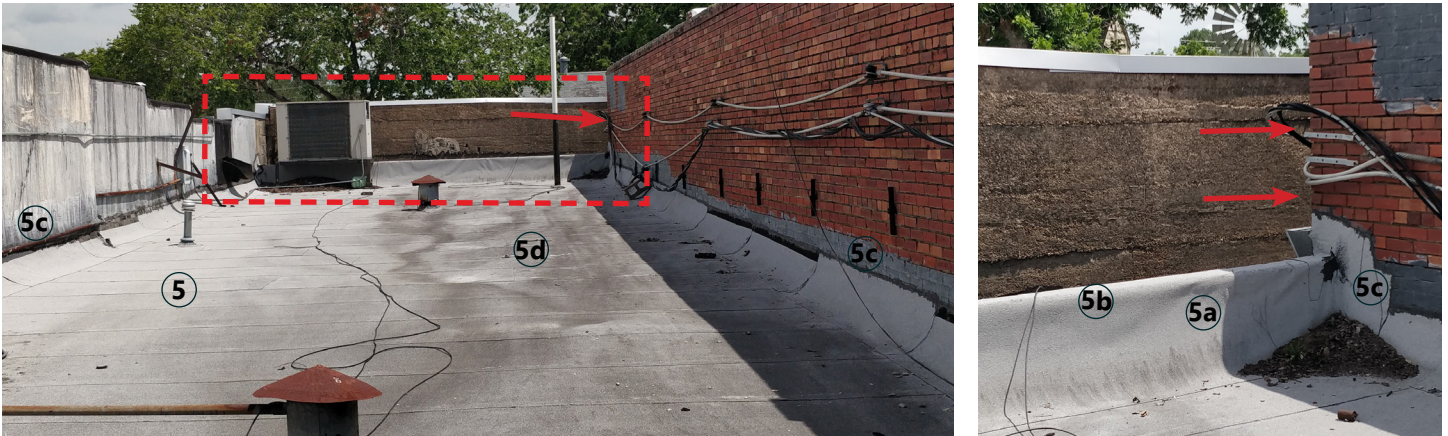
**EXISTING ROOF - BACK**

5. **Roof** currently slopes towards the front of the property to the existing collection boxes and downspouts. In the images provided on the following pages, the roof shows deterioration of membrane, which appears to lack adhesion and protection from support elements (parapet cap, drip edge, flashing). (5a)The roof membrane appears not properly installed, facilitating deterioration due to the exposure to wind, water, ultraviolet rays, and debris that could be puncturing the roofing material. (5b)The absence of a wall cap at the facade and back parapet walls increases the possibility for damage due to water infiltration. (5c) There is no flashing at party walls to protect from water. (5d) There appears to be evidence of water ponding in this area. Concerns due to ponding need to be investigated for hidden damage.

**Roof Option 2.** The owner has expressed an interest in the roof draining to the alley. This option might not be cost effective, further investigation of existing conditions and evaluation of other options is necessary. Redirecting water toward the south will require the design and installation of a new roof drainage system. This will require the reconfiguration of the entire roof slope, connection to collection box, horizontal and vertical downspouts to the ground level at the rear of the property. In order to change the roof slope, it is recommended to carefully install tapered insulation with membrane on top, altering slope of building from front to the back without adding additional roof framing. A new roof membrane would be placed on top of tapered insulation per manufacturers recommendations and roofing best practices. (Red arrows) Existing gaps between buildings at south end of the property suggest a possibility for horizontal downspout. It would require an agreement with adjacent property owners and approval from the city to drain the water this way. It is **not** recommended to build a new roof on top of existing in order to change the slope towards the back.

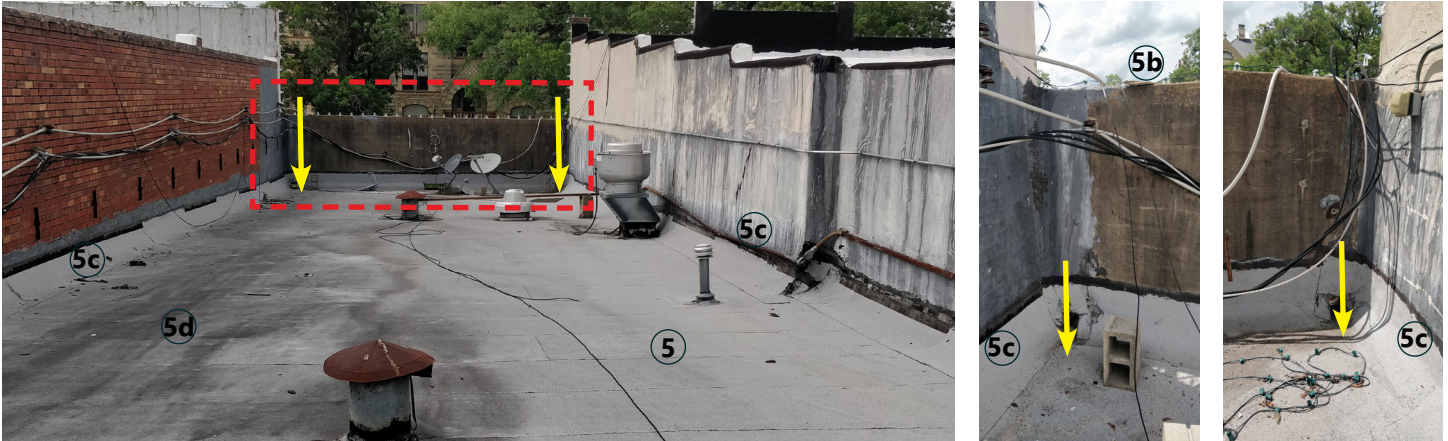
**EXISTING ROOF - FRONT**

**Roof Option 3.** This option is likely the most invasive and expensive. (Yellow arrows) At corners of the property behind walls suggest the possibility of internal drainage that would include a drain pipe at interior of space (not inside facade wall), passing through the floor, foundation underground and continuing under the sidewalk to the storm sewer (or daylighting at the curb and gutter). Existing conditions should be reviewed with contractor prior to any work to determine best option available. Refer to: [Preservation Brief #4 "Roofing for Historic Buildings"](#)

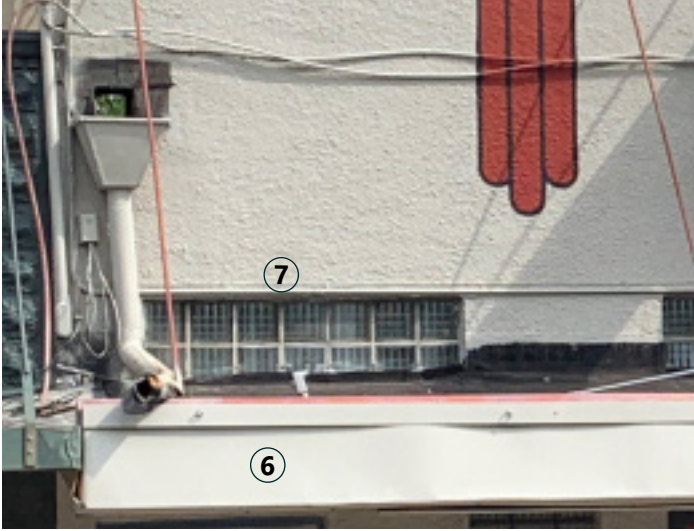
TRANSOM

7. **Glass Block** appears to have been installed by the 1940s. This is evident in the historic photographs provided. If required, consider carefully cleaning and repairing any missing or significantly damaged units. It also appears that at one point in time, the glass blocks along the right side of the door were removed and replaced by an aluminum window. An exact date of this installation is unknown. The grout shows signs of deterioration in numerous areas. Consider carefully repointing with a compatible grout mixture. The glass block is a distinctive architectural feature that should be preserved.

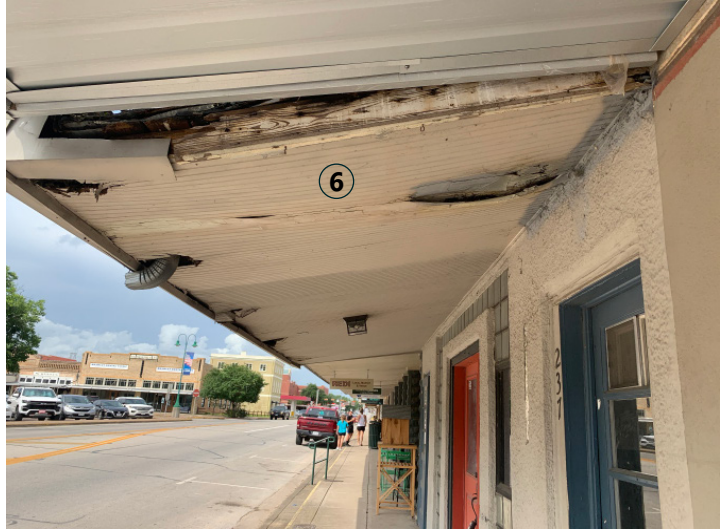
CANOPY

6. **Tie Rod Canopy** appears severely deteriorated. Connection to wall appears higher than transom window sills, this configuration obscures the transom and raises concerns for water infiltration. The existing wooden canopy should be replaced in kind with a new tie rod canopy. It should be installed lower than transom window sills to direct water away from the building. A typical tie-rod canopy is illustrated below and proposed connection points should be evaluated on the building for applicability, structural connection and reinforcement.

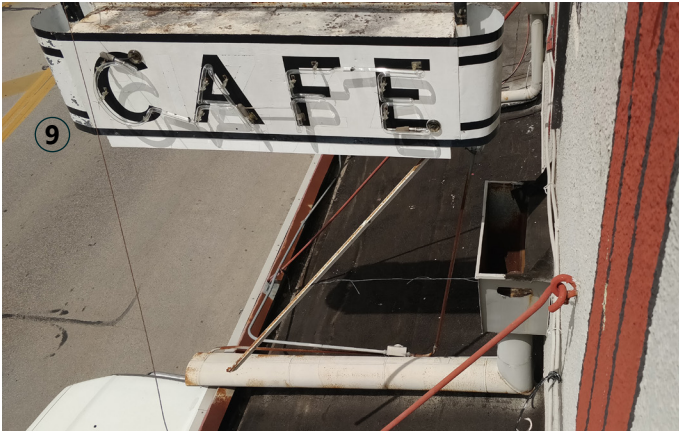
## EXISTING SIGN

9. **Signage.** Per the Signage section on the Local Design Guidelines, it is highly recommended to "Maintain and/or repair any original signage as it greatly contributes to the character of the building." However, the existing sign appears to obstruct the building name. If feasible, consider reinstalling at a lower height. Per owner's request, the new blade sign will be hanging below the existing sign. In addition, consider consulting with an experienced sign maker on appropriate materials and installation. Historical photos show evidence of blade sign hanging below the cafe sign.

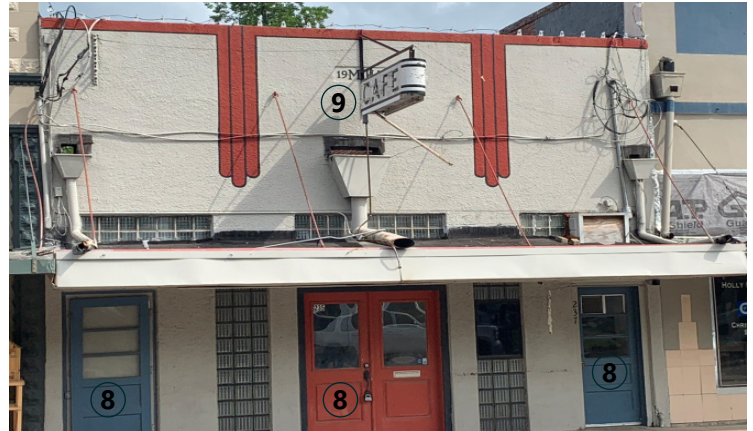
## FACADE

8. **Wood Doors** appeared to resemble the configuration in the 1940s photographs and current images show the doors in good condition. The left door appears to be a false door that swings outward and it has a plywood dutch-door behind. The plywood door behind should be removed to bring back access and natural light into the building. It is important to repair, repaint and weather strip air gaps around all the existing doors. It is recommended to keep and maintain all front facade doors, door framing, including jambs, sills and headers. Primary doors are very important and contribute to maintain the integrity of the building. Replacement is considered only when doors are deteriorated beyond repair. Replacement doors should be compatible in design to the original in style, materials and glazing.
