01 April 2022

Re: ACIS McKinney - Waters of the United States Delineation  
Approximately 8.133 acres located approximately 1,500 feet south of the southeastern corner of Bloomdale Road and U.S. Highway 75 in the City of McKinney, Collin County, Texas

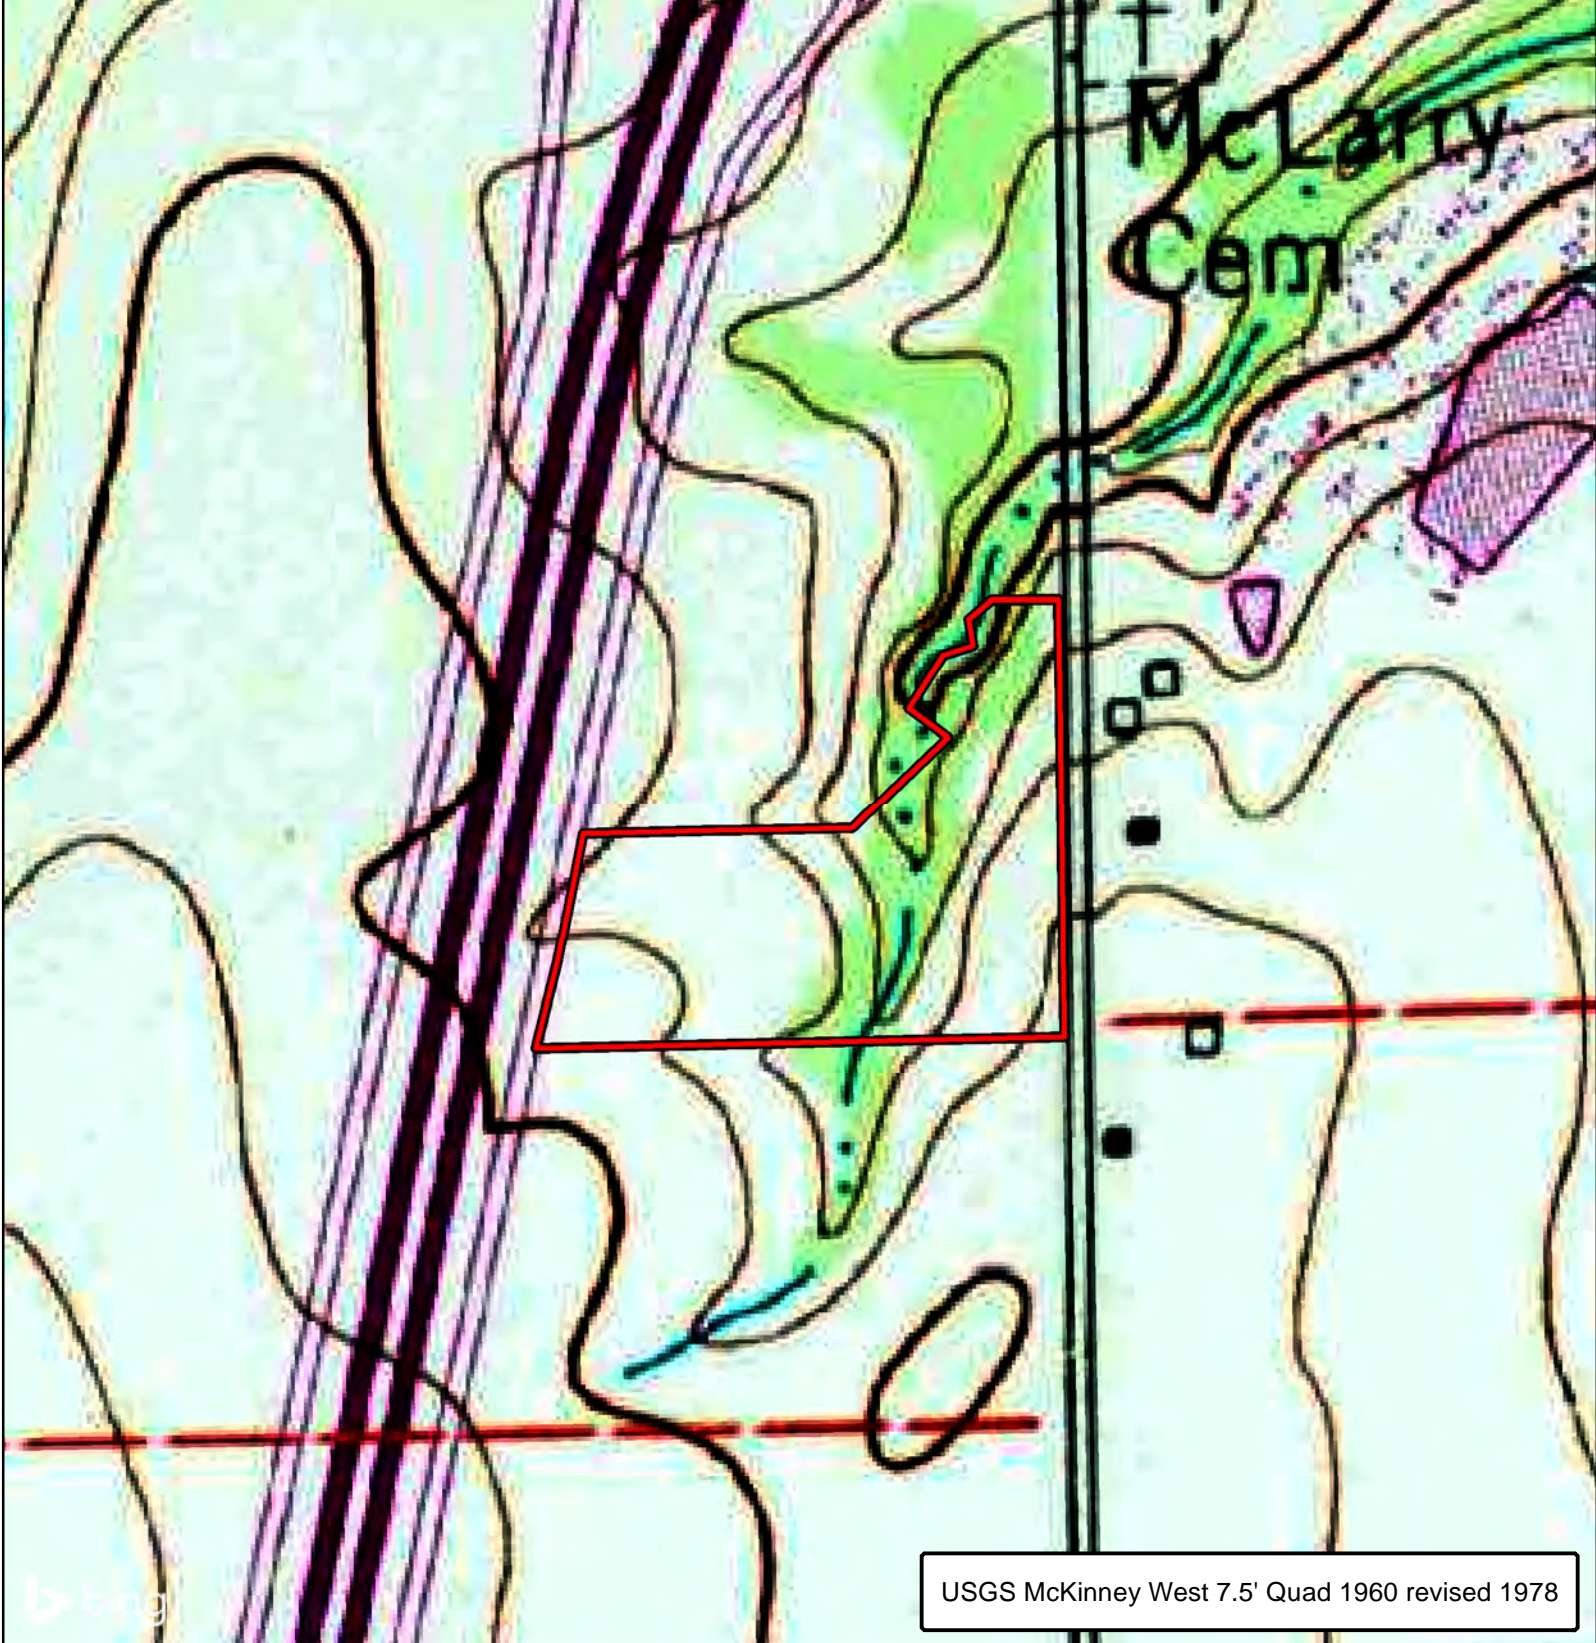
**Figure 2A.**  
**Topographic Setting**

The USGS topographic map (McKinney West 7.5' Quadrangle 1960, revised 1978) illustrates one blue line feature, oriented south-to-north, in the east (see **Attachment A, Figure 2A**). The 2019 McKinney West 7.5' Quadrangle map illustrates the blue line feature in similar alignment (see **Attachment A, Figure 2B**). The overall site topography was illustrated with slopes oriented southwest-to-northeast or southeast-to-northwest, towards the blue line feature. The maximum site elevation was approximately 640 feet above mean sea level (amsl) and a minimum elevation of approximately 600 feet amsl.

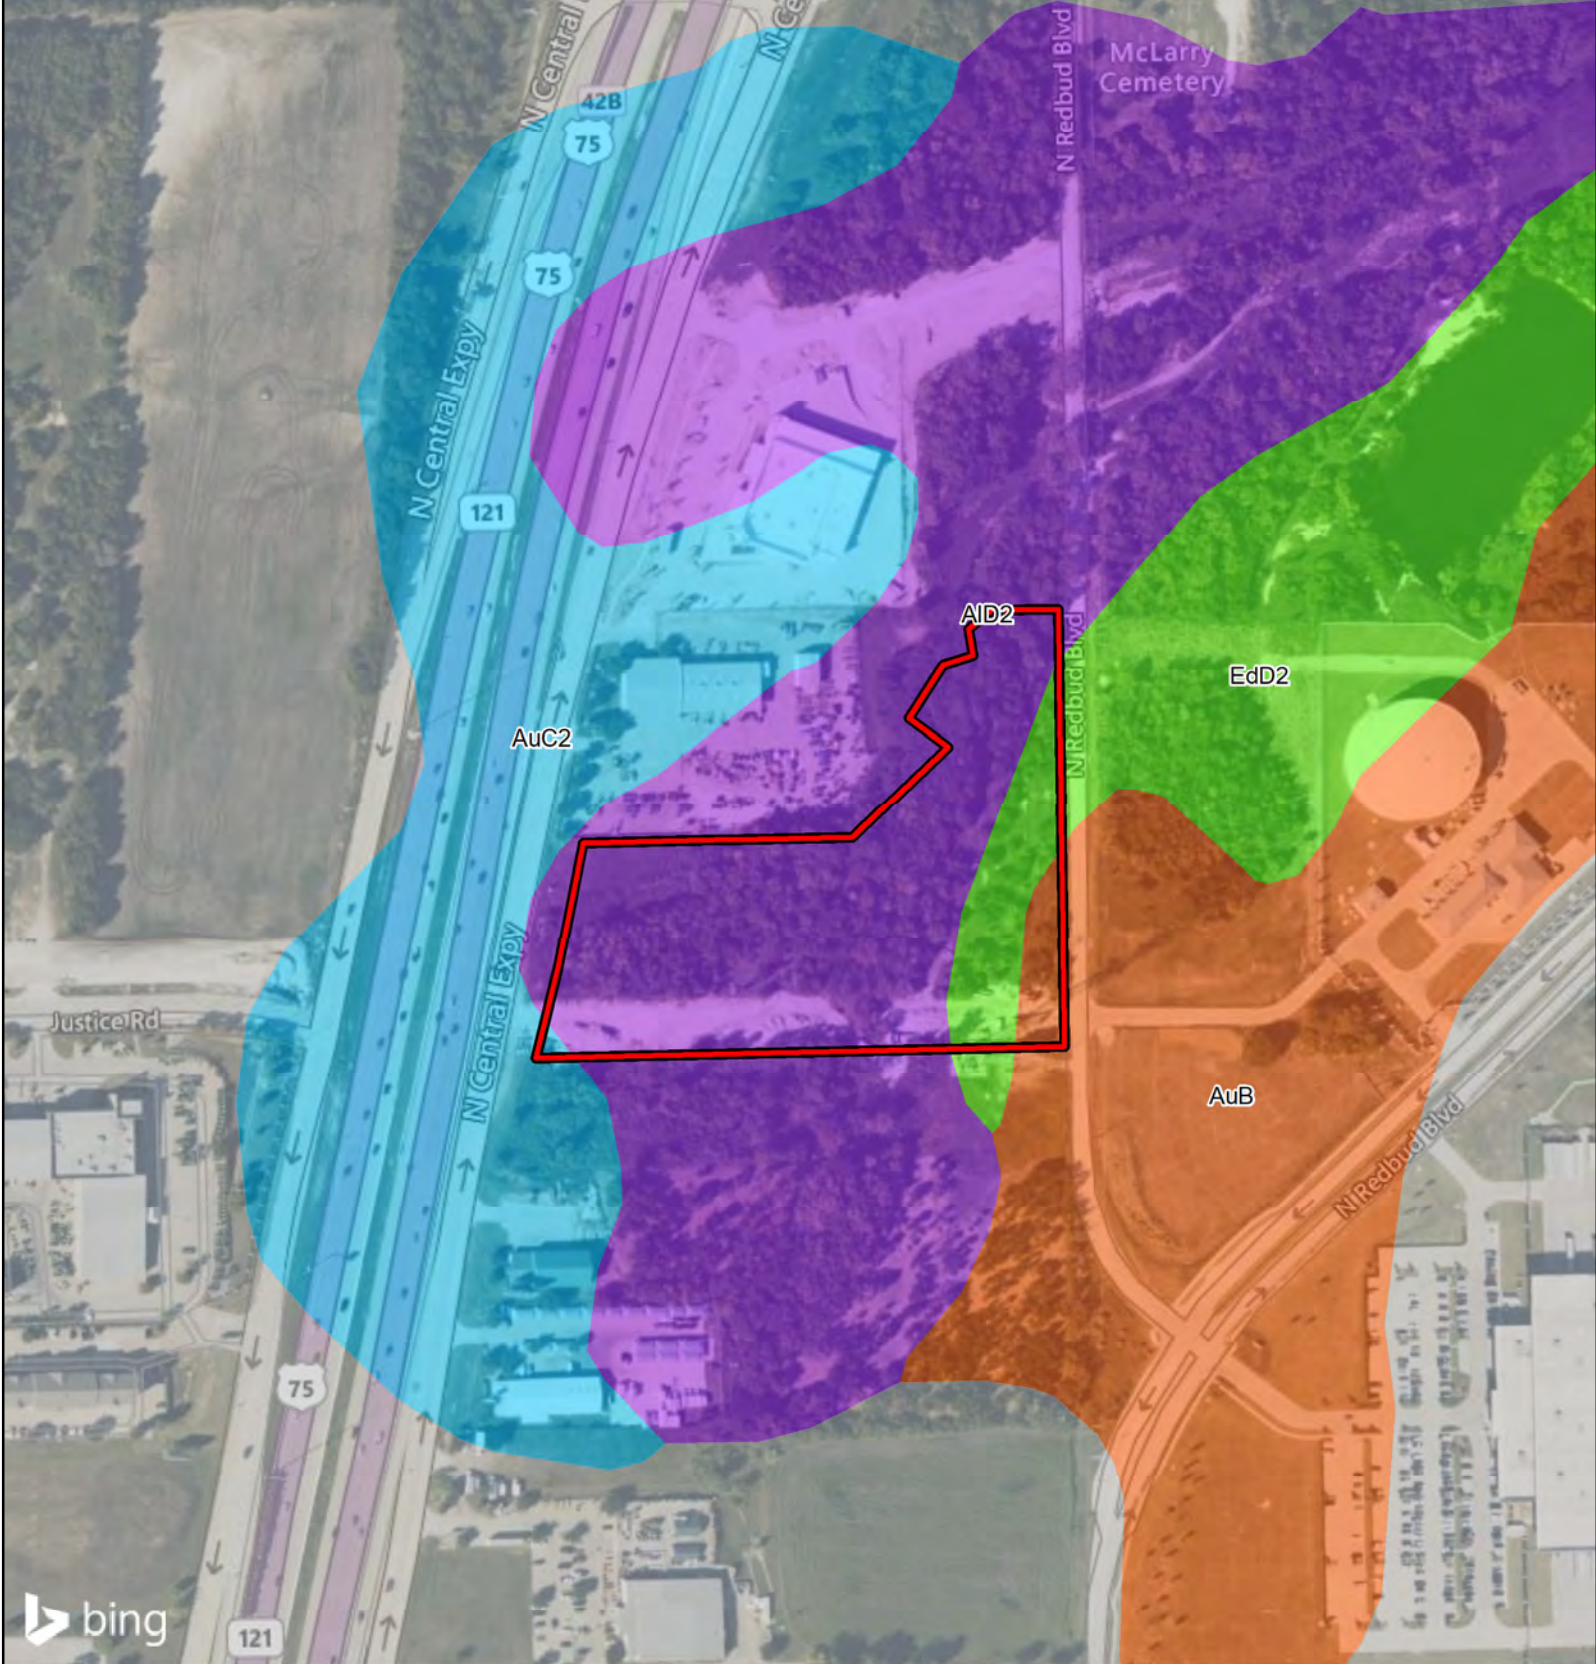
**Figure 3.  
Soils Map**

The USDA NRCS Web Soil Survey identified four soil map units within the survey area, Altoga silty clay, 5 to 8 percent slopes, eroded; Austin silty clay, 1 to 3 percent slopes; Austin silty clay, 2 to 5 percent slopes, eroded; and Eddy gravelly clay loam, 3 to 8 percent slopes, eroded. None of these soil map units were listed as a hydric soil on the Hydric Soils of Texas list prepared by the National Technical Committee for Hydric Soils (accessed 21 March 2022, Collin County, Texas) (see **Attachment A, Figure 3**). Hydric soils are described as those soils that are sufficiently wet in the upper part to develop anaerobic conditions during the growing season.

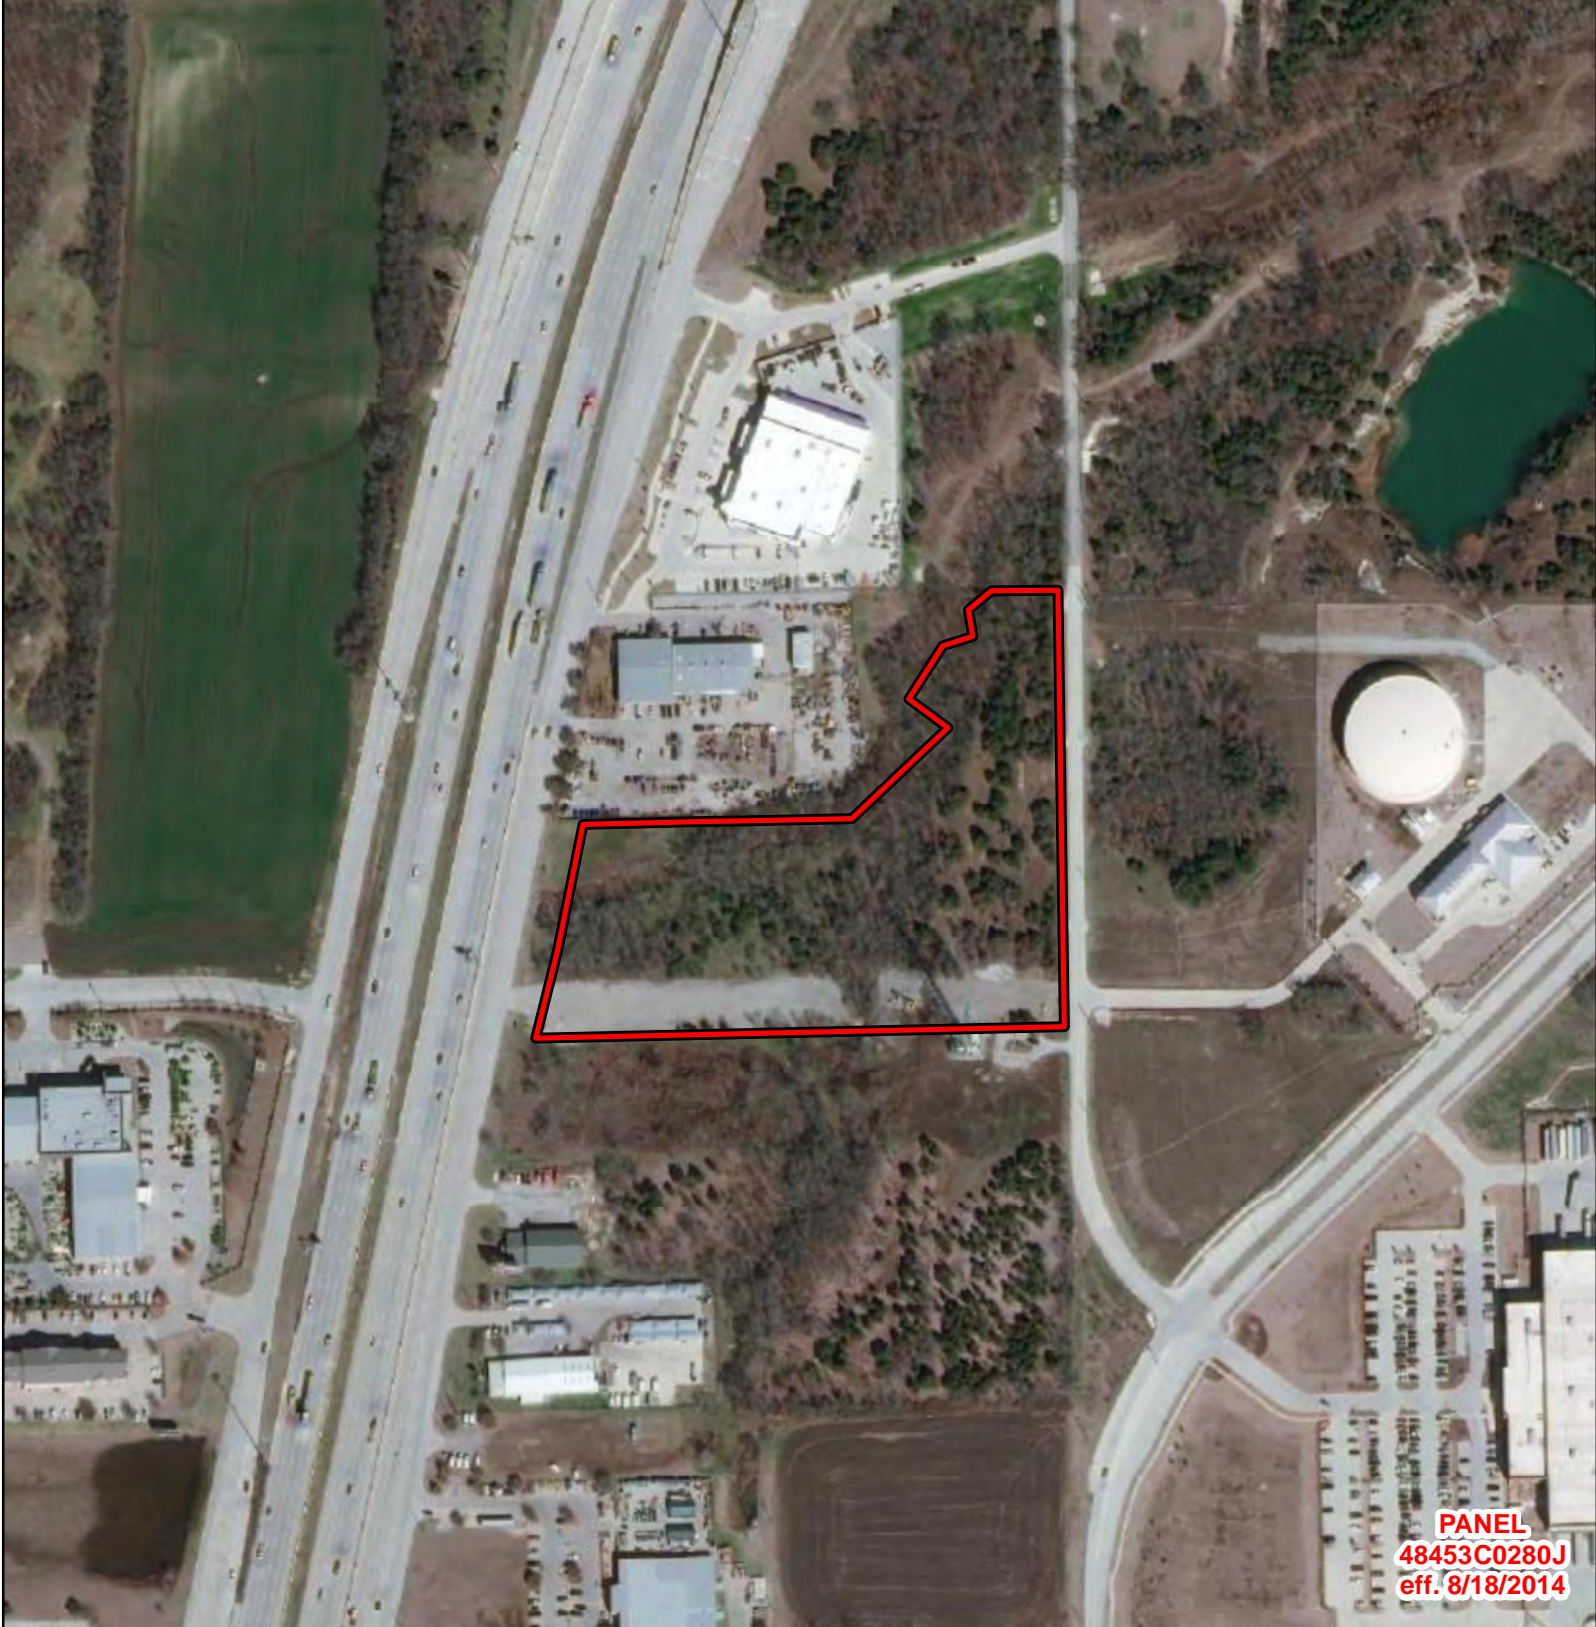
**Figure 4.**  
**Federal Emergency**  
**Management Agency**  
**Flood Insurance Rate Map**

The FEMA FIRM (Collin County; Map Panel 48453C0280J; effective 18 August 2014) shows the entire survey area within Zone X (Areas determined to be outside the 0.2 percent annual chance floodplain) (see **Attachment A, Figure 4**).

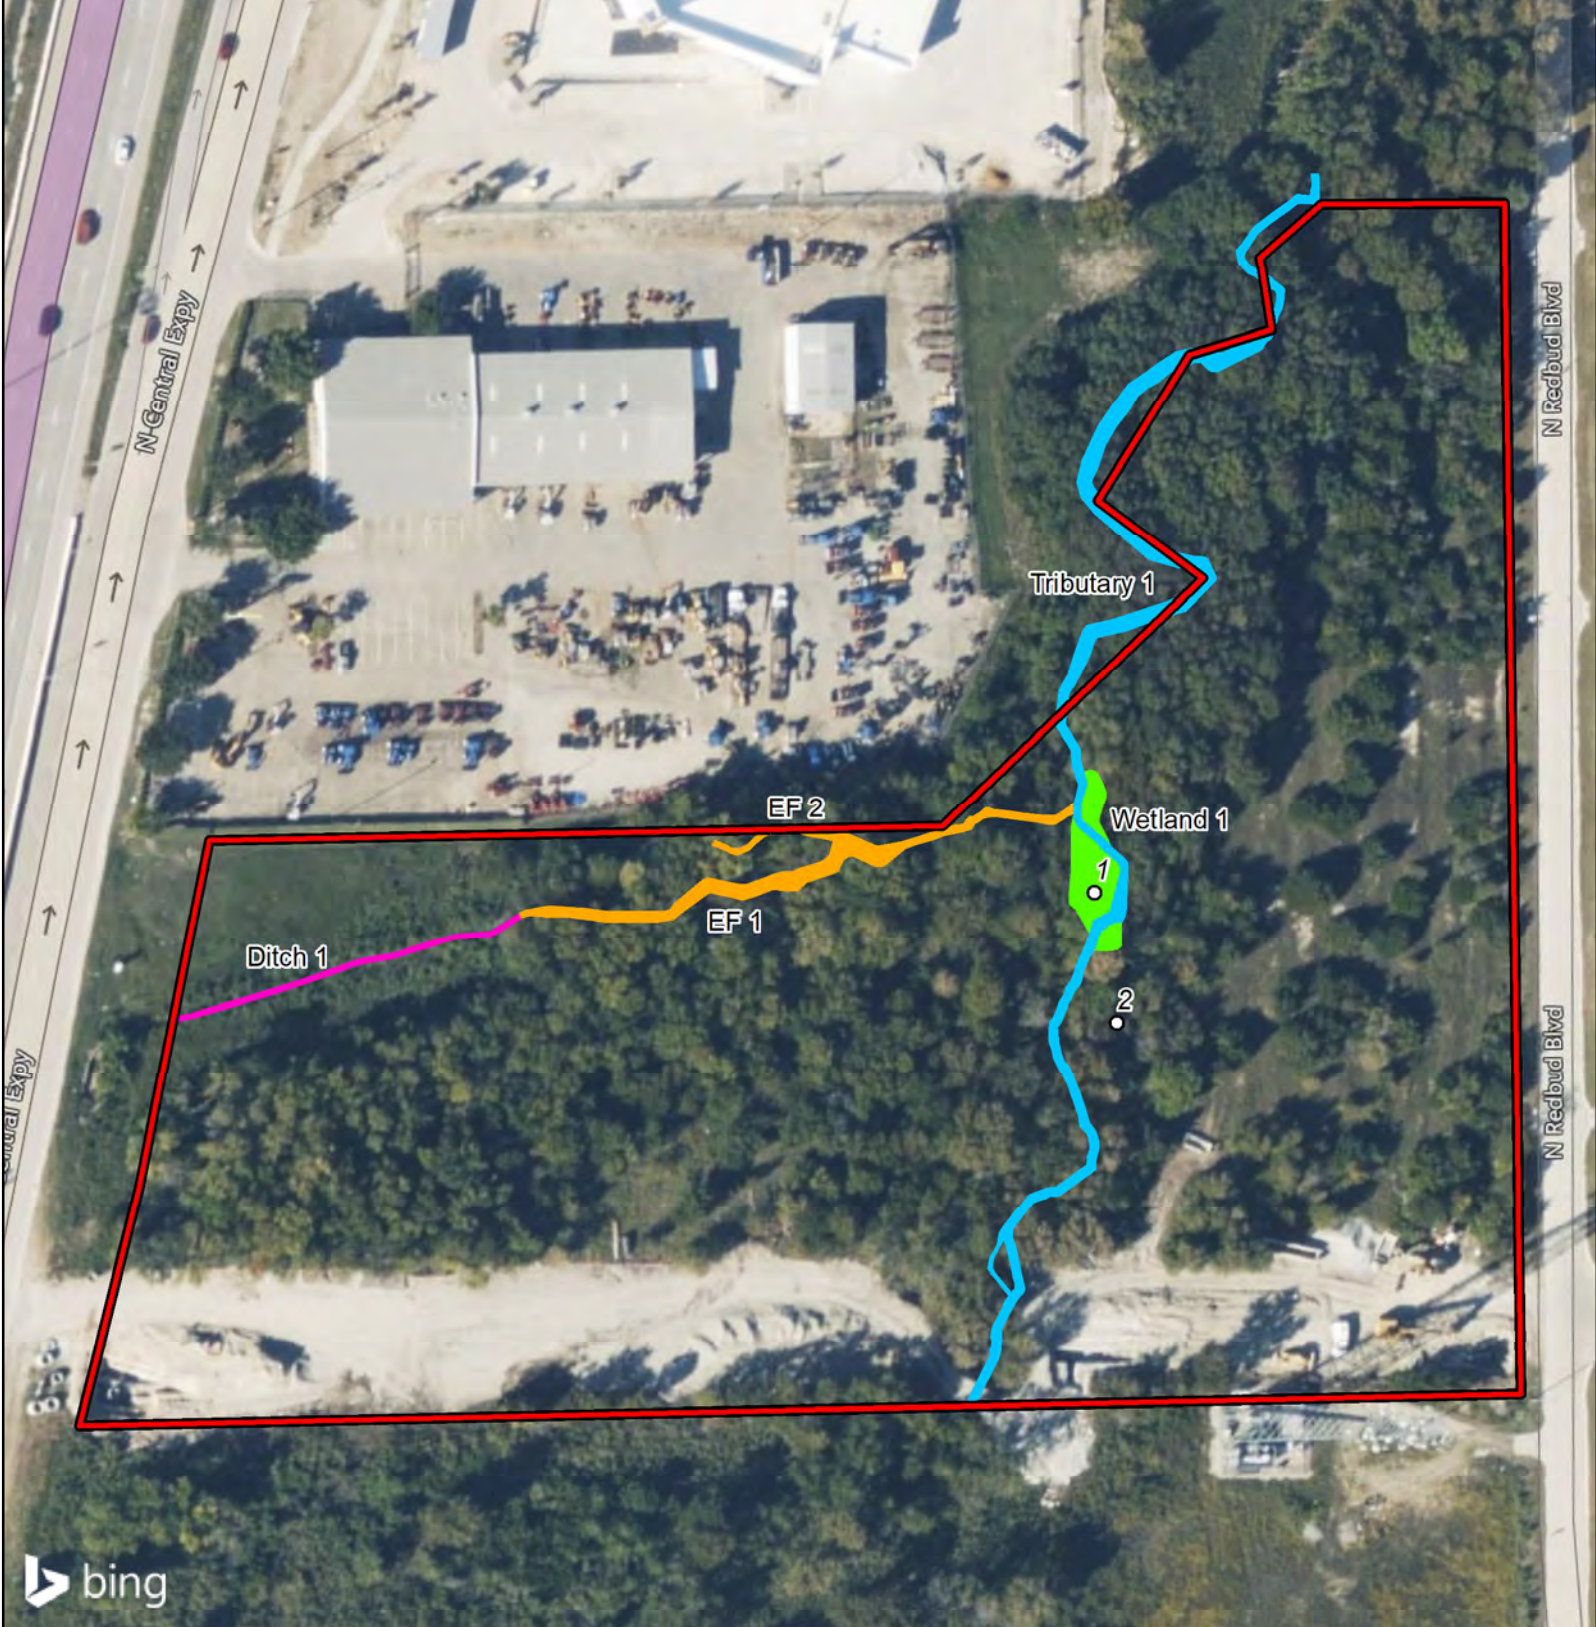
**Figure 5.**  
**Aquatic Resources Identified**  
**within the Survey Area**

Water from the survey area flows northeast into an unnamed drainageway, into Honey Creek, into the East Fork Trinity River, and ultimately into the Trinity River, a TNW. **Table 1** and the following paragraphs detail the aquatic features identified within the survey area at the time of evaluation (**Attachment A, Figure 5**).

**Tributary 1** was an intermittent tributary which bisects the project site, similar to the location illustrated on the USGS topographic map. The tributary was delineated by an OHWM identified by the destruction of terrestrial vegetation, bed and bank, waterline, a natural line impressed in the bank, and sediment sorting. The average OHWM width was between 4 to 9 feet in width and was incised into the landscape between 1 to 4 feet in depth with water depths between 6 inches to 2 feet. The channel substrate composition was largely comprised of fine sediments such as silt, clay, sand, and some gravel. At the time of survey, the tributary was observed with several pooled areas and surface flow between the pools, throughout the length of the tributary. Based on the amount of flowing water, the size of the watershed, and the channel geometry, it is IES's professional opinion that Tributary 1 would be considered an intermittent tributary.

**Wetland 1** was identified centrally abutting Tributary 1. Wetland 1 was a forested wetland dominated by American elm, cedar elm, green ash, and inflated narrow-leaf sedge. Hydric soil for Wetland 1 was indicated by Redox Dark Surface with a matrix of 10YR 3/2 with redoximorphic concentrations of 5YR 4/6 in the and matrix. Hydrologic indicators consisted of high water table, saturation, water marks, sediment deposits, drift deposits, water stained leaves, and drainage patterns. Given the location of Wetland 1 in the landscape, this wetland is likely saturated seasonally after flooding or rainfall events.

**Ditch 1** was observed originating from a culvert outfall under the east side of US 75, along the western boundary of the project site. The ditch was identified as a man-made ditch, constructed to direct flow to the east across the project site and away from US 75 and the associated service road. A review of aerial photography illustrated Ditch 1 was created between the 1951 and the 1968 aerial photographs when US 75 was constructed. Portions of Ditch 1 were vegetated with both woody and herbaceous species. The project site received approximately 1.54 inches of precipitation within 72 hours prior to the field investigation, and water was pooled in Ditch 1 at the time of evaluation. As such, it is IES's professional opinion that Ditch 1 would be considered to have ephemeral flow.

**Erosion Features 1 and 2** were identified as ephemeral erosion features characterized by the presence of inconsistent OHWM characteristics and sporadic channel scours. EF 1 originated at the terminal end of Ditch 1. The confined stormwater flowing through the drainage ditch appears to have been further accelerated down the hillside. Evidence from historic aerial photographs indicates the hillside was covered in herbaceous vegetation with sparse woody cover at the time the drainage ditch was constructed, circa 1968. Since that time, the site has been left fallow and woody brush has enveloped the area. EF 1 was approximately 4 to 8 feet in width and was incised into the landscape between 6 to 12 feet in depth. Given the narrow nature of the feature compared to the depth at which it has eroded, the position of the feature in relation to the man-made drainage ditch, lack of evidence of an existing tributary from historic aerial photographs, inconsistent bed and banks, and exposed tree roots across the feature, it was determined that EF 1 was the result of artificially accelerated down the natural gradient, across erodible soils in the upland setting. The project site received approximately 1.54 inches of precipitation within 72 hours prior to the field investigation, and water was pooled in EF 1 at the time of evaluation. As such, it is IES's professional opinion that EF 1 would be considered to have ephemeral flow. EF 2 originated from a hillside swale along a steep slope with inconsistent bed and banks as well as exposed tree root beds across the feature. EF 2 was dry at the time of evaluation. Given the erosion features high location in the watershed, lack of flowing or pooled water, and lack of seasonal hydrology indicators, it is IES's professional opinion that EF 2 would be considered to have ephemeral flow.
