01 April 2022

Re: ACIS McKinney - Waters of the United States Delineation  
Approximately 8.133 acres located approximately 1,500 feet south of the southeastern corner of Bloomdale Road and U.S. Highway 75 in the City of McKinney, Collin County, Texas

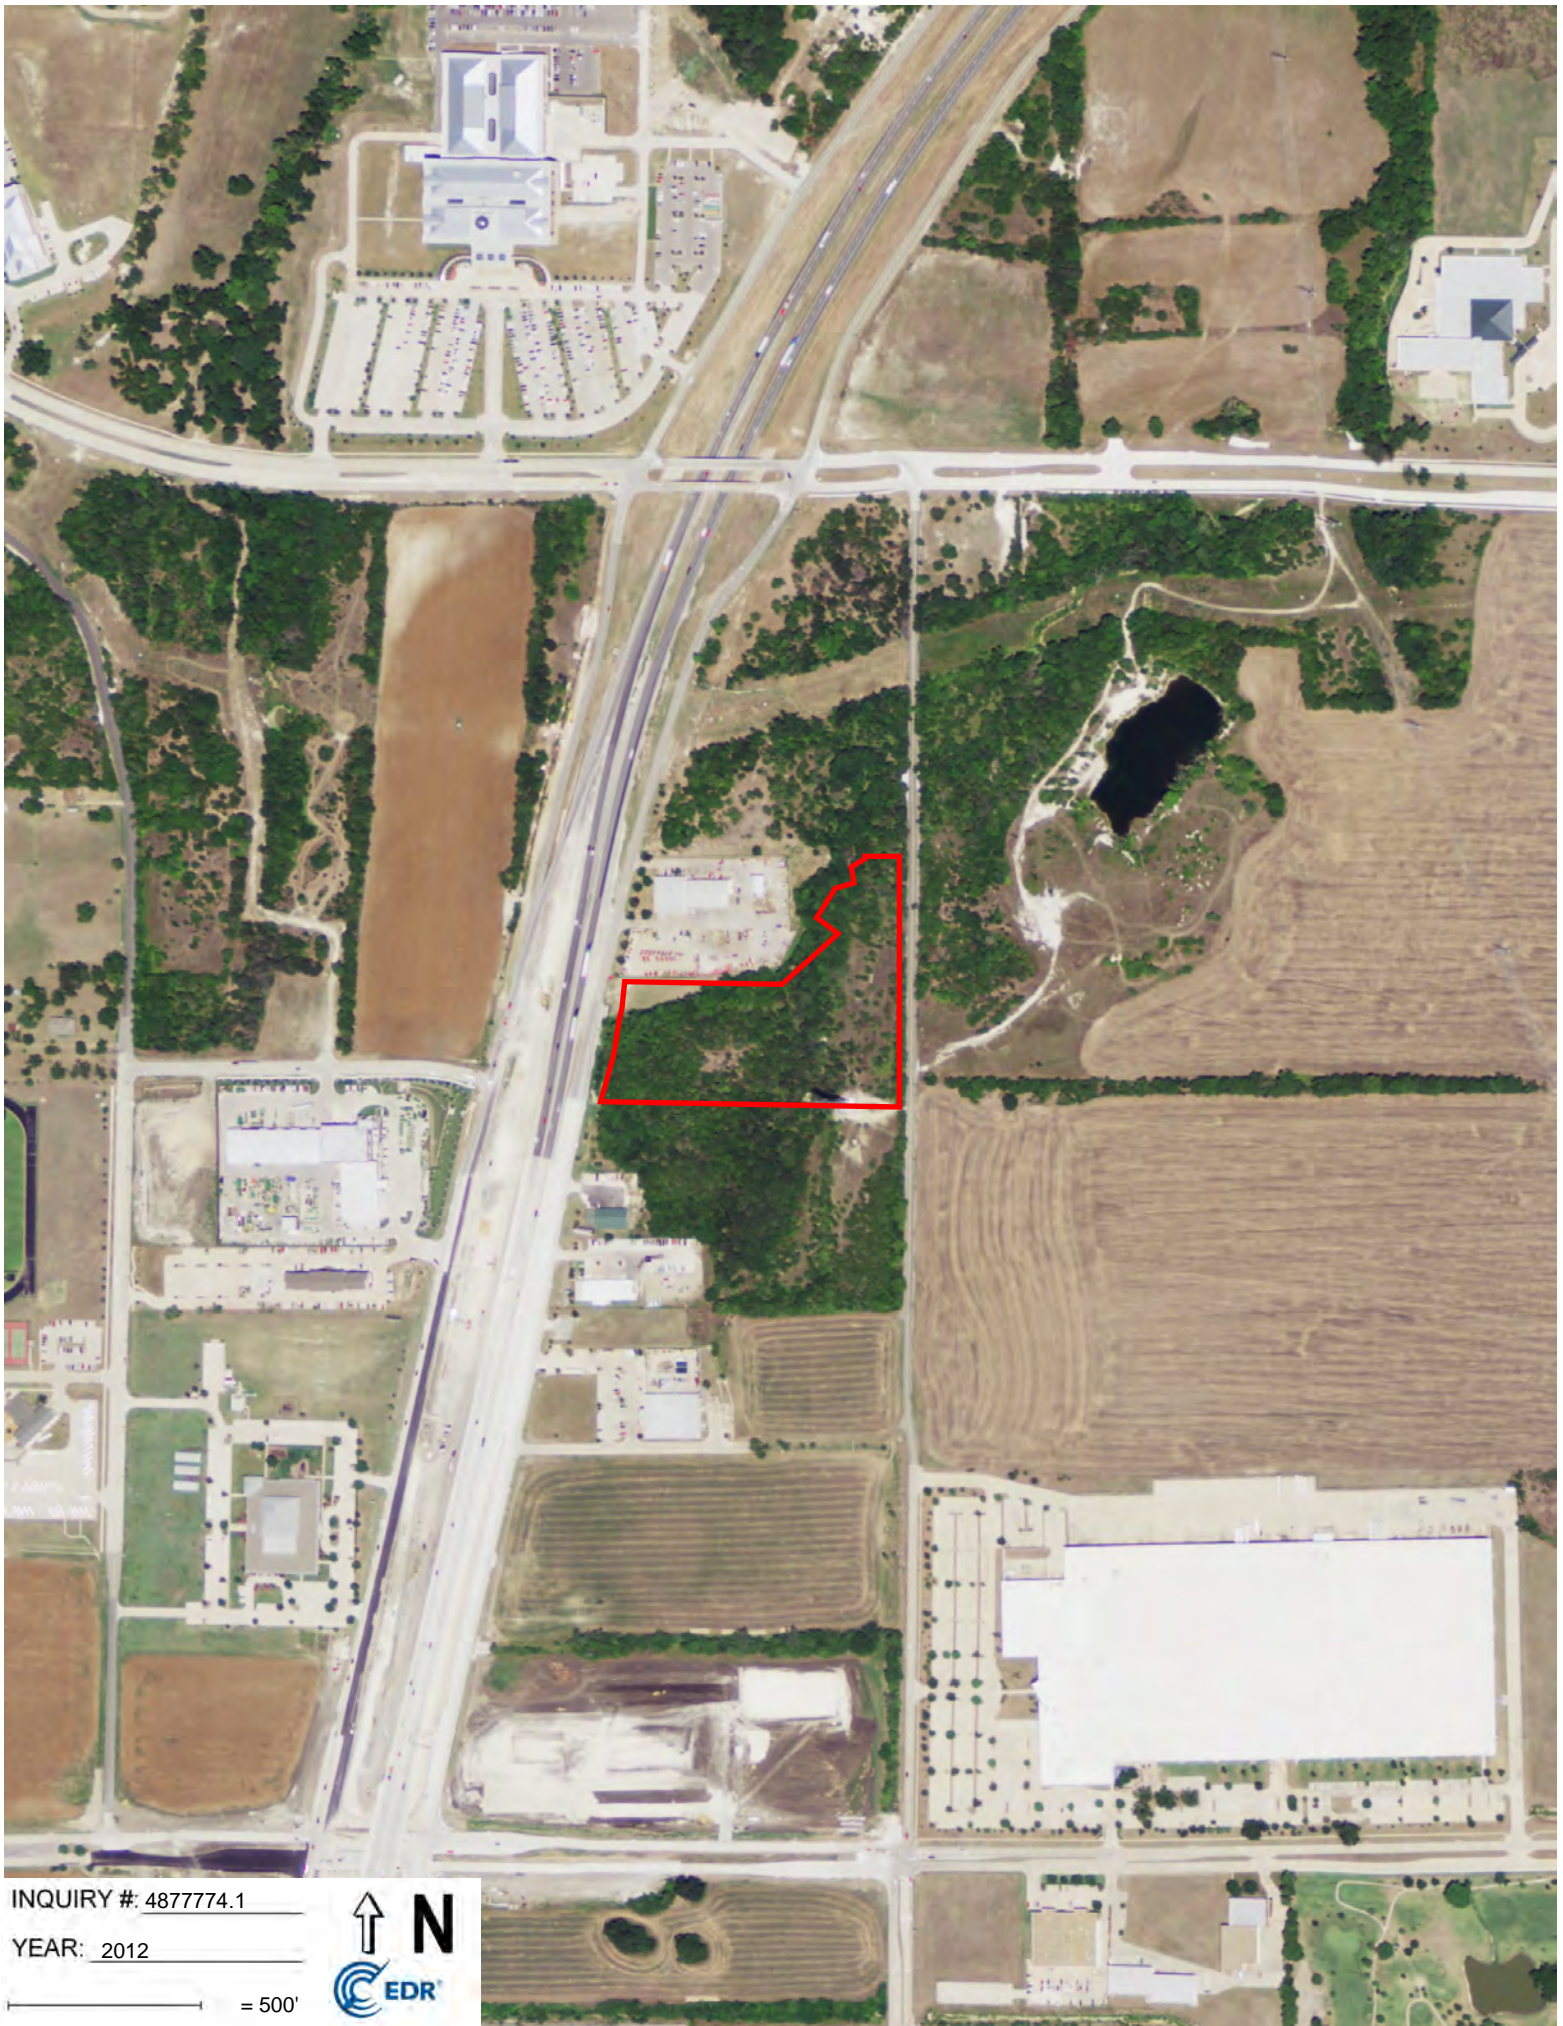
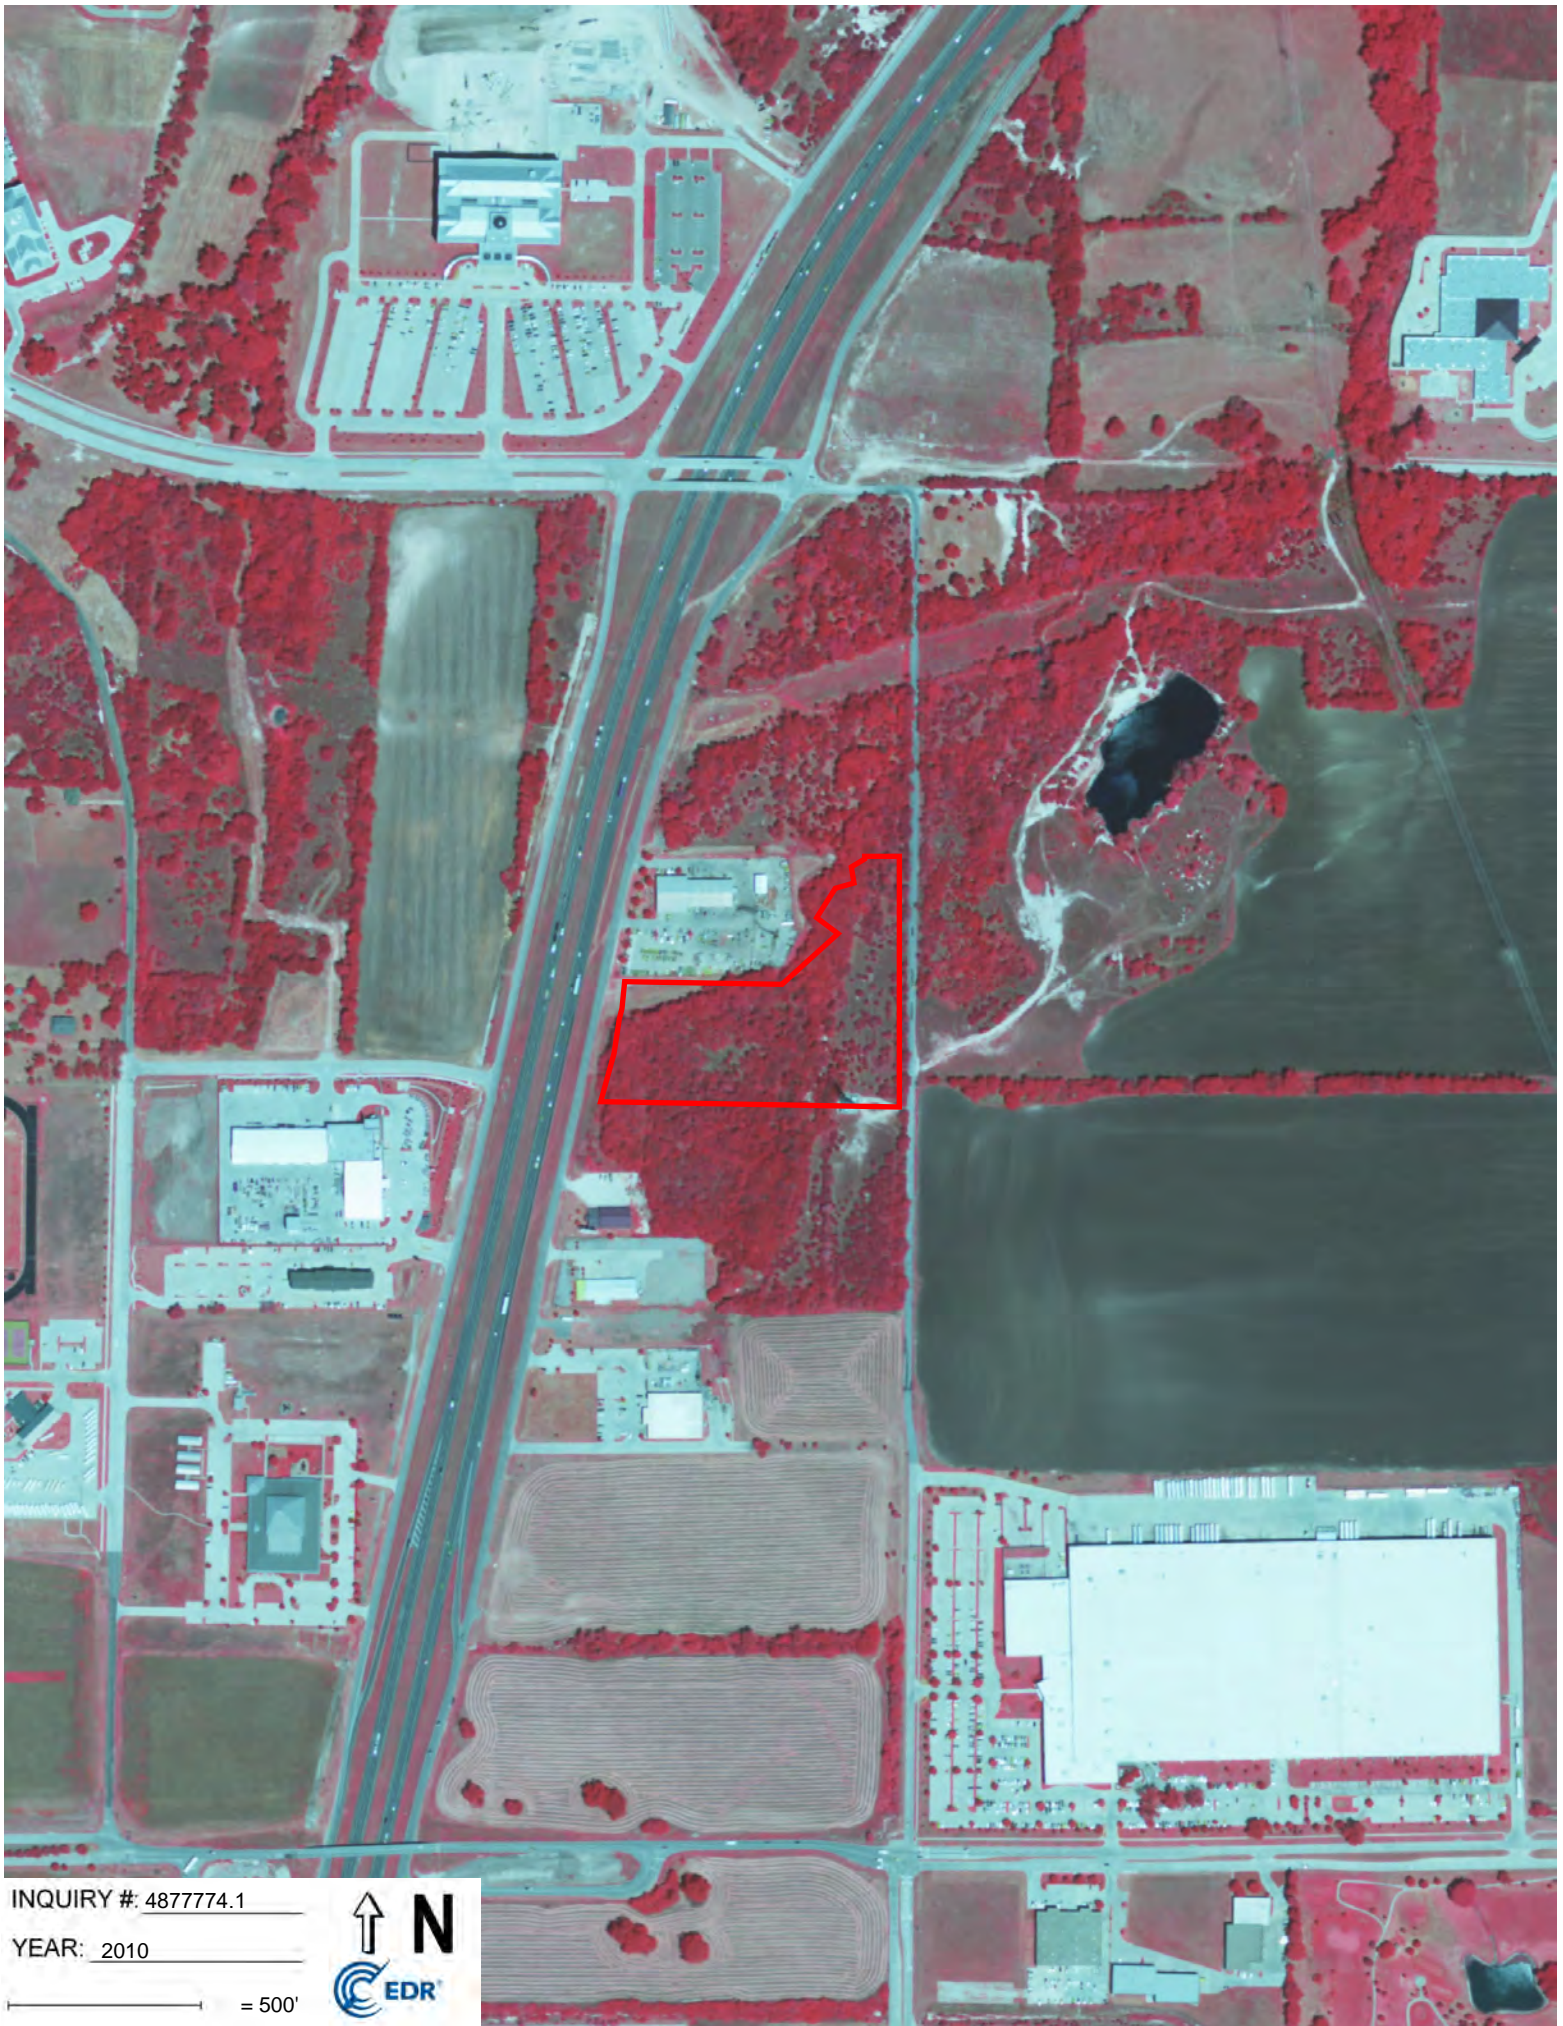
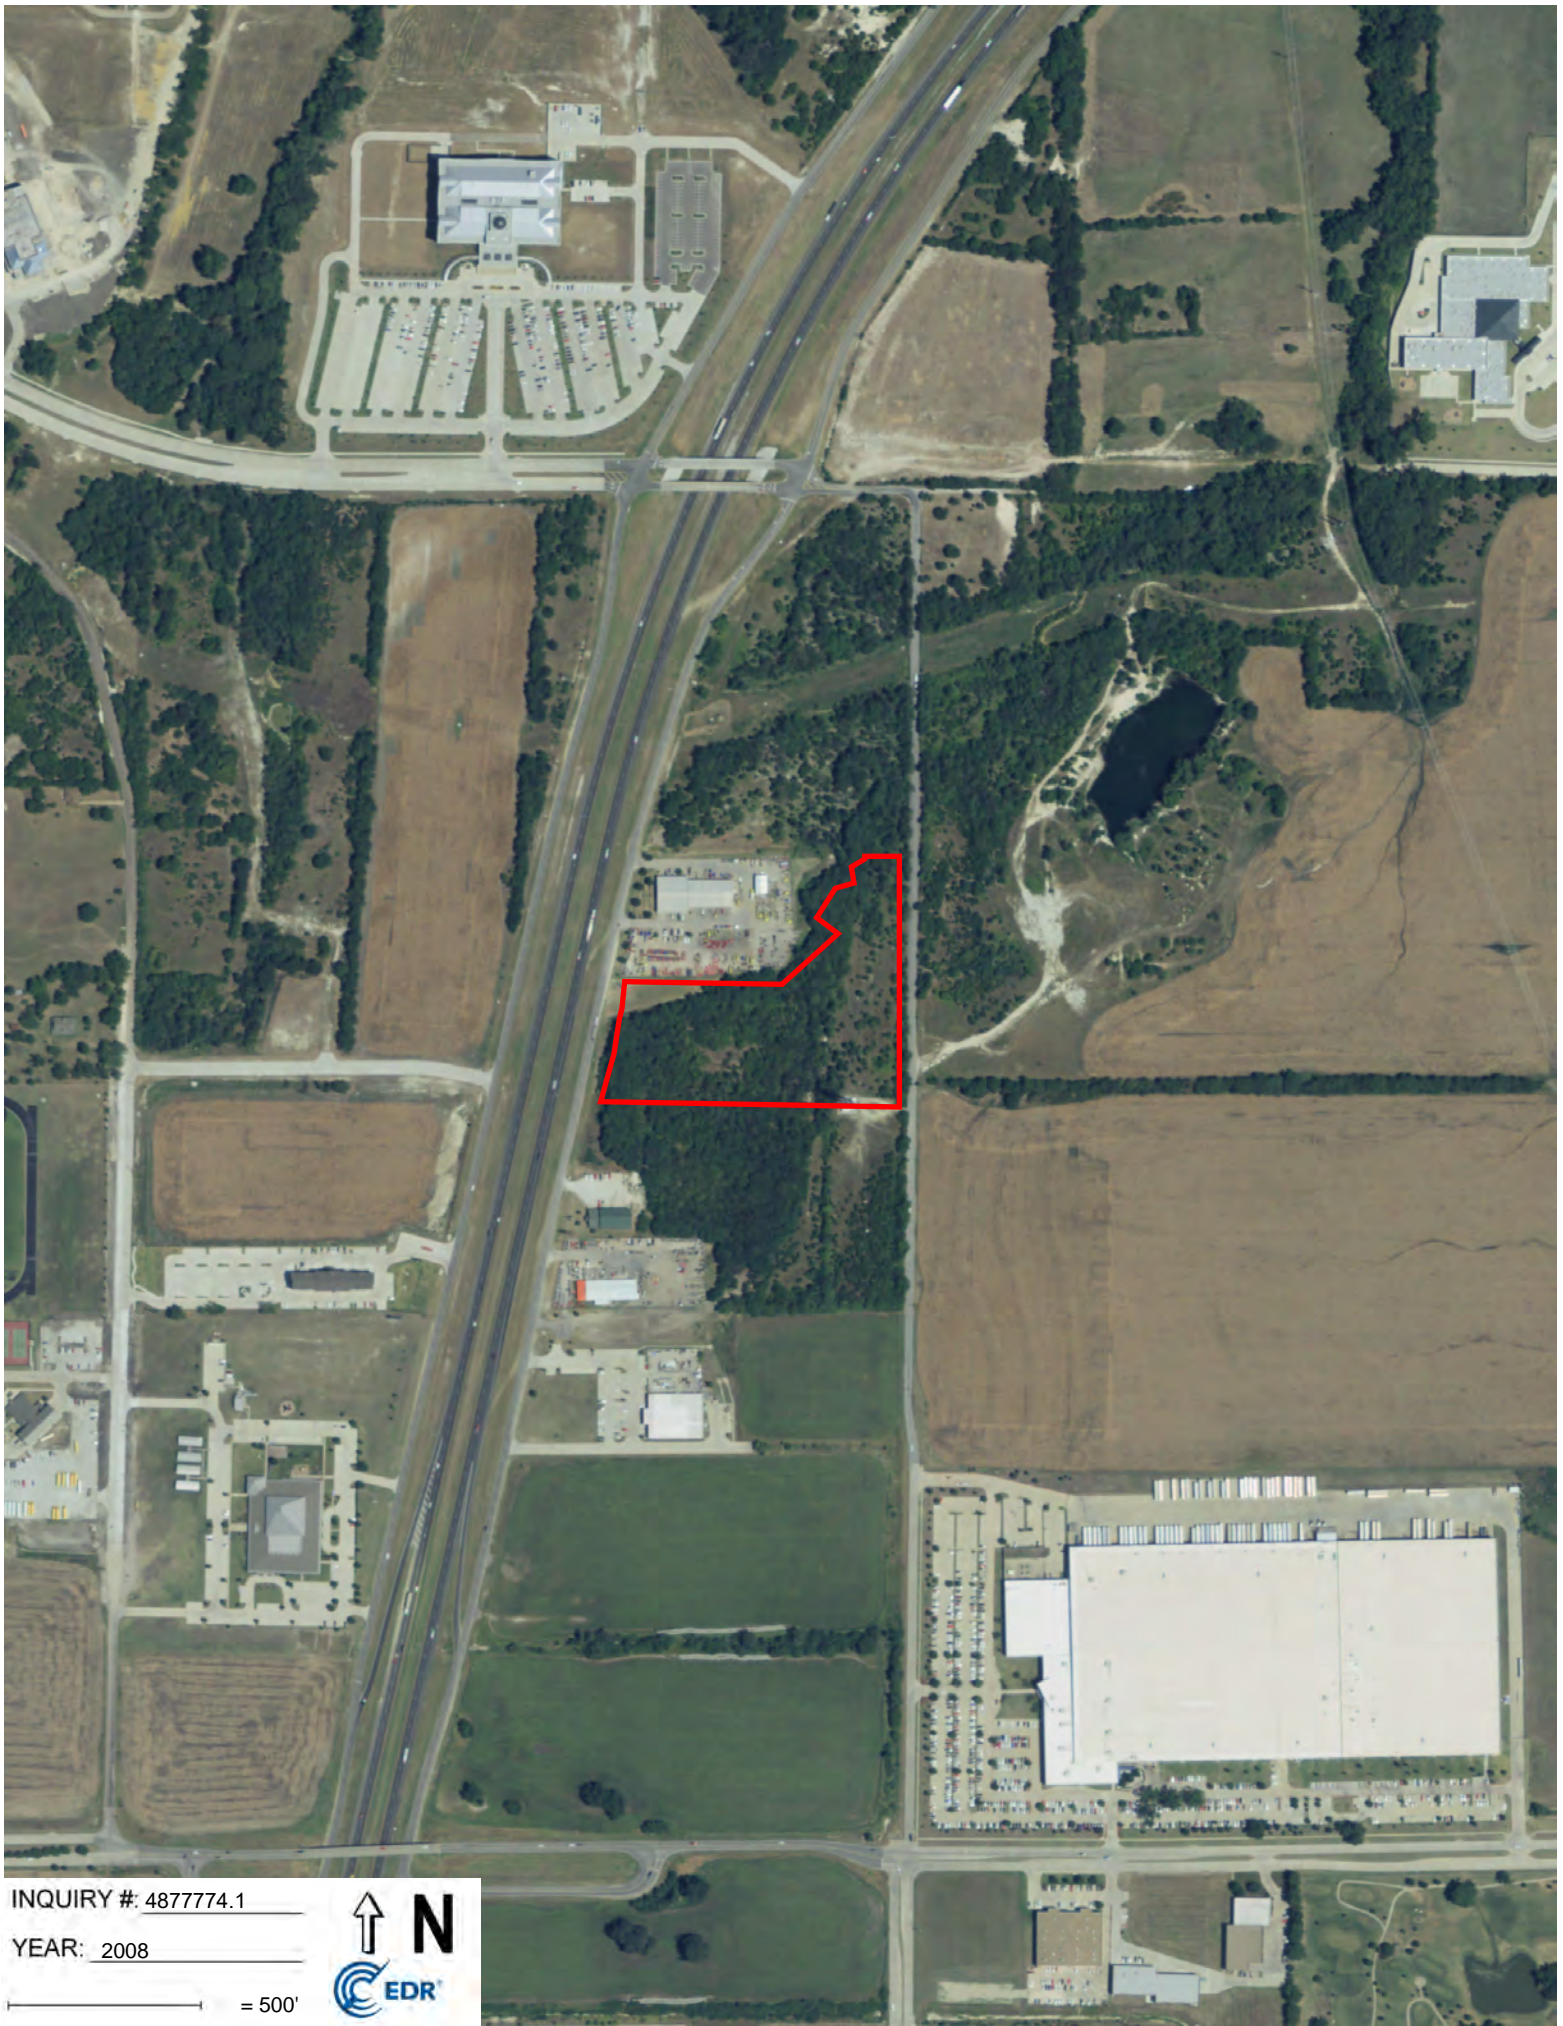
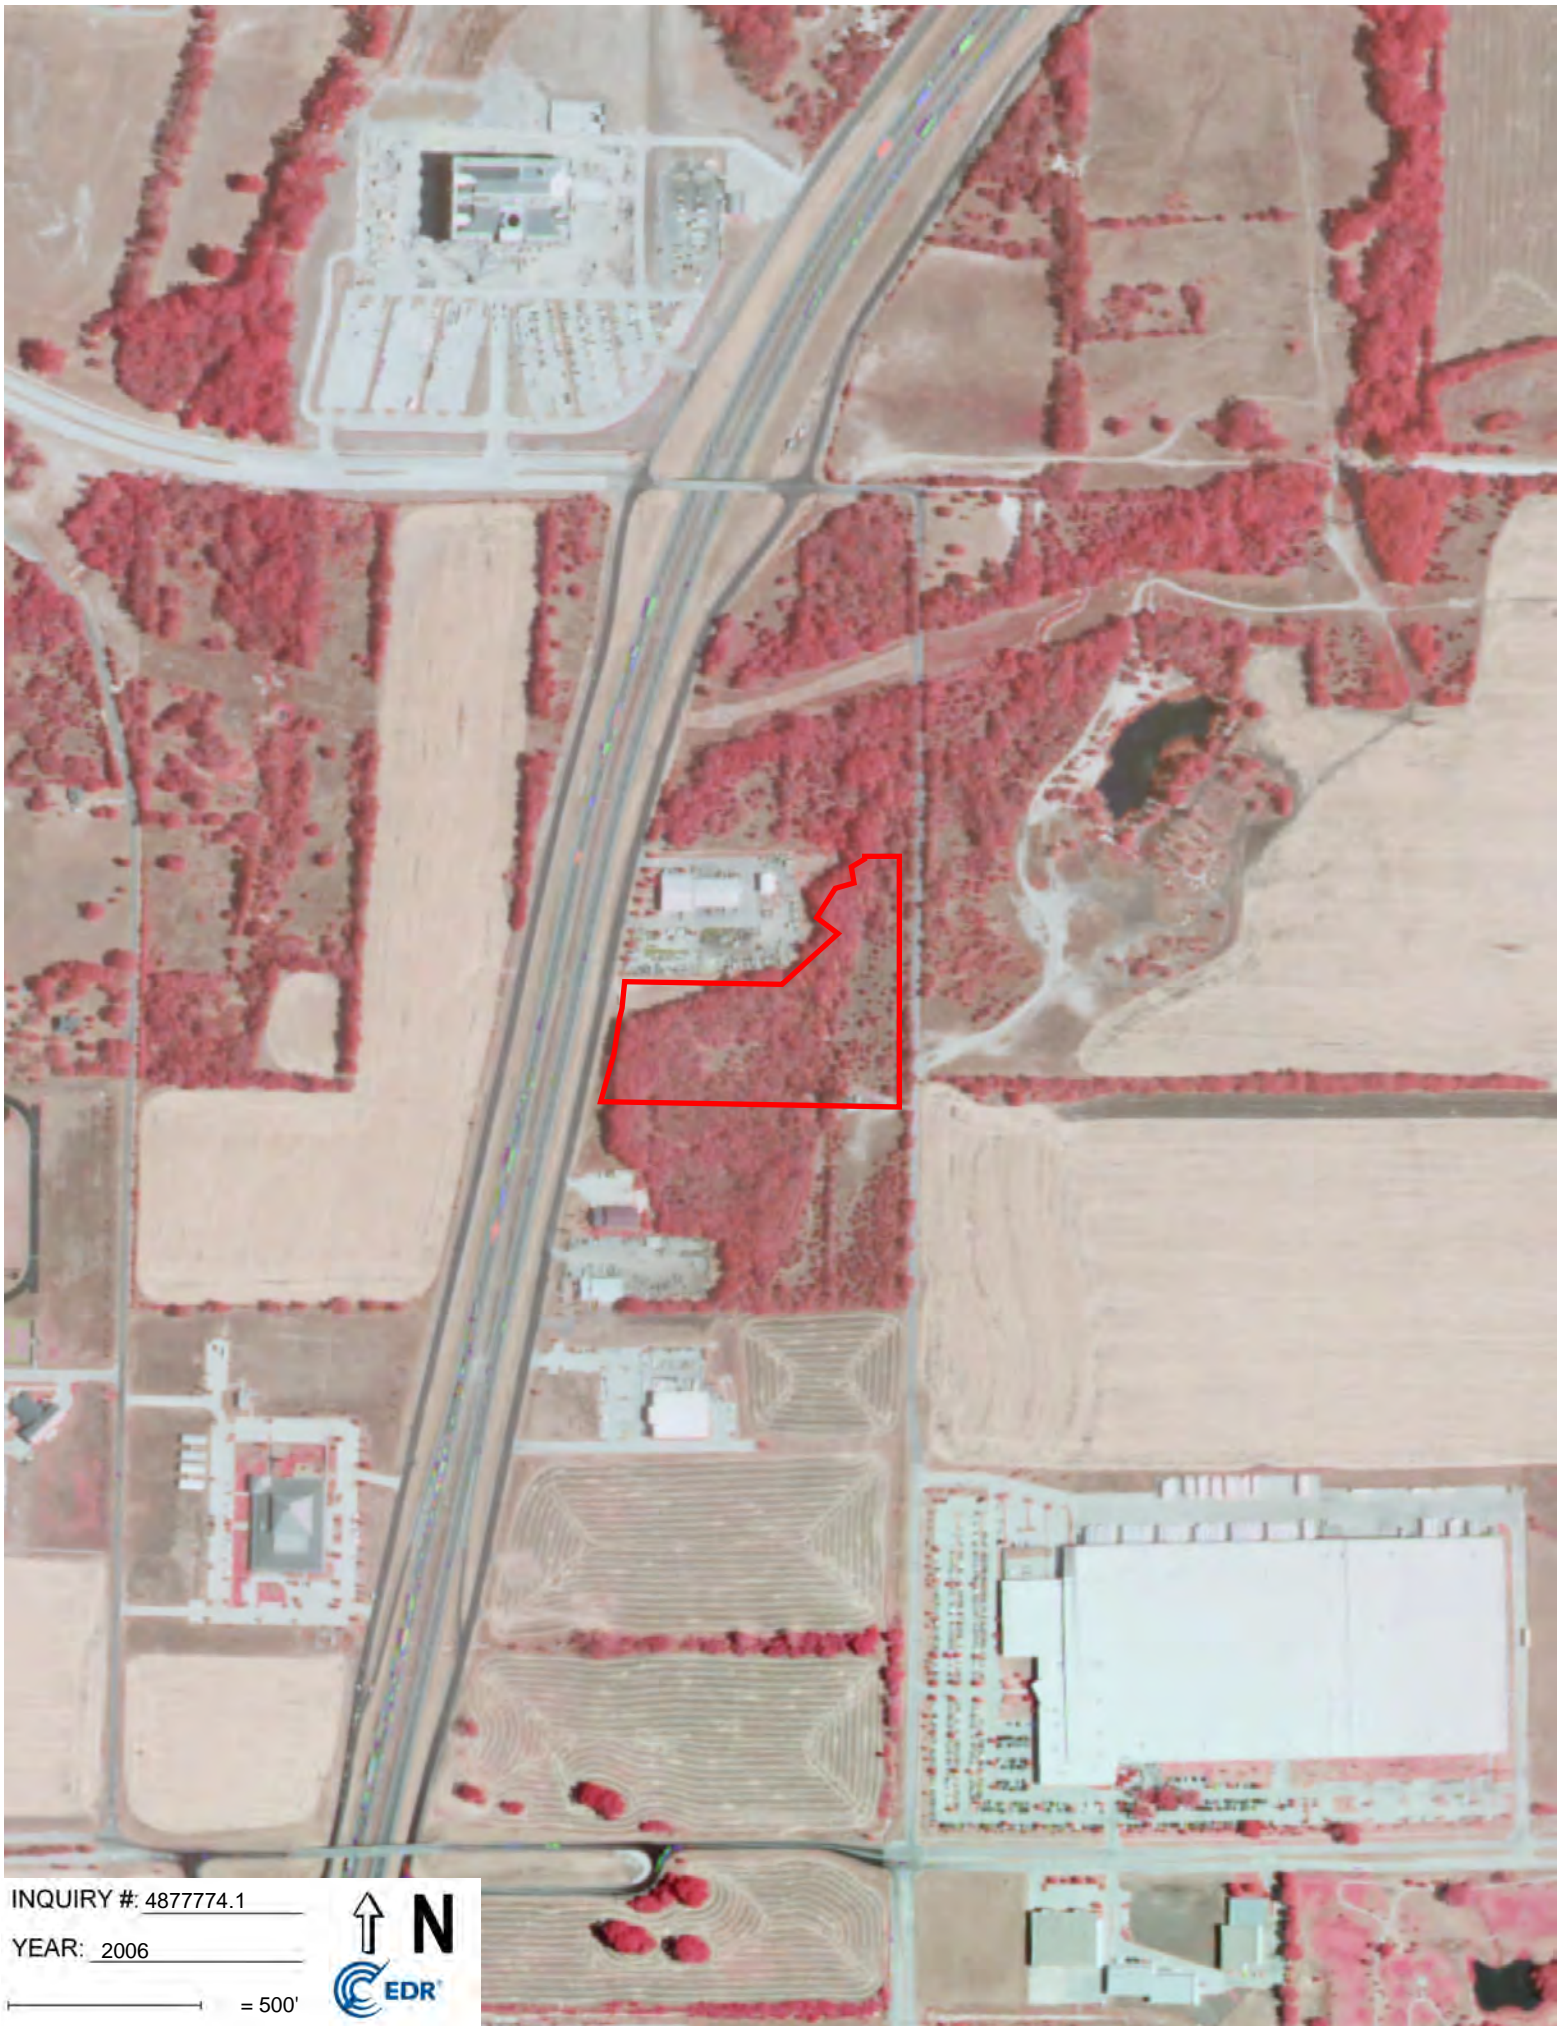
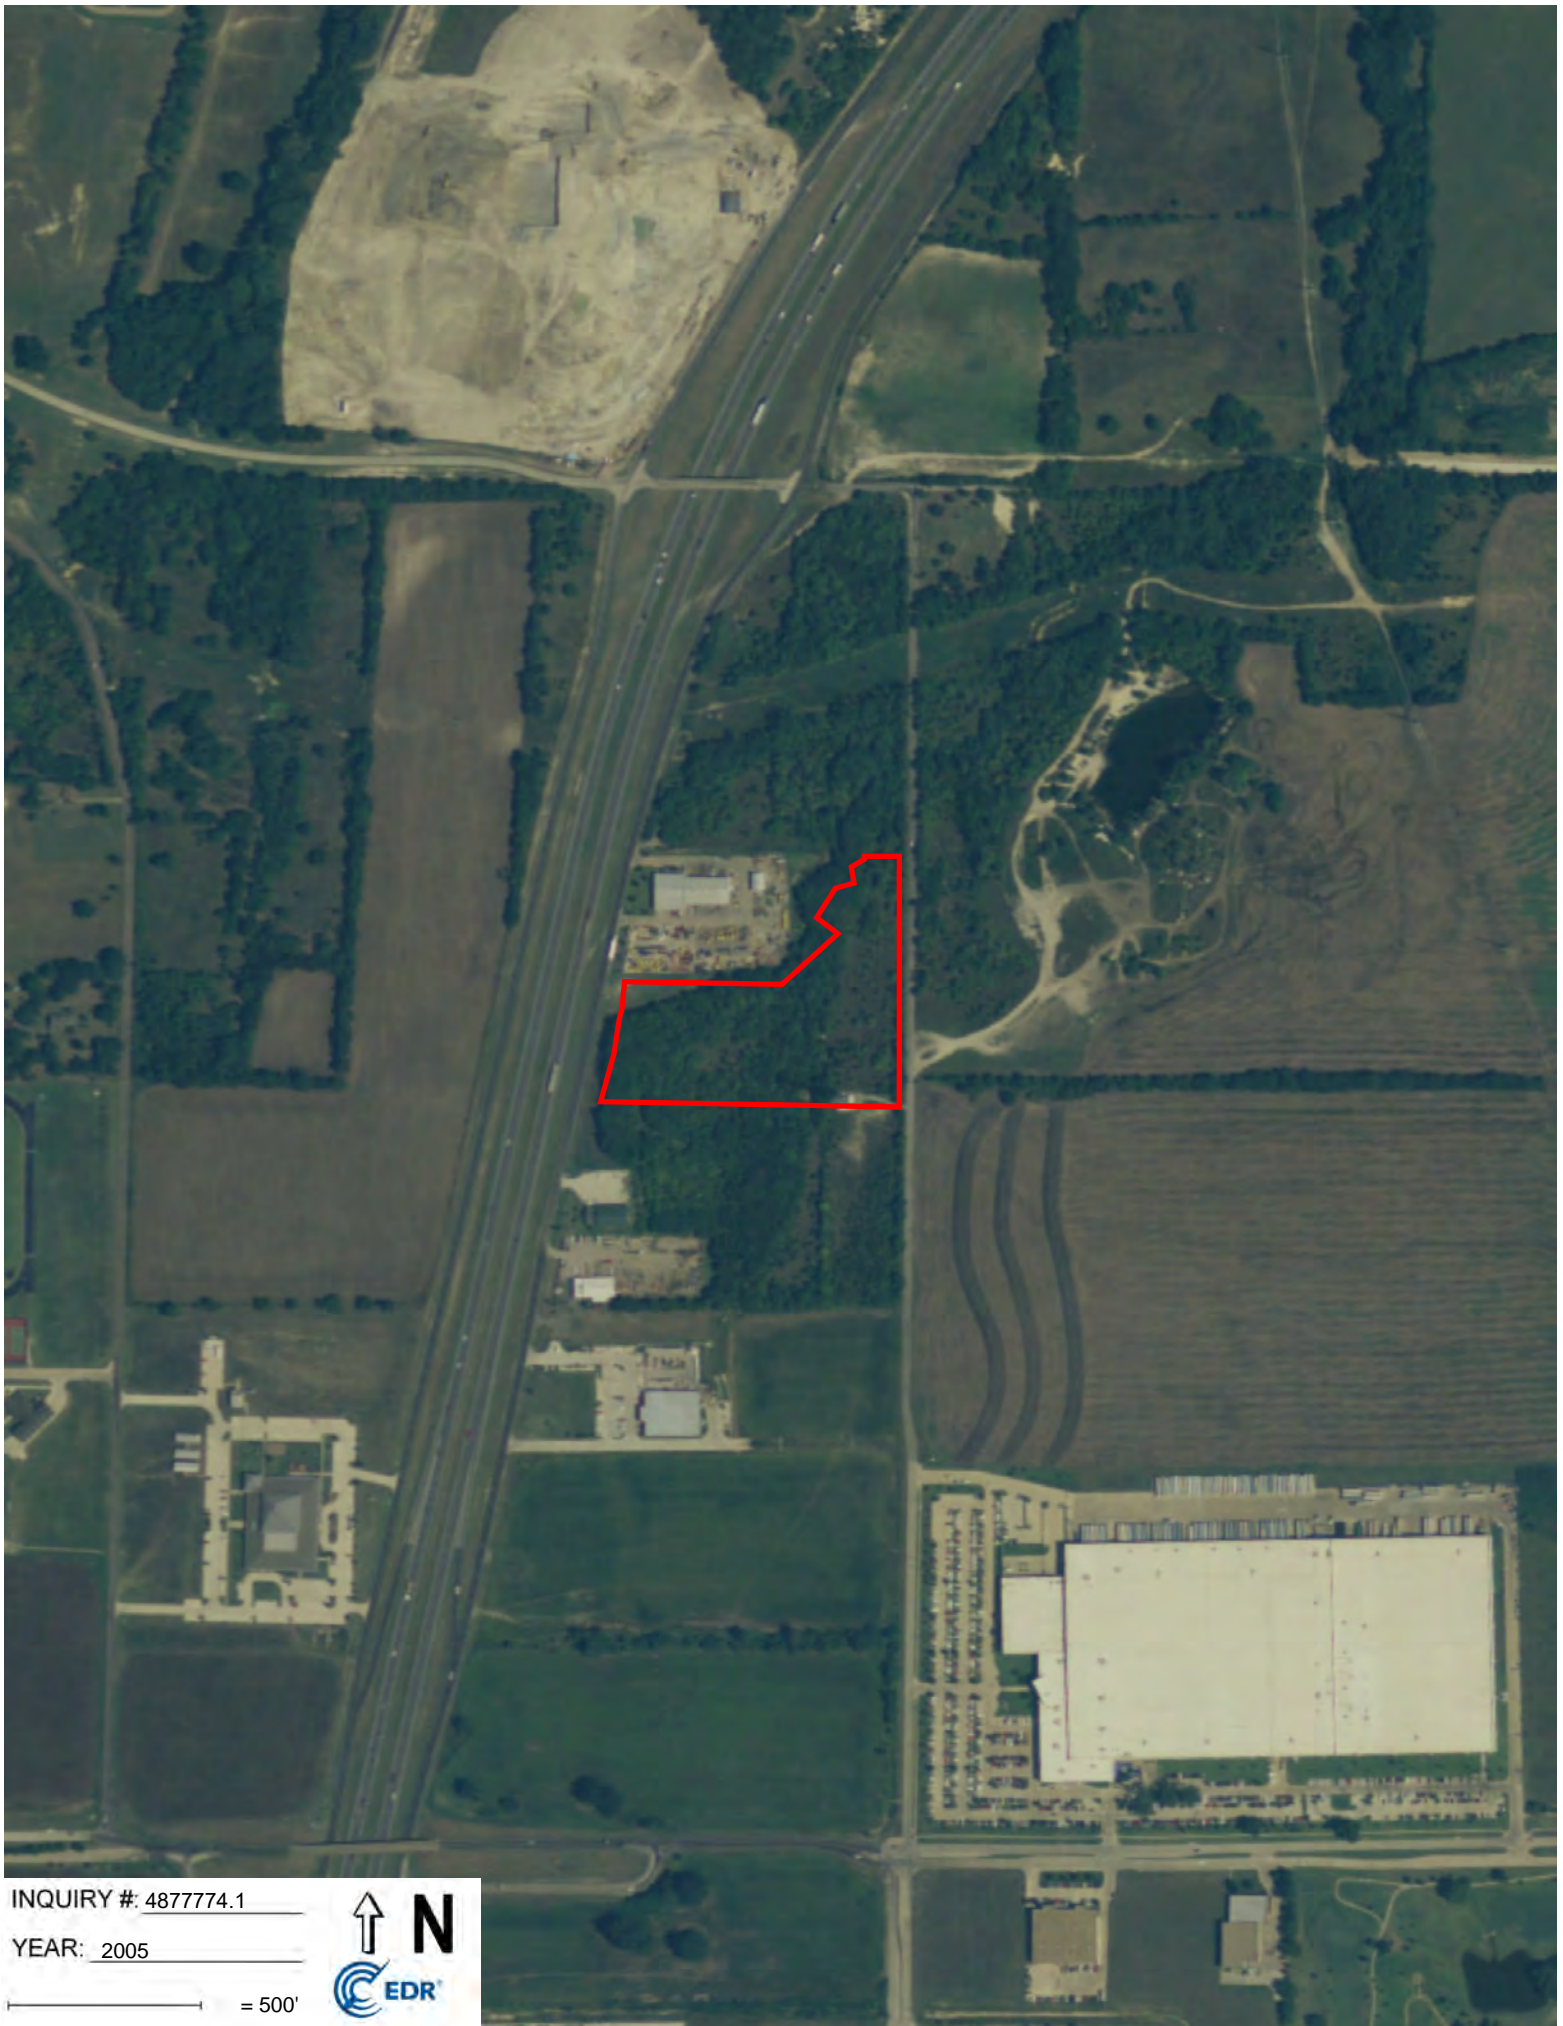
2005-2012 – The property directly north has developed, while the drainage ditch, just to the south of the new development is still maintained. Woody cover has claimed the entire western portion to the drainage course along with some woody encroachment in the eastern field. A small pad site is evident beginning in the 2005 aerial photograph in the far southeastern corner.

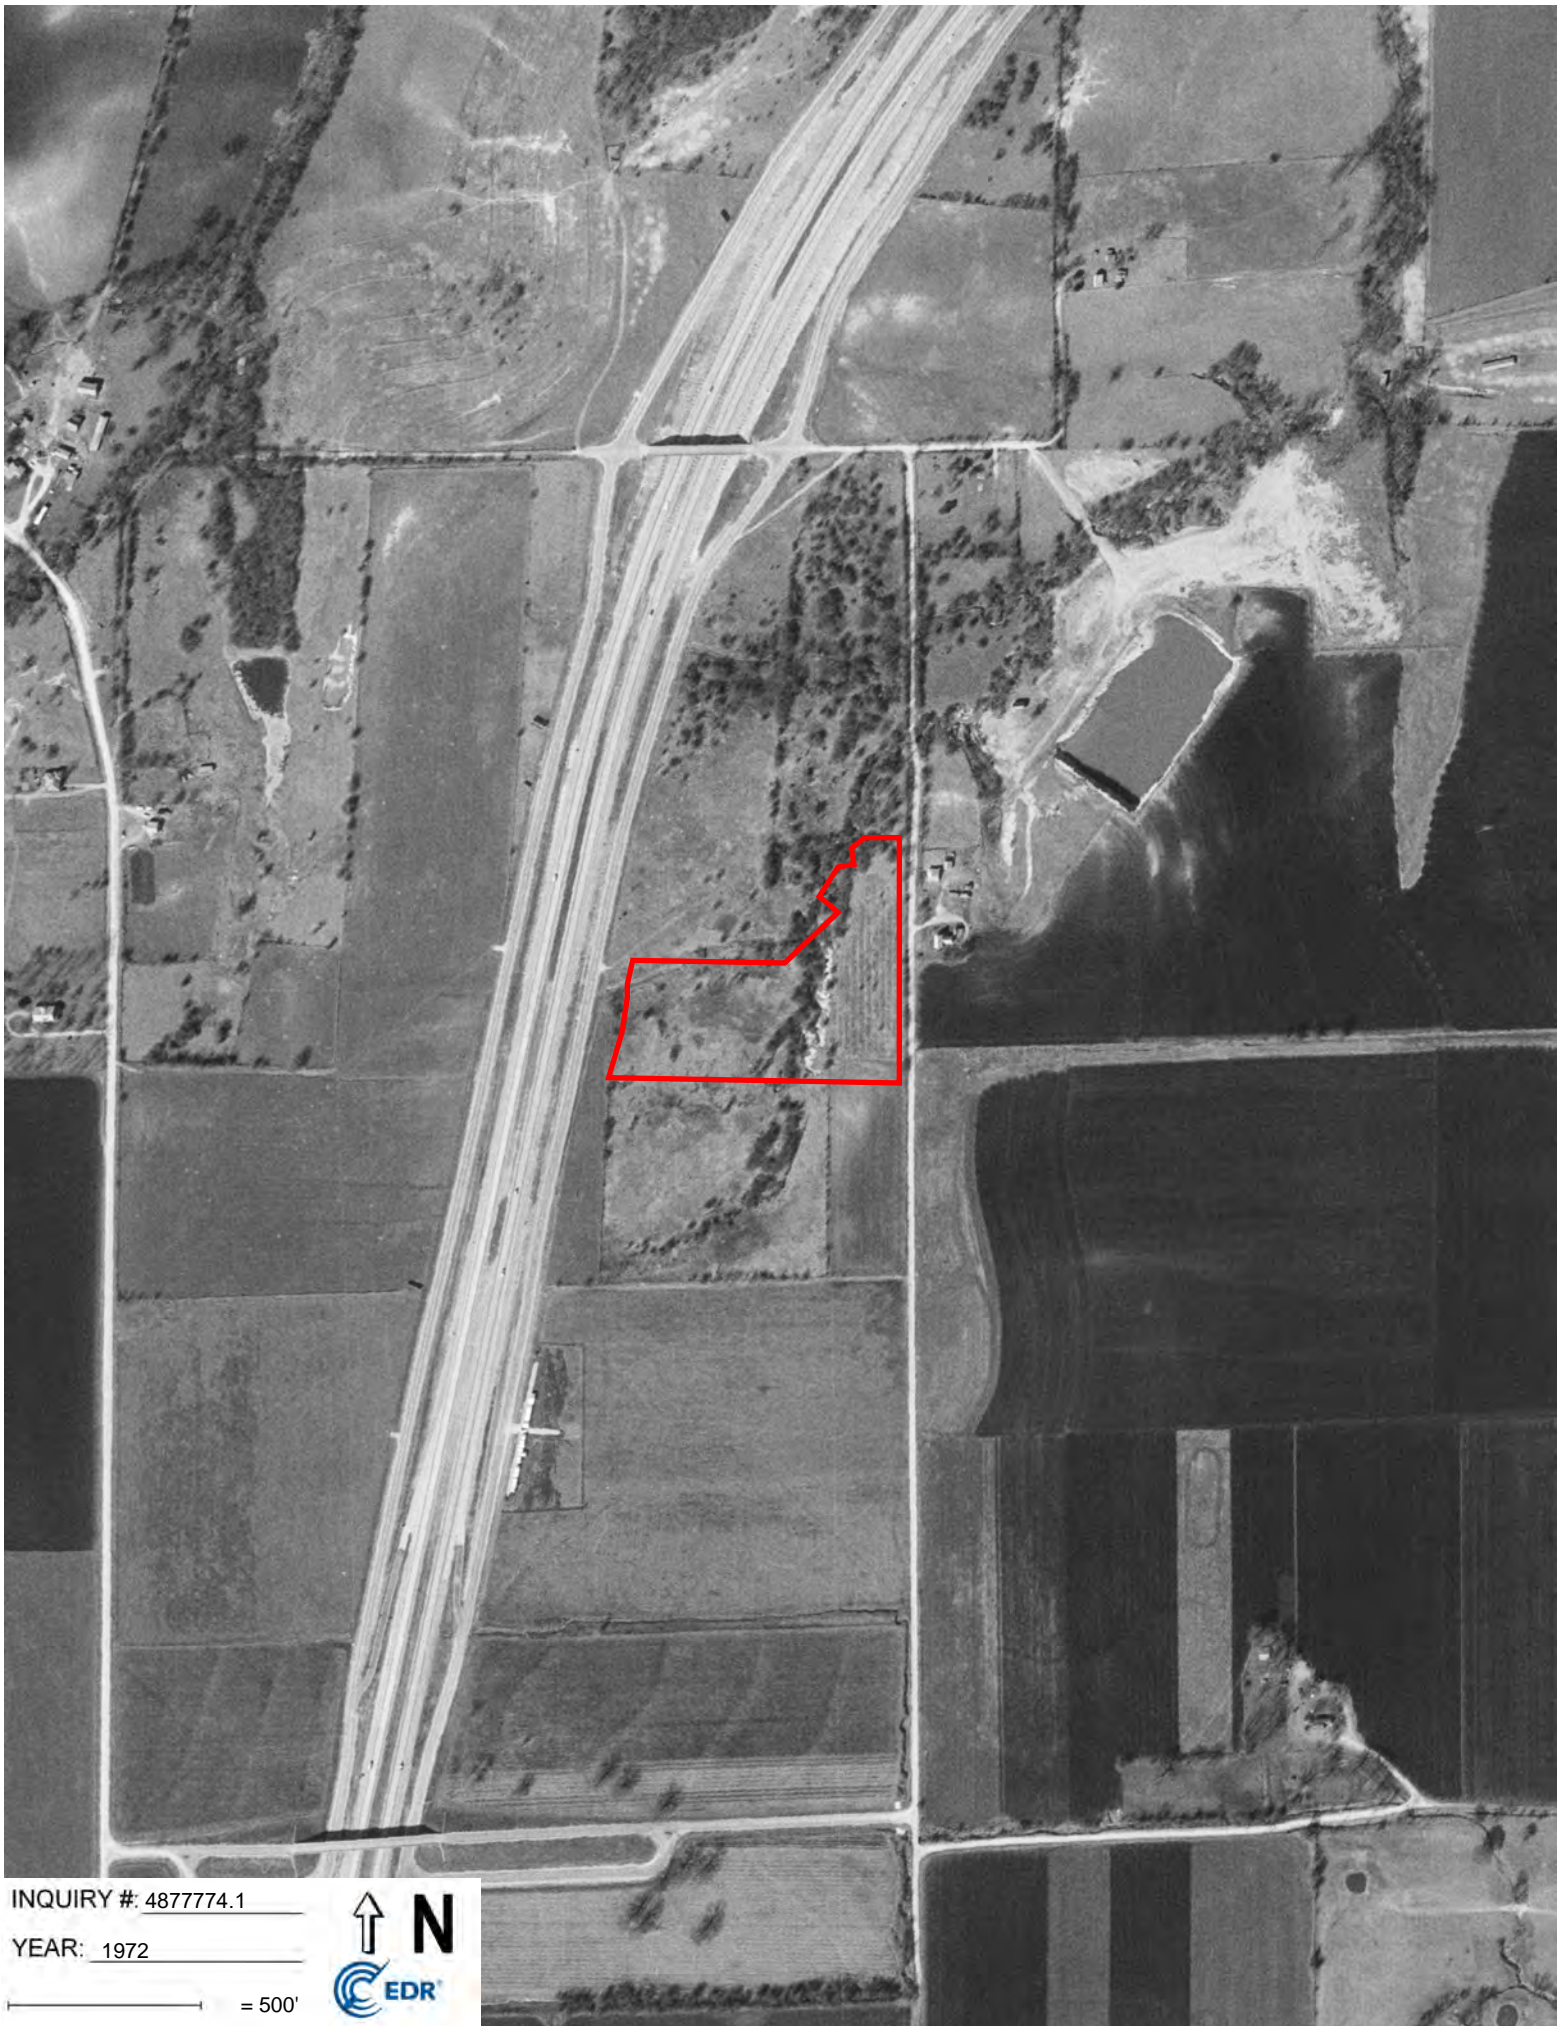
YEAR: 1972

1972 – The drainage ditch is still apparent from US 75 with less erosional scarring evident in this photograph. The drainage course has a strong woody canopy with clear evidence of downcutting to bedrock on the eastern bank. The eastern field still appears maintained as there is little woody encroachment.

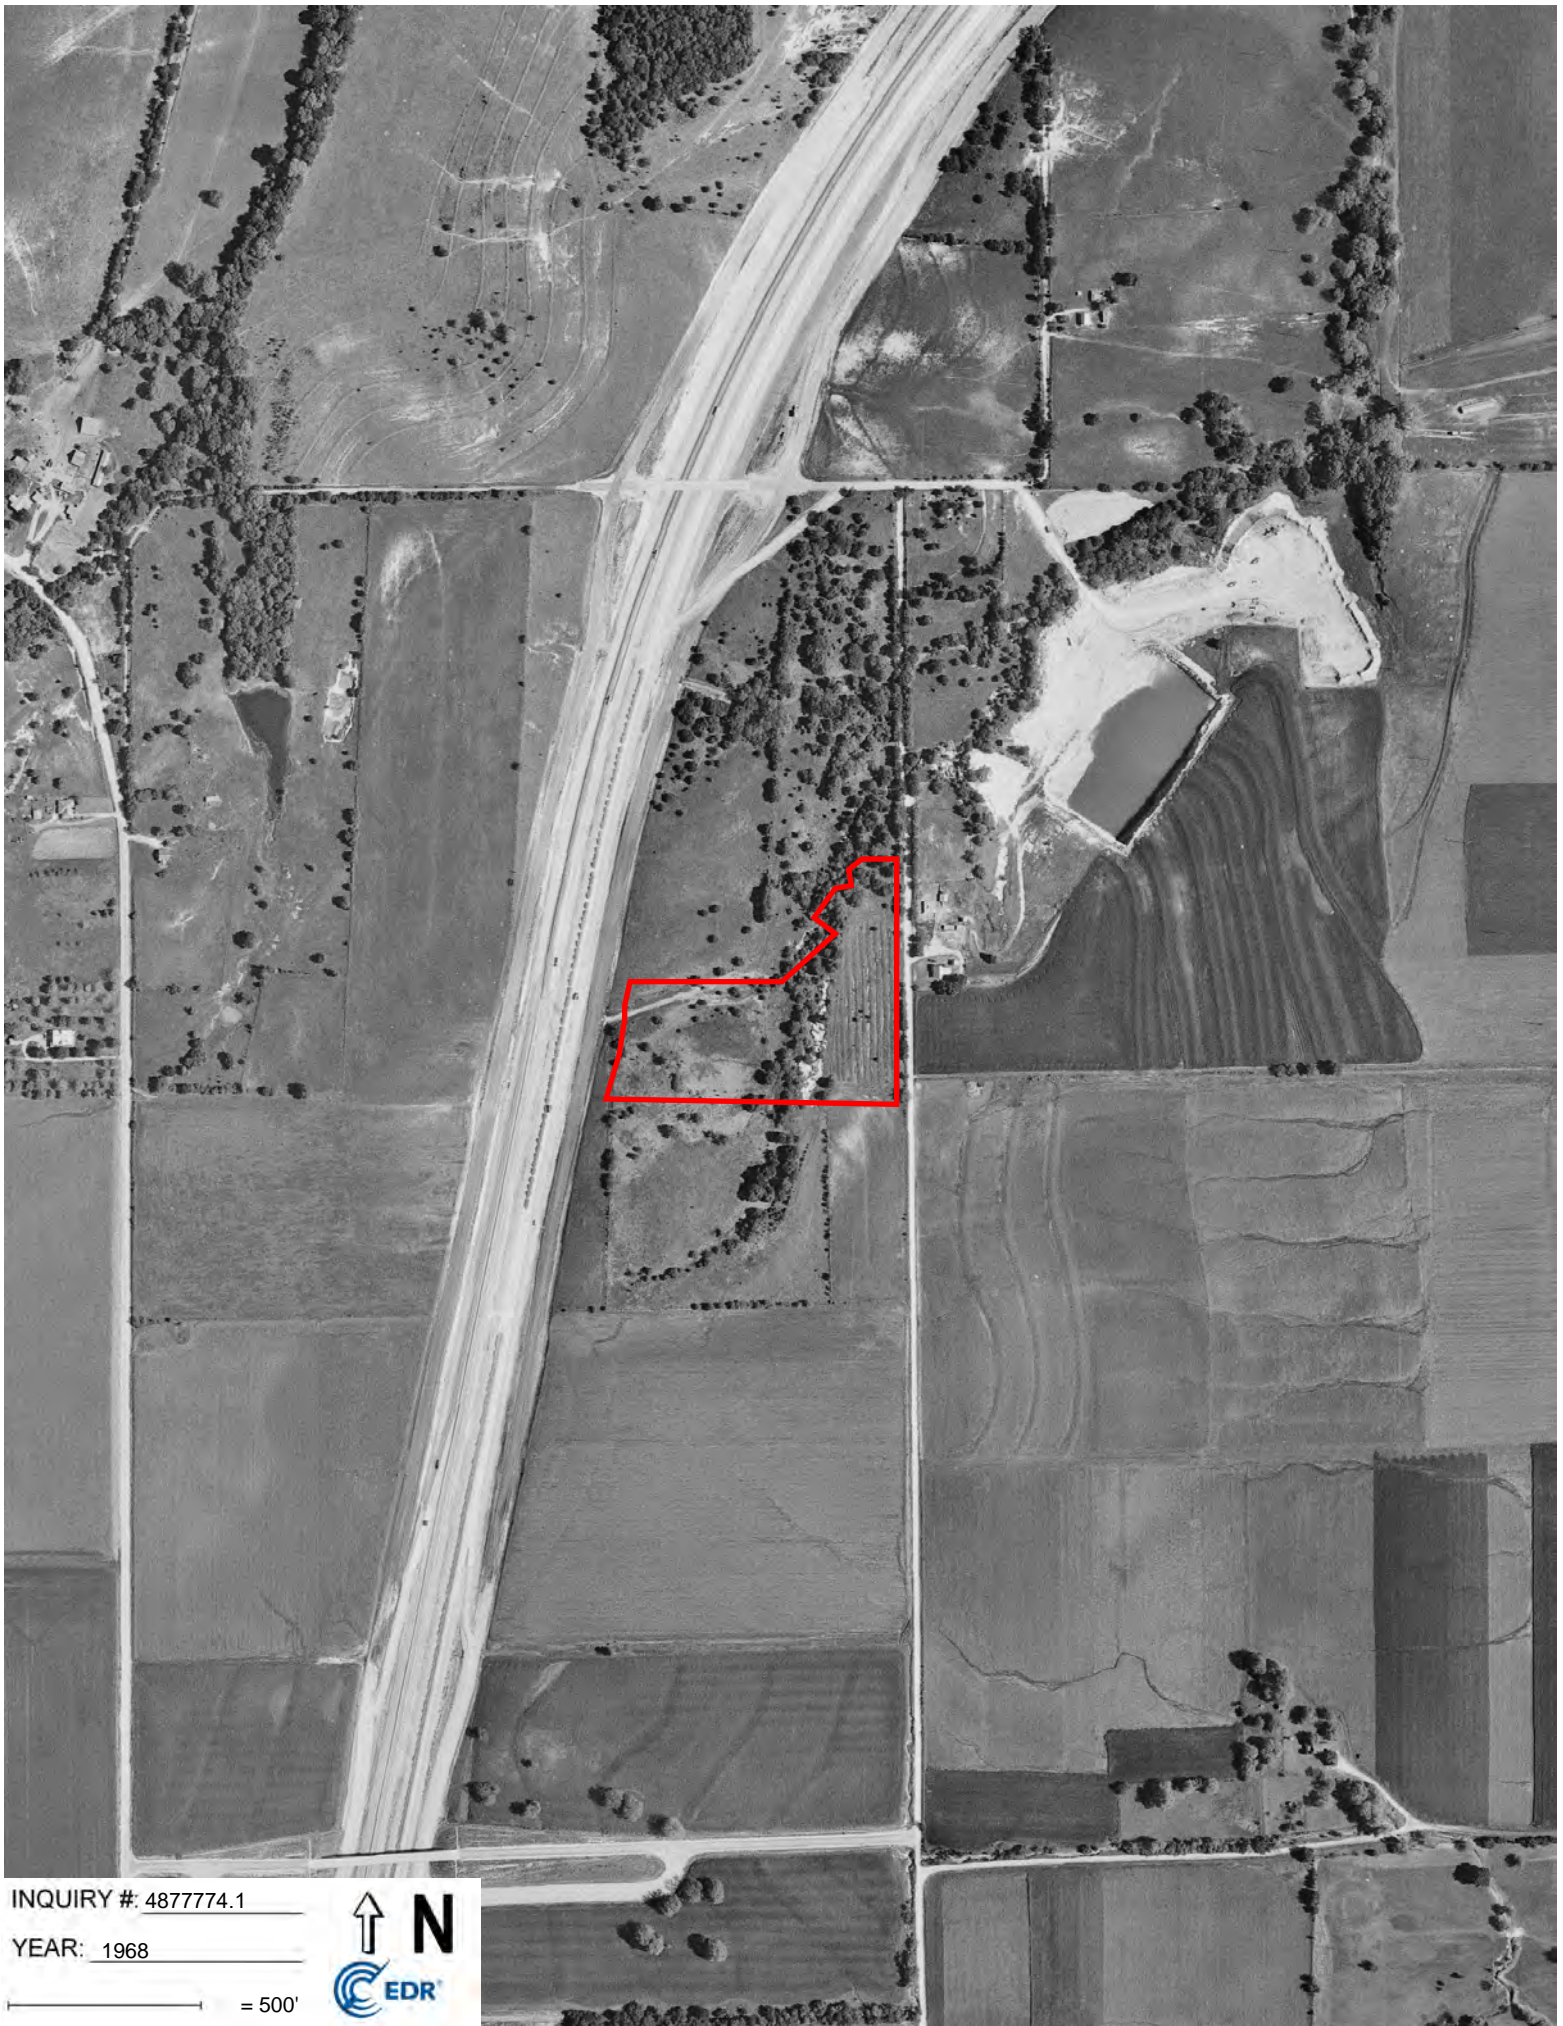
YEAR: 1968

1968 – Tree cover increases along the drainage course and sporadically in the west. The trees in the eastern field are no longer apparent; however, the rows are clearing visible. Construction has begun on US 75 to the west. A linear drainage ditch has been cut along the northern boundary of the western field originating at the roadside ditch on the northbound US 75. Erosion scars are evident from the end of the linear ditch toward the drainage course.
