01 April 2022

Re: ACIS McKinney - Waters of the United States Delineation  
Approximately 8.133 acres located approximately 1,500 feet south of the southeastern corner of Bloomdale Road and U.S. Highway 75 in the City of McKinney, Collin County, Texas

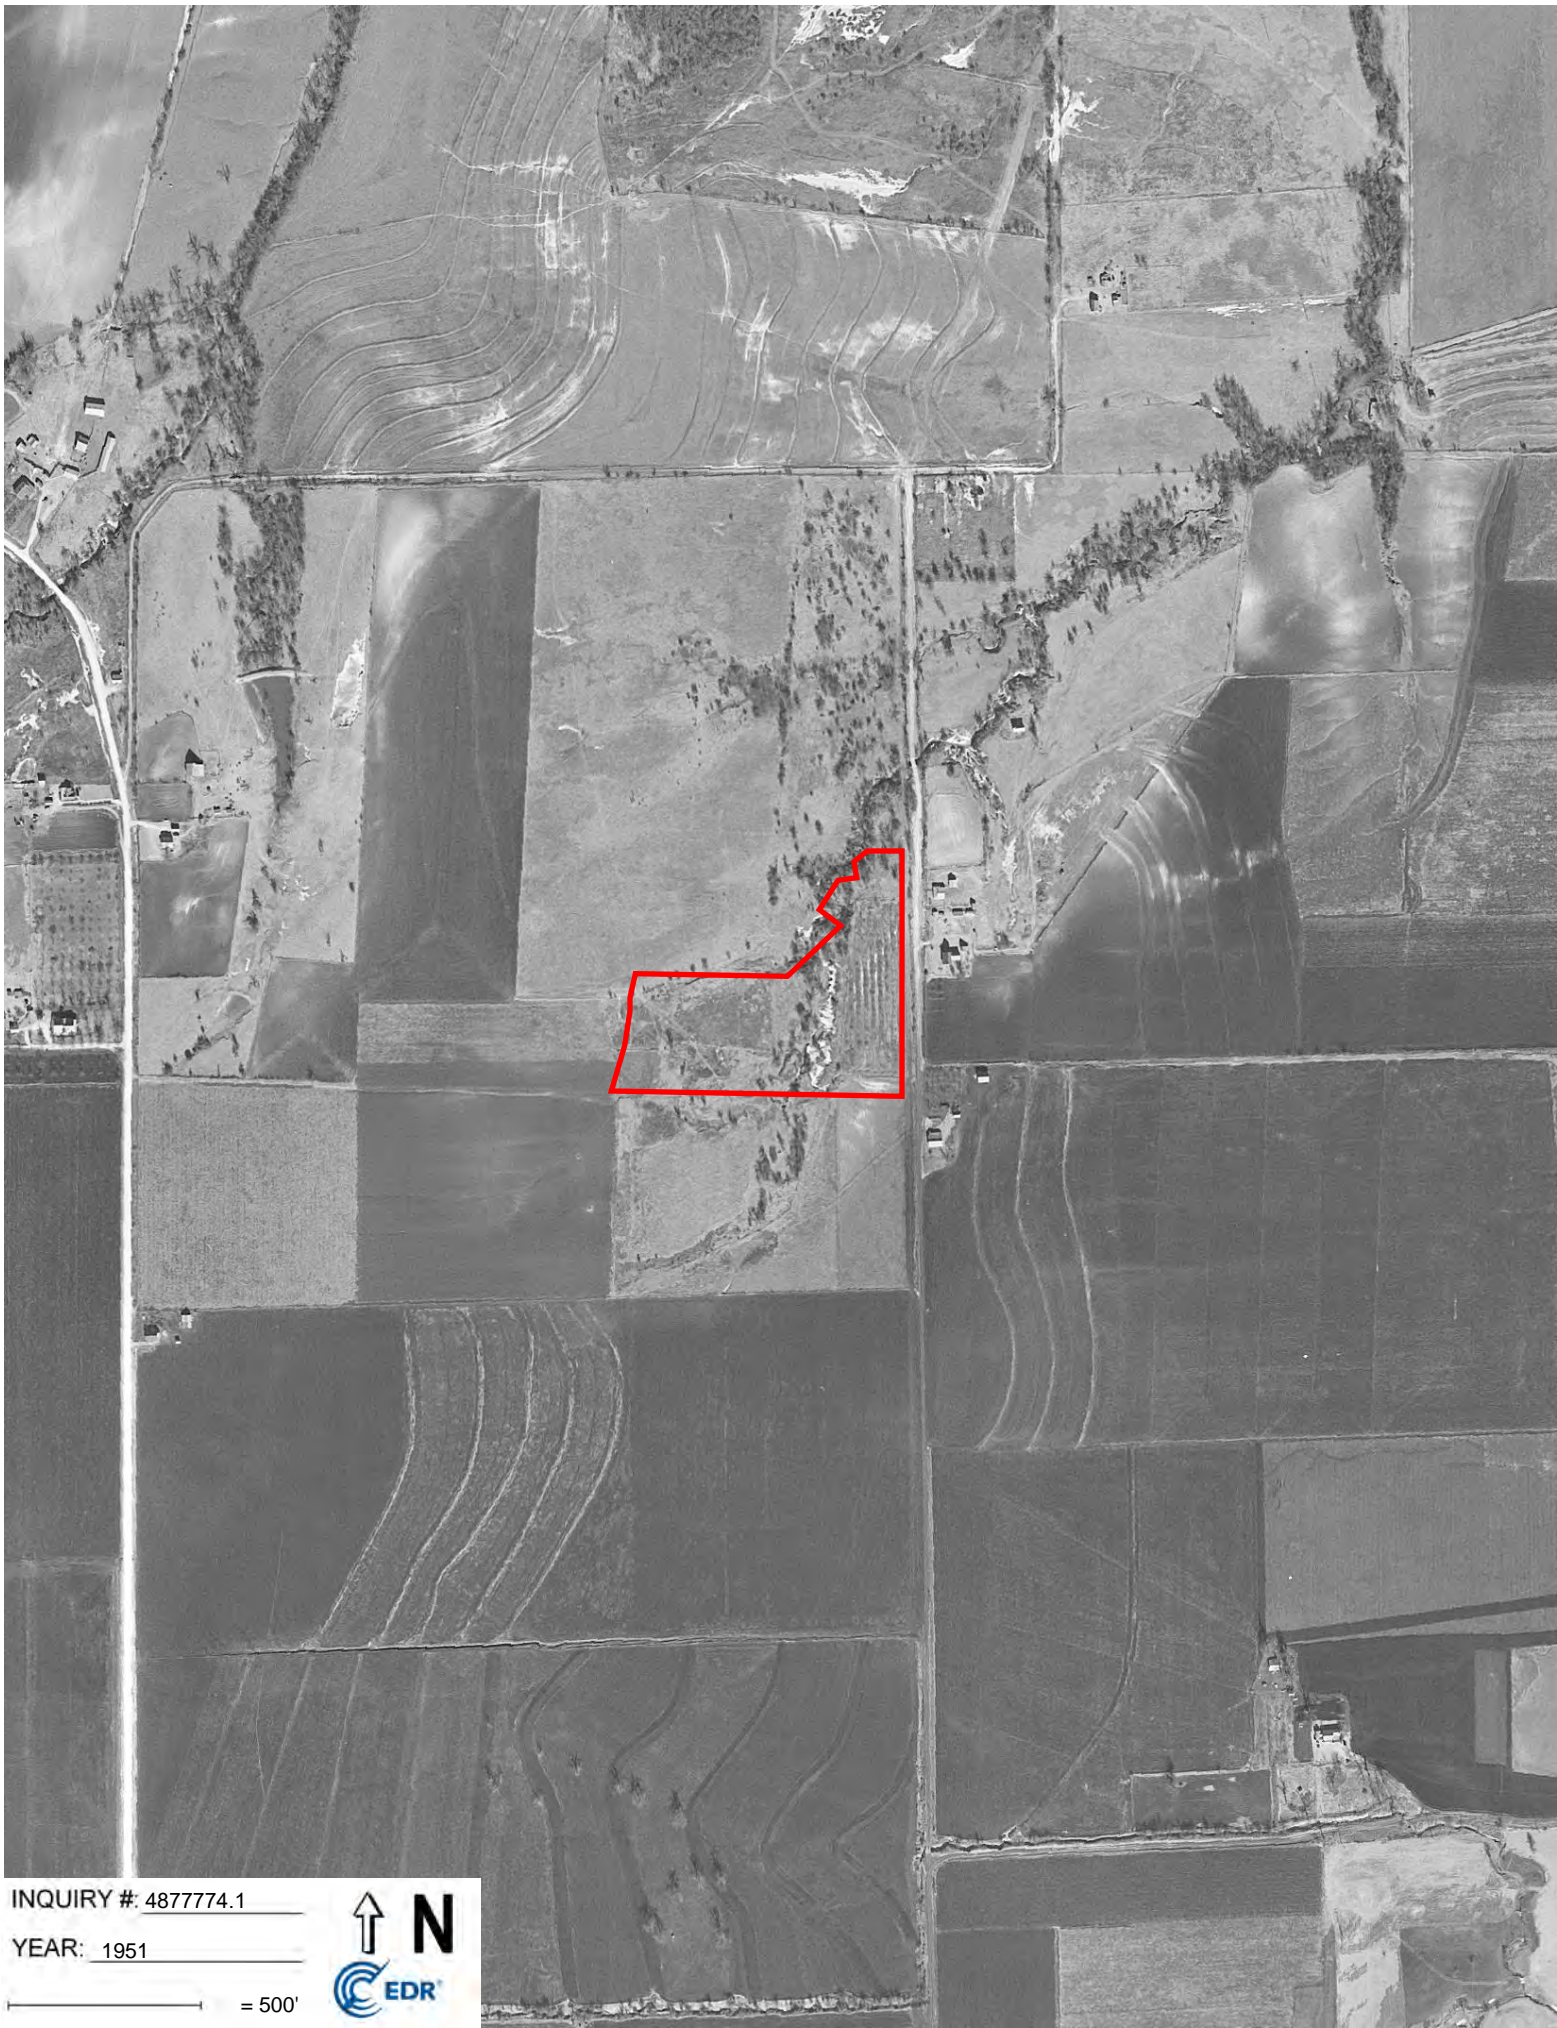
YEAR: 1951

1951 – The southwestern homestead is no longer visible. The western plowed field appears as pastureland, which is no longer actively plowed. The trees in the eastern field appear larger. The drainage course is still visible with indication of further downcutting and erosion off the fields.

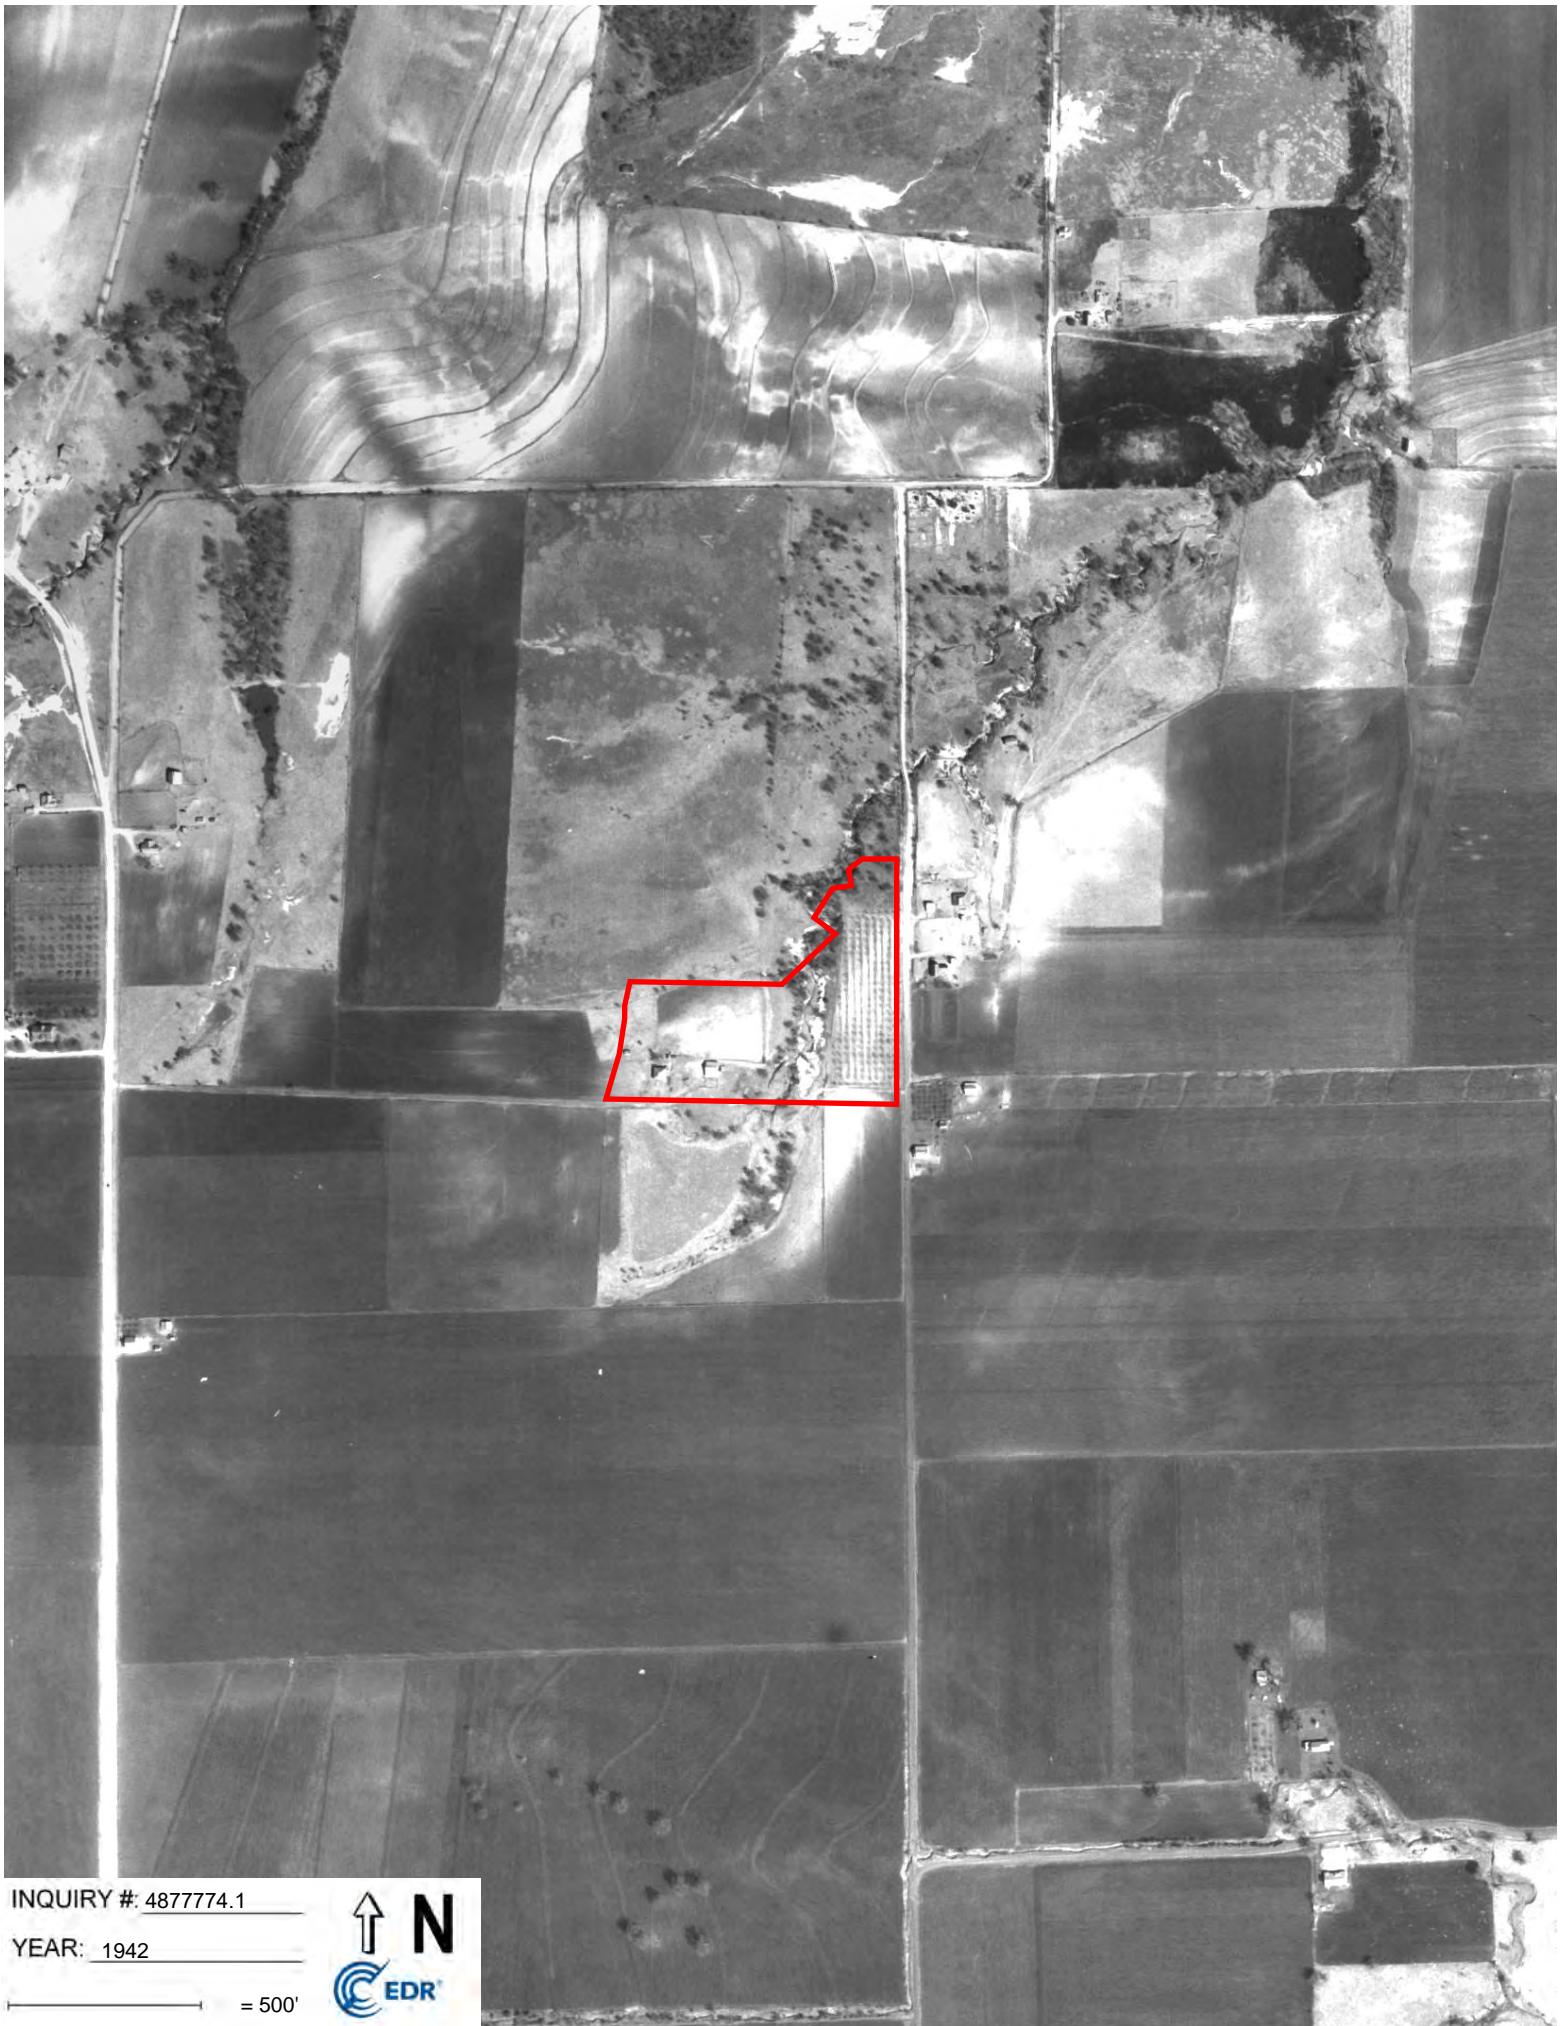
YEAR: 1942

1942 – The survey area is characterized as an active agricultural field comprised of plowed fields in the west and indications of planted tree rows in the east, a drainage course bisects the property originating to the south and flowing out of the northern boundary. A homestead is visible in the southwest. Surrounding properties consist of similar land use including plowed fields, terraces, roads, drainages, and homesteads.
