HISTORIC RESOURCES INVENTORY
BUILDING AND STRUCTURES

1. BUILDING NAME (Common) Hotchkiss Bros. Office		(Historic) Same
2. TOWN/CITY Torrington	VILLAGE	COUNTY Litchfield
3. STREET AND NUMBER (and/or location) 199 Water Street		
4. OWNER(S) Hotchkiss Bros. Co. <input type="checkbox"/> Public <input checked="" type="checkbox"/> Private		
5. USE (Present) Offices		(Historic) Same
6. ACCESSIBILITY TO PUBLIC:	EXTERIOR VISIBLE FROM PUBLIC ROAD <input checked="" type="checkbox"/> Yes <input type="checkbox"/> No	INTERIOR ACCESSIBLE <input checked="" type="checkbox"/> Yes <input type="checkbox"/> No
IF YES, EXPLAIN By appointment

Hotchkiss Brothers Office

Hotchkiss Brothers: A History

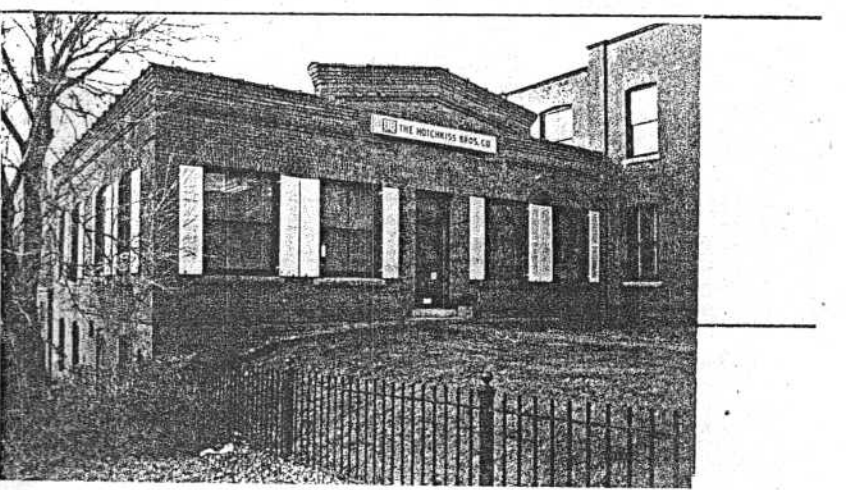
PHOTOGRAPHER: Mark McEachern 1/83
 VIEW: NE NEGATIVE
 NAME: William E. Devlin 6/83
 ORGANIZATION:
 ADDRESS:

17. OTHER NOTABLE FEATURES OF BUILDING OR SITE (interior and/or exterior)
 The office of the Hotchkiss Bros. Co. is four bays wide facing Water St. with a central entry. The original door in the entry is wooden, 3/4-glazed and panelled, with a large transom above. It is flanked by two windows with 2 over 2 sash (except for the southernmost window) which have wooden shutters, rusticated granite sills and flat arched lintels of gauged brick. Brick is laid in Running bond. The building's most distinctive feature is its corbelled cornice built up in four layers from an entablature that in its turn is formed by corbelled brick. A pediment rises in the center built up of corbelled brick like the cornice. A raised brick panel carrying the company's sign is in the center of the area below the pediment, its top and bottom even with the lines of the cornice and entablature. The cornice is carried around the south elevation. The north elevation is a party wall with the factory building next to it. The interior of the office is noteworthy for the richness of its trim, as

17. one might expect from a company that traditionally has dealt in wood products. The front door opens onto a narrow hall with a reception office to the right. The office is richly panelled in quartered oak. Wainscoting in the hallway has been removed or covered with paneling. The corridor turns right ; the offices of the president and vice-president are to the left. The president's office is panelled in mahogany. Doors have shouldered architraves, and a concave crown molding runs around the ceiling. This office is lighted by the two large front windows. After the corridor takes its turn to the right it leads to another office, in the right side of the building #1. The window and door surrounds in this office feature bull's eye corner blocks. A doorway leads from this office into the factory buildings to the rest of the complex. To the rear is a one-story garage.

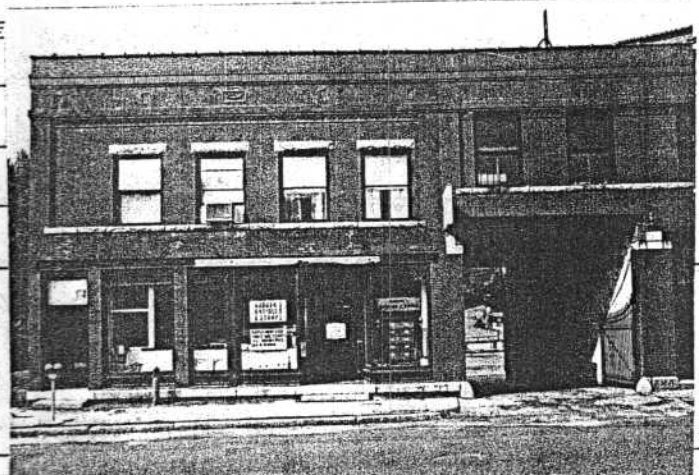
North

This combined factory and commercial building is four bays wide and contains two stories. The storefronts were originally used by Hotchkiss Bros. as a retail store for building supplies. An old illustration of the Hotchkiss Bros. plant in the 1890s shows a large, central, round-arched window in the second story. This was replaced by four windows with lintels of rusticated granite and a common sill course of the same material. Above is an entablature formed by corbelled brick with a row of brick set on edge suggesting a dentil effect. The frieze has a central swag of terra cotta and above a corbelled cornice with a parapet above that. Other inset terra cotta panels with egg and dart moldings around the edges flank the central swag in the frieze. The storefront is cast iron, its cornice a large I-beam. The patera-like ends of the metal floor rods ornament it. Above the large plate glass display windows, separated by panelled pilasters, is a row of dentils. The rear first floor

17. of this building was originally office space and continues to be use as such. Reached from the office by a stairway with tongue-and-groove wainscoting and a chair rail, is a lunchroom on the second floor. The lunchroom, well lighted by large windows facing south, also has tongue-and-groove wainscoting and a chair rail. The floor is maple. In a nearby room is a large iron safe, manufactured by the Warth-Baum Safe Co of Cincinnati. The safe probably dates to the nineteenth or early twentieth century. Doors in this section are panelled. The presence of the safe indicates that this second floor was also used as office space at one time. There is a covered walkway (bridge) which leads from the second floor to Building #2 (1924). This provides access to the factory (west) and lunchroom and offices(east). The storefronts on the street currently house an antique business.

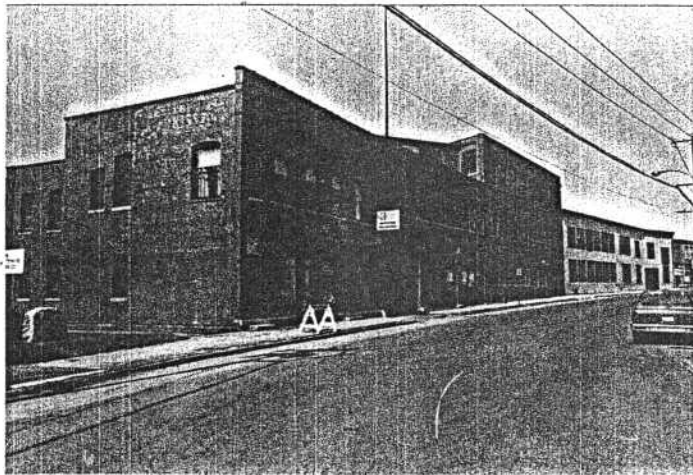
Photograph:

Northeast view showing Factory Building #1, its two-story rear section and the relationship to the rest of the complex

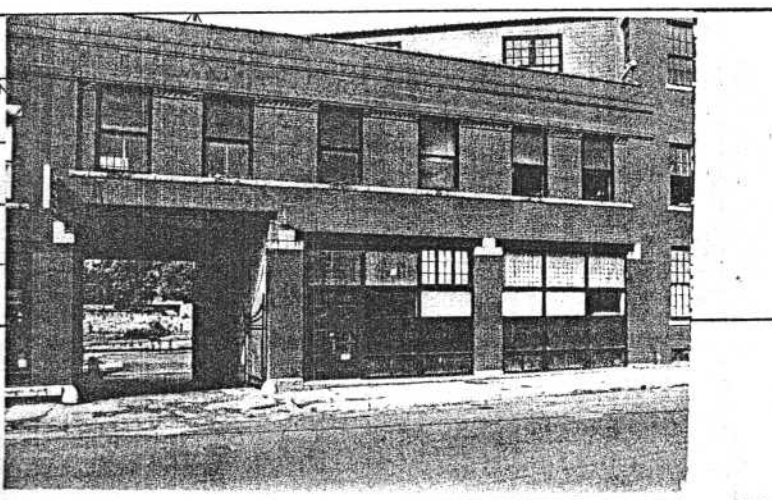
VIEW: E NEGATIVE ON: _____

This factory building houses the Hotchkiss Bros.' Shipping and Receiving Department in the rear. Its facade is eight bays wide on the second story. The southernmost bays on the ground floor are a driveway leading to the complex's rear side. The windows have a sill course of rustic granite, and the cornice, entablature, frieze and parapet are a continuation of Building #1 to its south. There are two storefronts, with plate-glass windows and large transoms with glass blocks, surmounted by an I-beam. Piers separate the storefronts, accented at the base and cornice by cast stone bands. The building is long and deep with a monitor roof, and reaches three stories in the rear. It is sixteen bays deep and has 15 over 15 windows separated by brick piers. This building is brick and mill construction with all posts and beams chamfered. The members are 8 X 12 and 8X8 held together by angle iron. Windows are original 15 over 15 sash. Doors are panelled with transoms. The floors

17. are hardwood. The monitor top is set back from the street so that the facade matches that of Building #1. The monitor top connects with the third floor of Building #3 which was built shortly thereafter in 1924. Both top floors in Buildings #2 and #3 were used for door woodwork

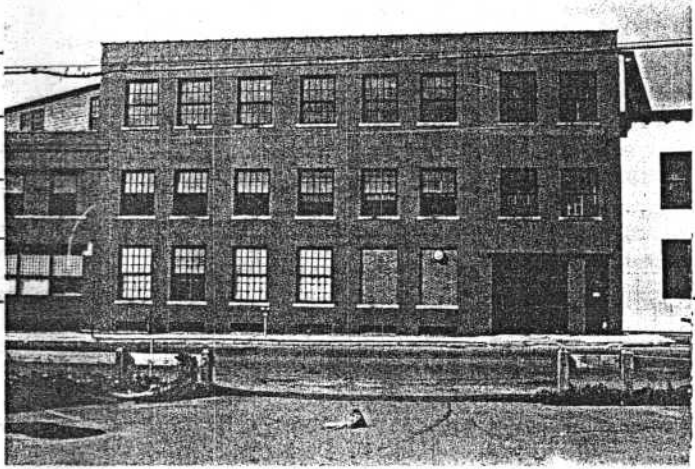
VIEW
N

This tall brick building is eight bays wide, the last two bays on the north being later additions. There are two doors, side by side in the two northern bays. Windows are 10 over 10, with rusticated granite sills and flat arched lintels. There is a corbelled cornice with parapet above. The interior is of mill construction. Wood beams are 9 X 15 supported by Lally columns, with steel cross beams. Walls are brick, floors are maple. In this building are the sash room and blind room. Window sash are metal.

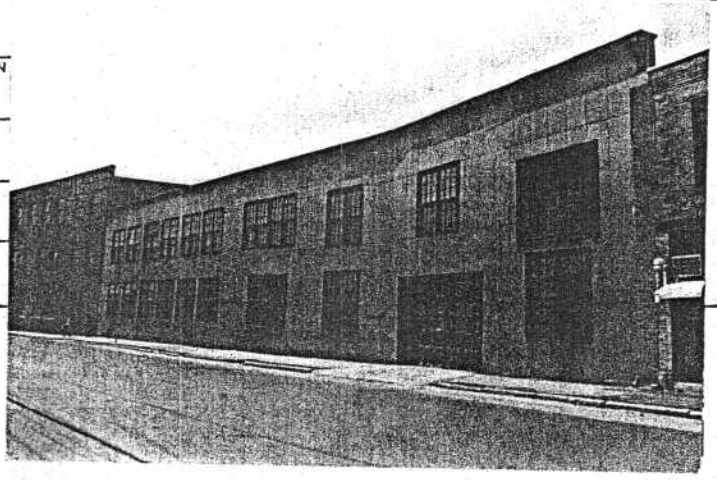
17. wall is within the present building. Floor of the building is mapl
The foundation is cut granite ashlar.

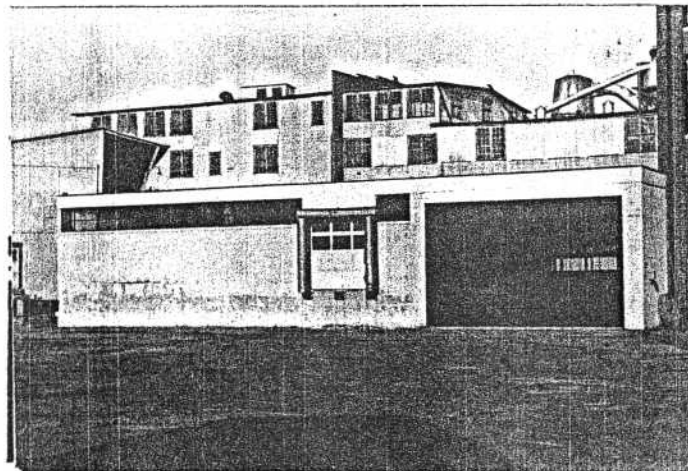
Photograph: Rear Addition

There is a large three story addition on the rear of this building.
This dates to 1912-see photo #2 for a view of this addition with its
paired 12 over 12 sash. Like the original building, it has clapboard
siding covered with asbestos shingle and then a layer of corrugated
metal. A prominent brick fire wall cuts through the addition. It may
have been constructed because the paint shop was in the rear top floor.
