Highway Frontage in Boerne 5 +/- Acres of Improved Land

31001 Interstate 10
Boerne, TX 78006

PHASE I ENVIRONMENTAL SITE ASSESSMENT

FIVE ACRES IN BOERNE, TEXAS
31001 IH 10 WEST
BOERNE, KENDALL COUNTY, TEXAS

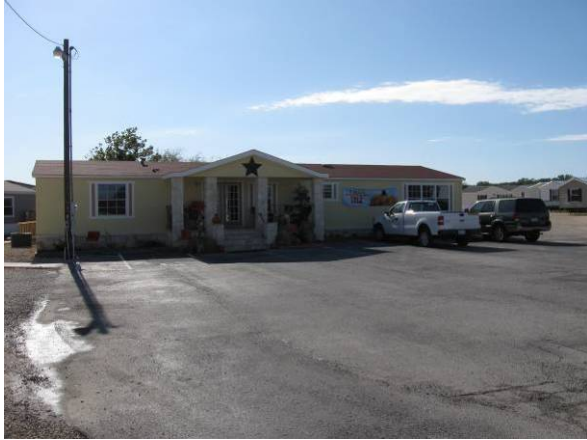
Photo #1 Photo showing the paved parking area and main office on the site.

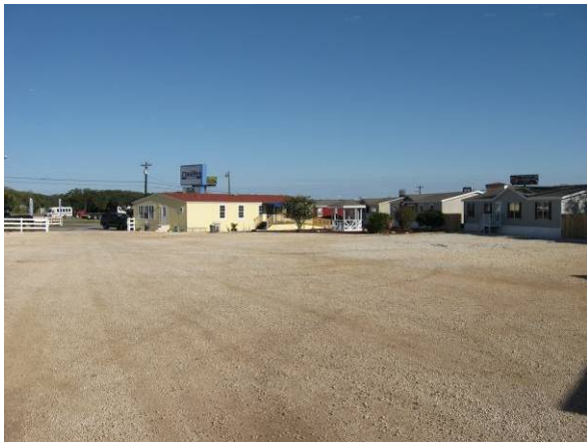
Photo #3 Photo showing base material and mobile homes on the site.

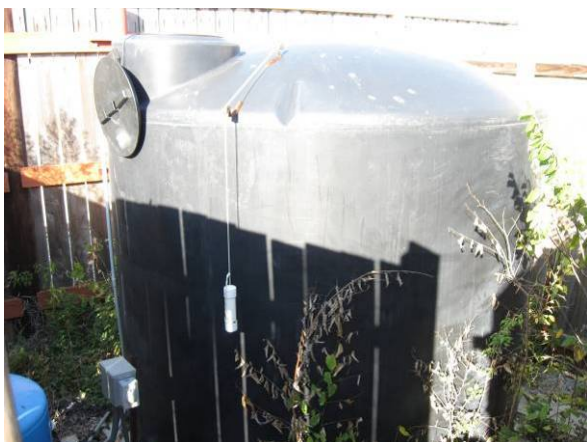
Photo #5 Photo showing the water storage tank on the site. Note the blue pressure tank left of the water tank.

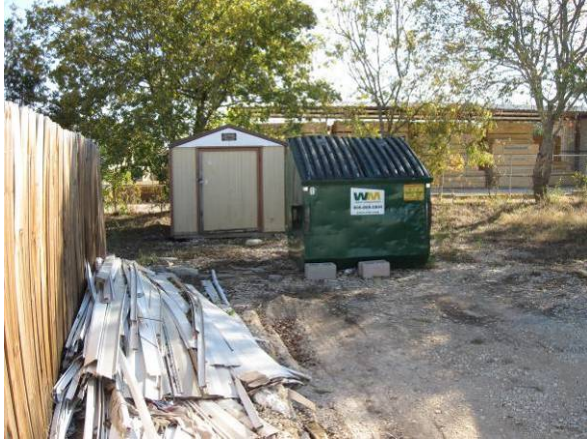
One solid waste disposal dumpster, serviced by Waste Management, was observed near the center of the site along the southern fence. No evidence of staining, noxious odors or hazardous waste disposal was observed within or in the vicinity of the on-site dumpster.

Photo #7 Photo showing the dumpster on the site.

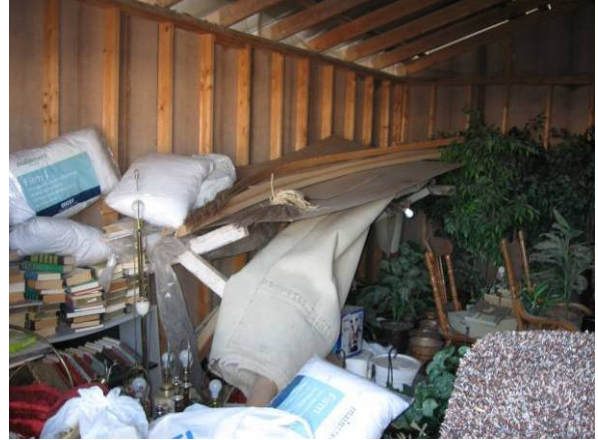
Photo #8 Photo showing the contents of one of the sheds on the site. Only furniture and decorations are stored in these sheds.
