Project: Landlord Improvements - Suite 100A

19019 Hawthorne Blvd. Torrance, CA 90503

Re: Mechanical, Electrical & Plumbing (MEP) Site Survey Report

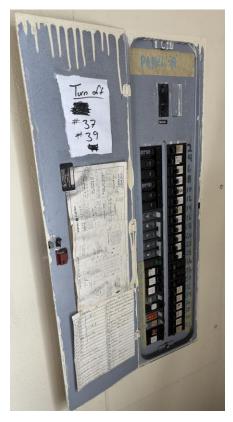
Photo #: E-2

One electrical panel (Panel A) is located adjacent to the restroom wall. This panel is rated at 200A, 120/240V and also appears to be in good working condition. However, depending on future tenant requirements, the panel may require replacement or relocation.

EXISTING PANEL IN TENANT SPACE.

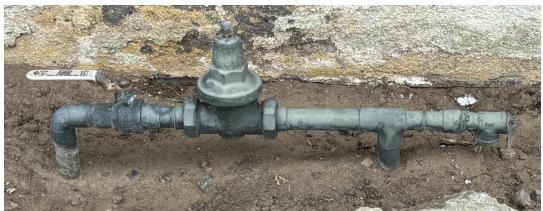
Photo #: P-1

A single 1" water line serves the building. The water meter is located on the sidewalk at the south corner of the building. Though the line is underground, it appears to be in good condition.

EXISTING WATER METERS LOCATED ON SOUTH CORNER OF BUILDING.
