Jonathan Bray Home Inspections  
P.O.Box 3971  
Fresno, CA 93650  
jbrayinspections@yahoo.com

# PROPERTY INSPECTION REPORT

Prepared Especially for Jimmy Cannizzaro  
1262 N. Marks Ave., Fresno 93722  
June 23, 2026

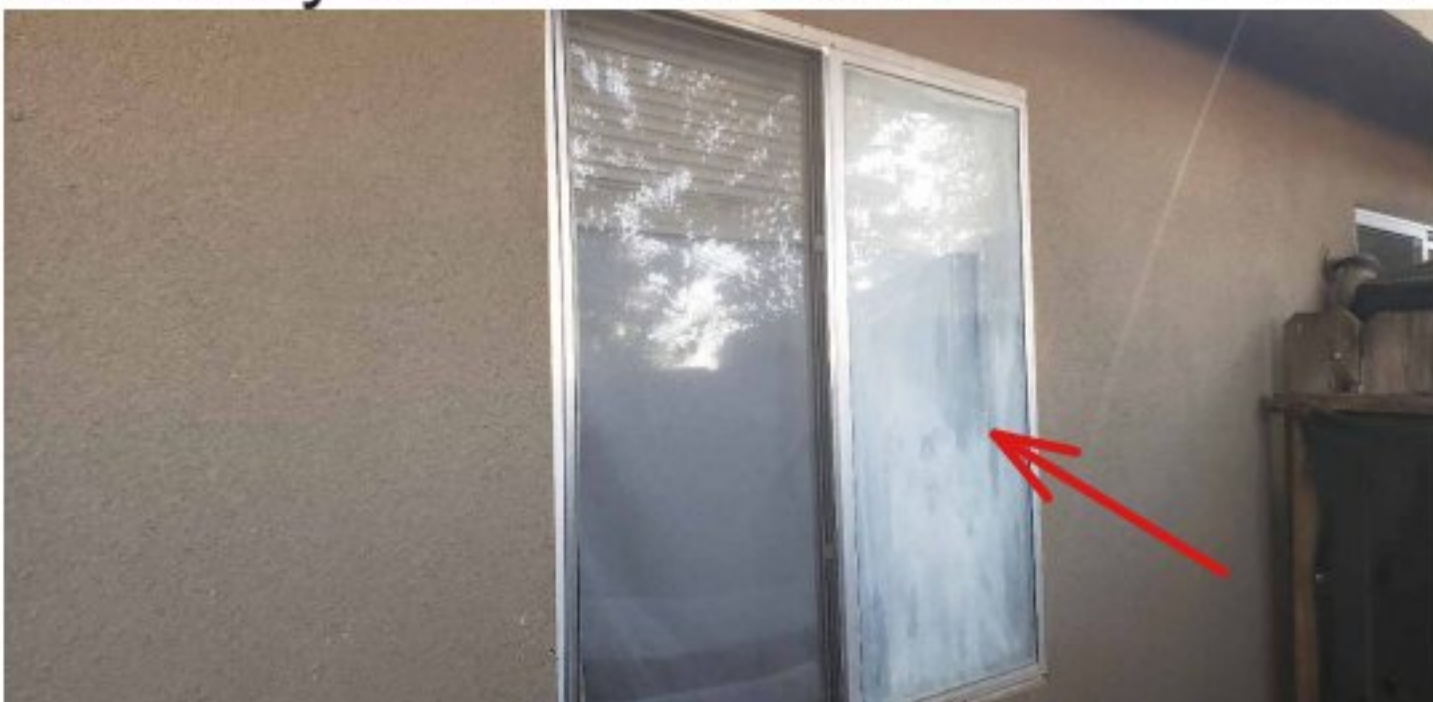
105, 120: Dual pane window noted to be fogged up indicating seal has failed. This not only allows condensation to build up between the panes, but also negates the energy efficiency of the window. Recommend evaluation and repair by qualified professional.

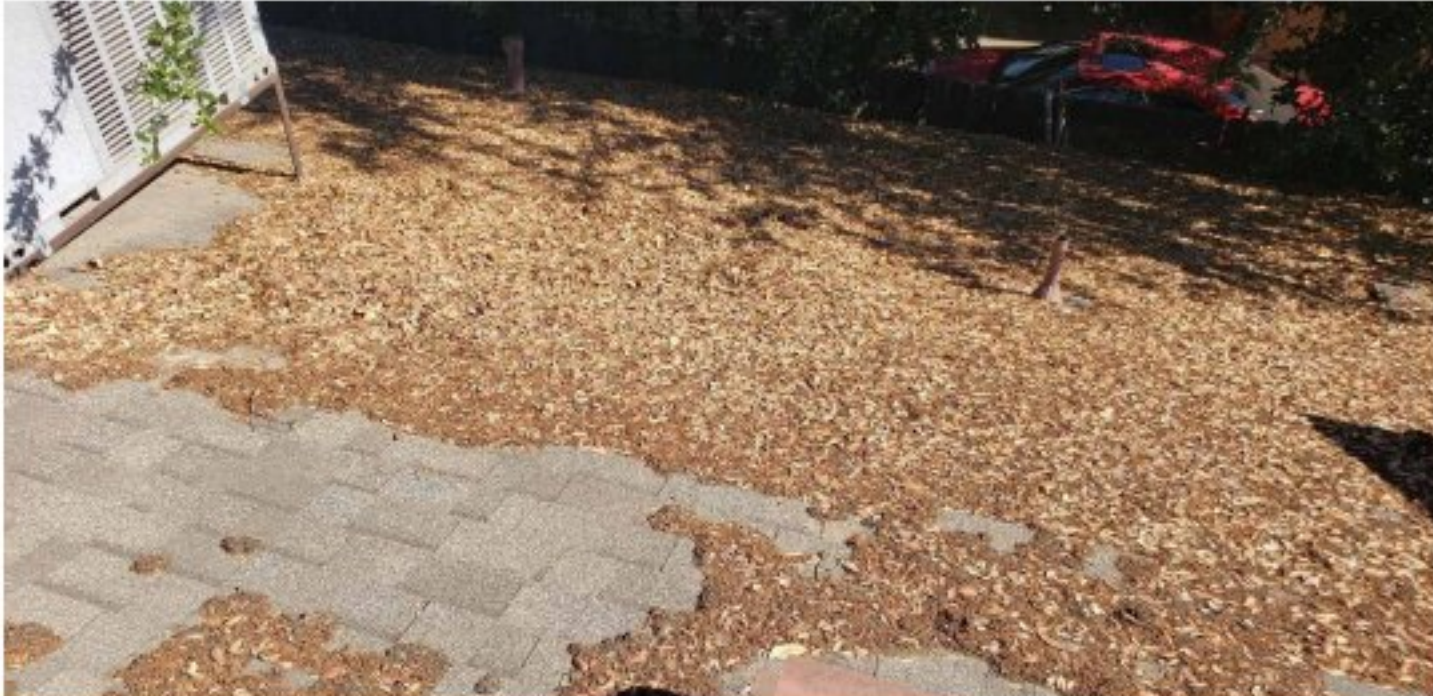
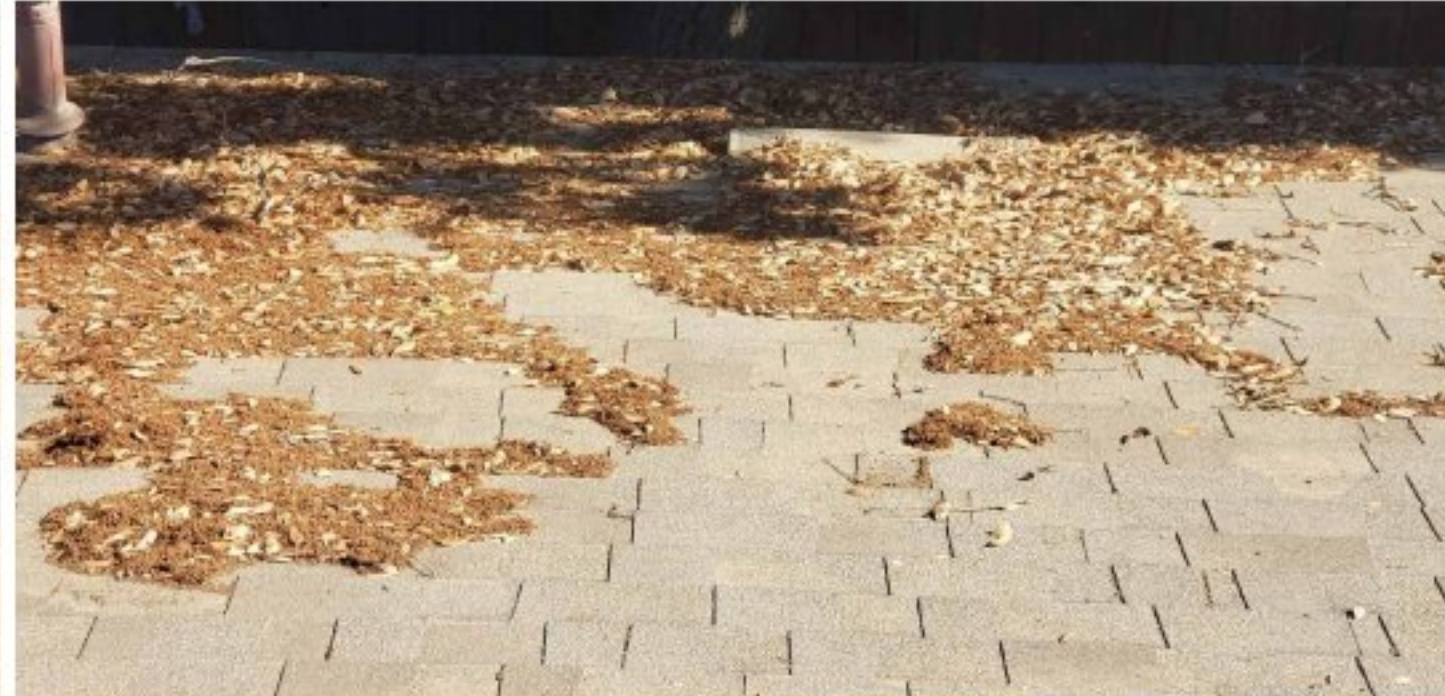
Recommend keeping leaves and debris off of roof materials to prevent premature damage.

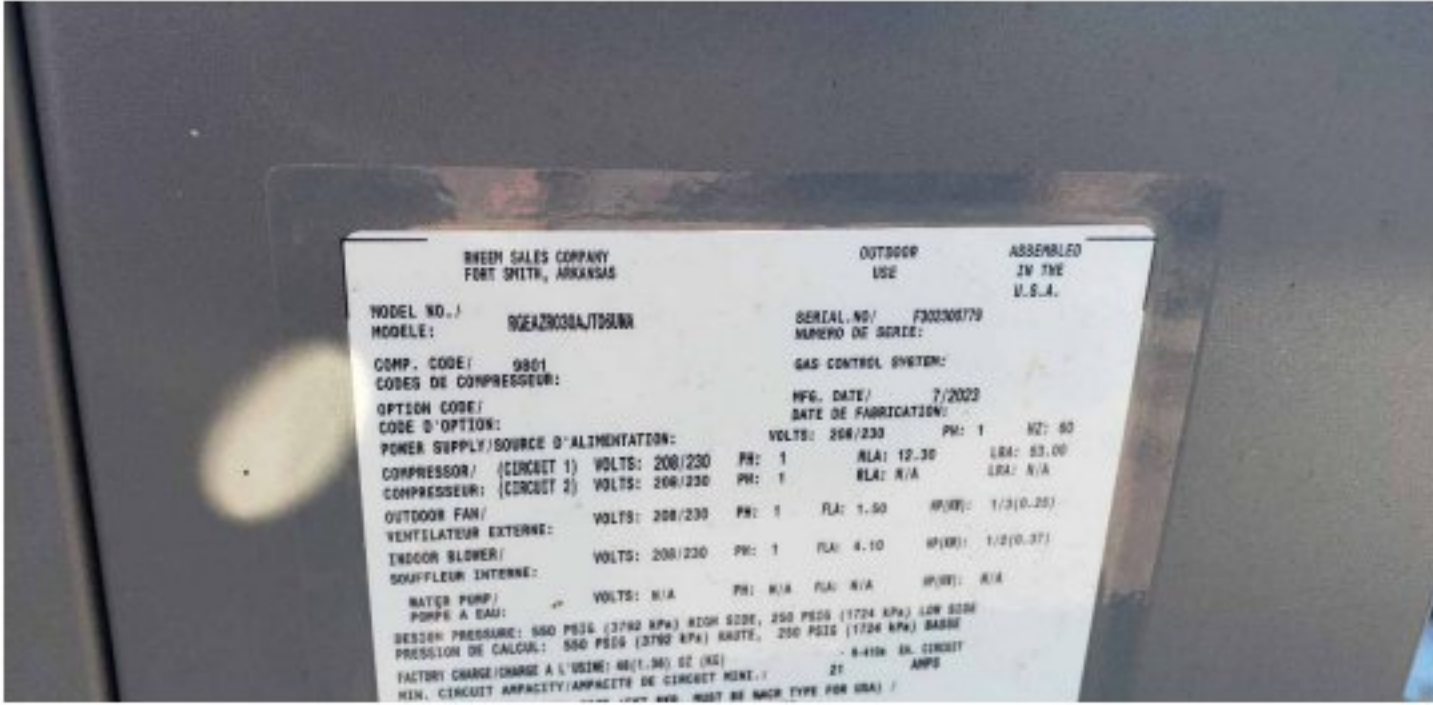
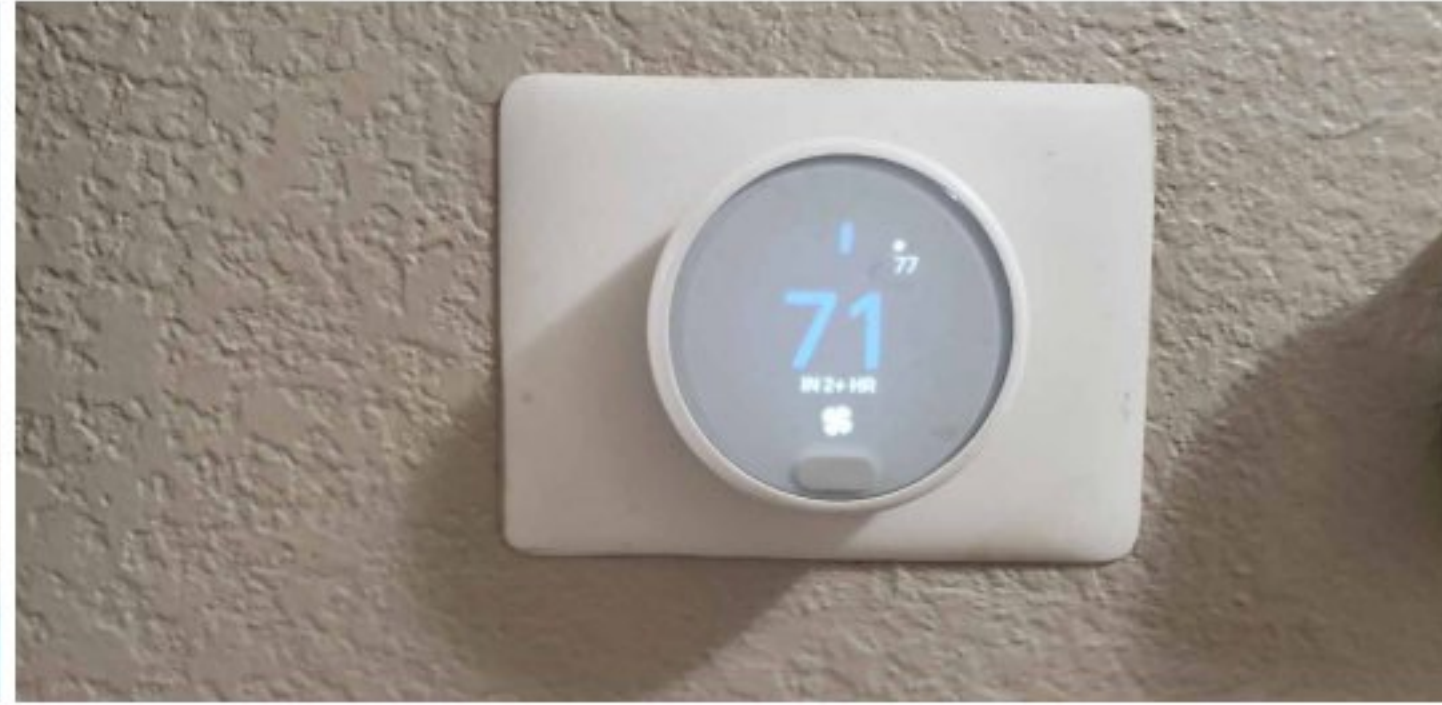
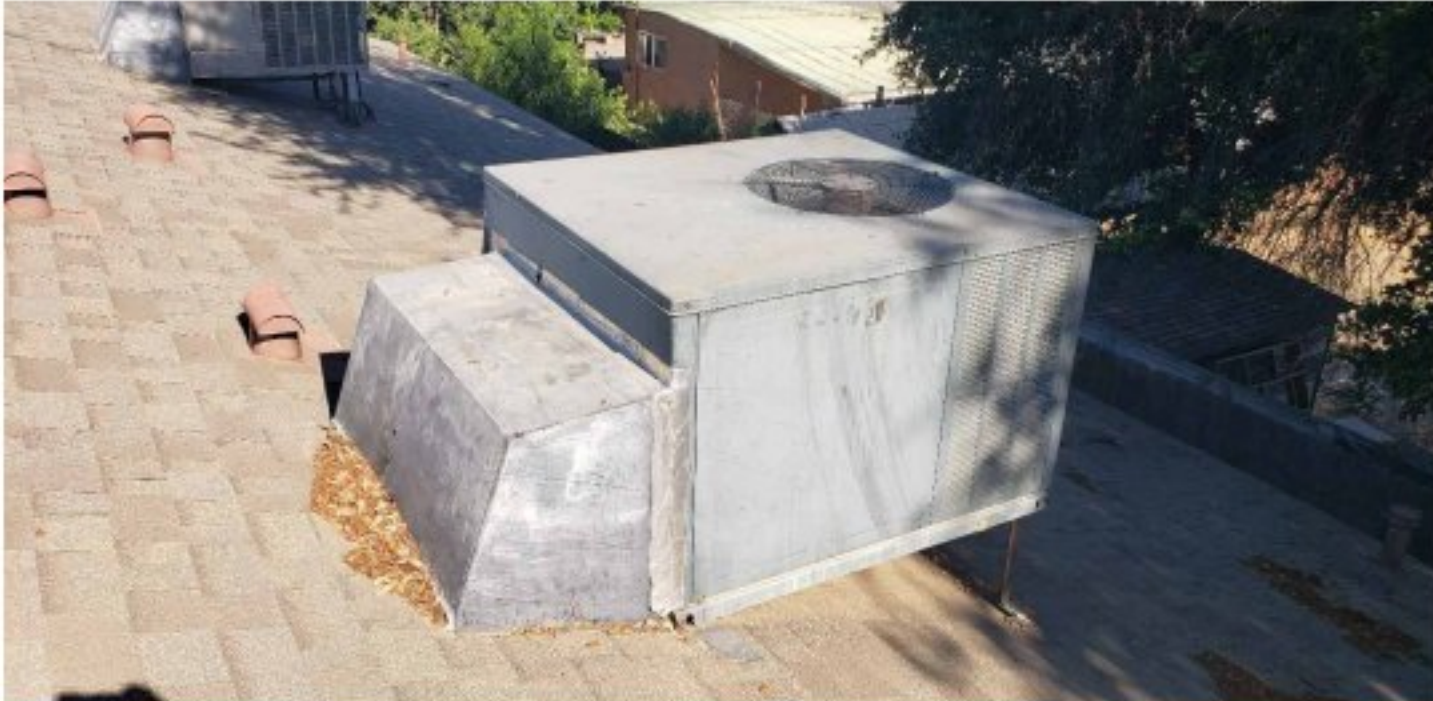
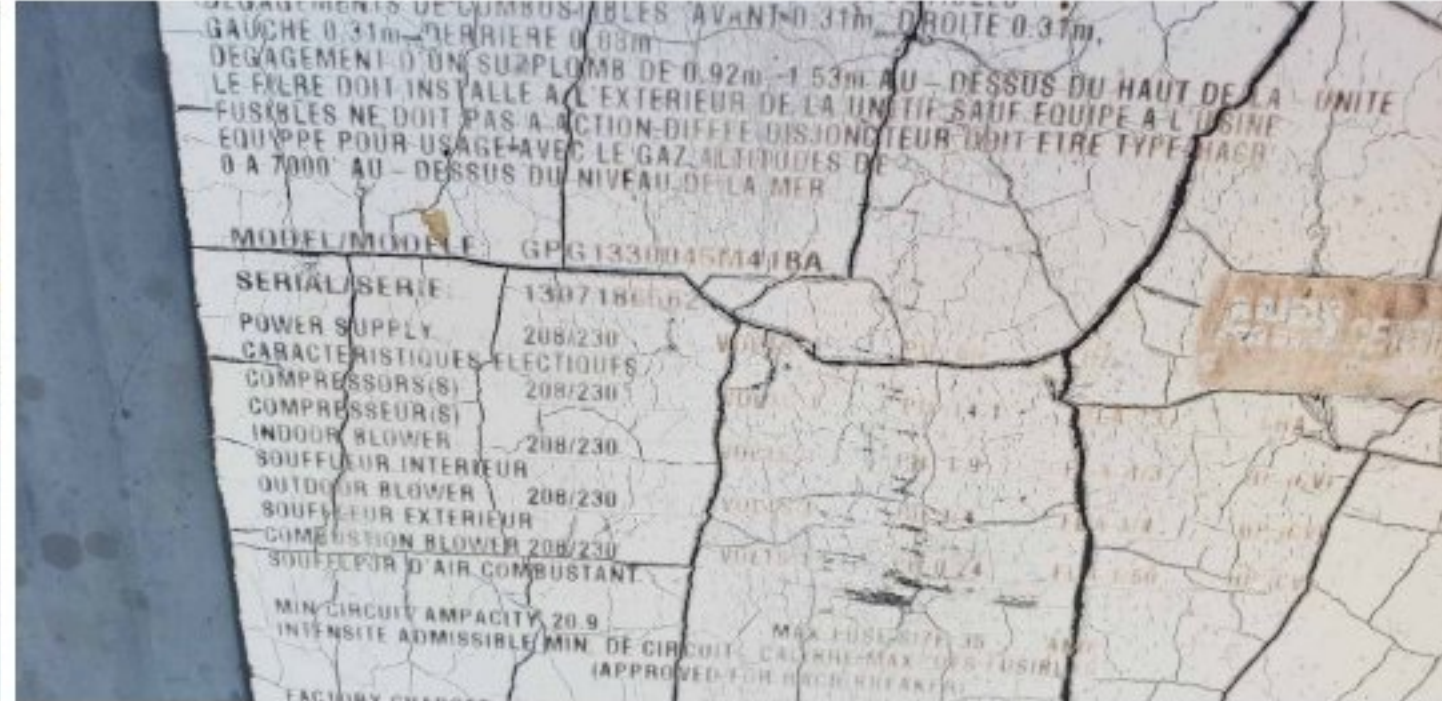
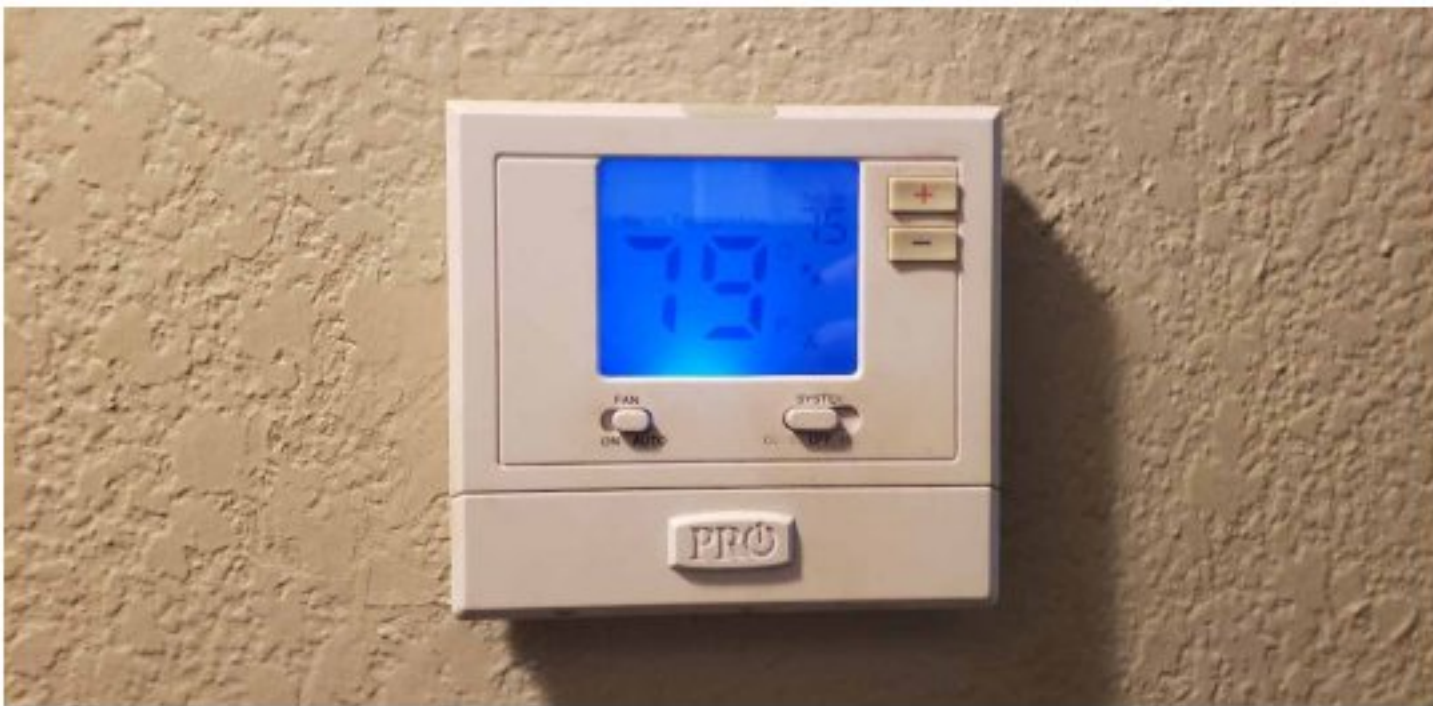
- 5. AC System A/C System Operation:** Appears serviceable -  
 104, 115, 117: Air coming out of vents was not cooled as expected. Temperature differential did not reach the desired -18 to -25 degree. Recommend evaluation and repair as needed by qualified HVAC professional.

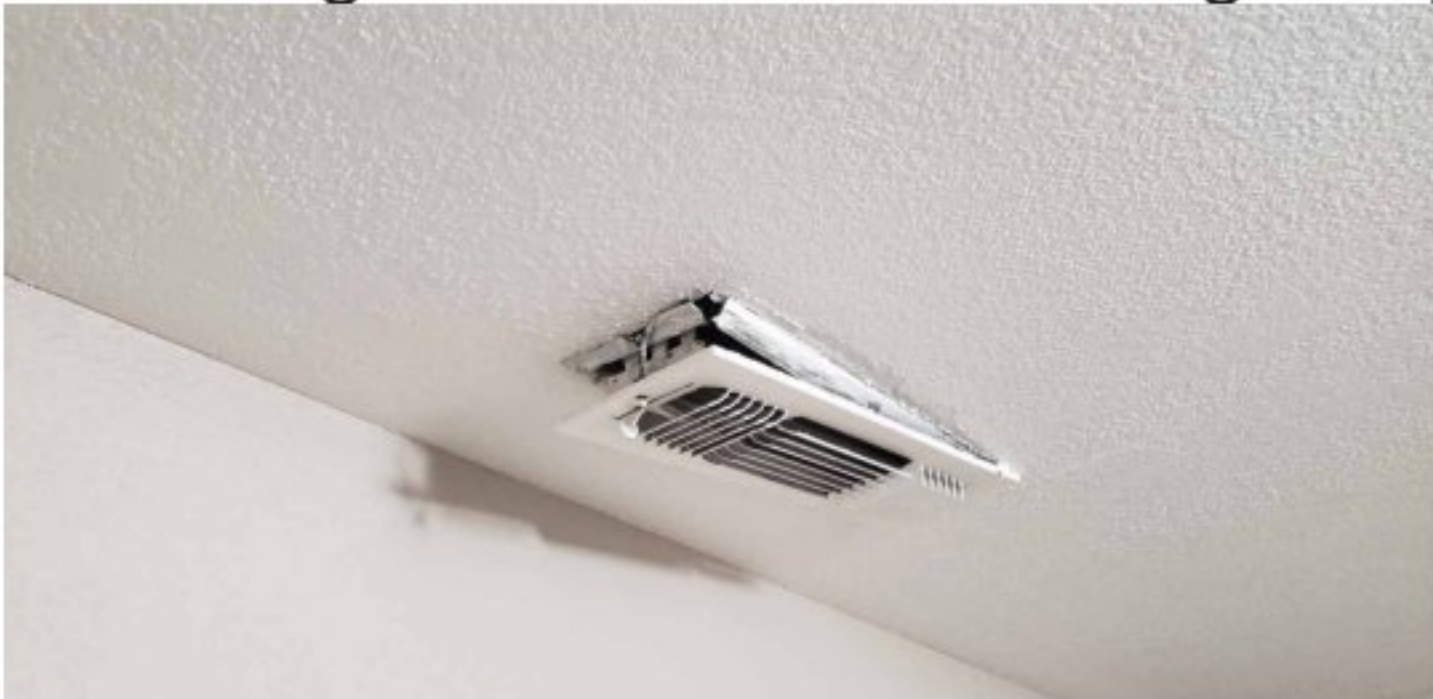
- 6. Distribution:** Insulated ductwork -  
111: AC grille noted to be coming away from the ceiling.

111: AC grille noted to be coming away from the ceiling.

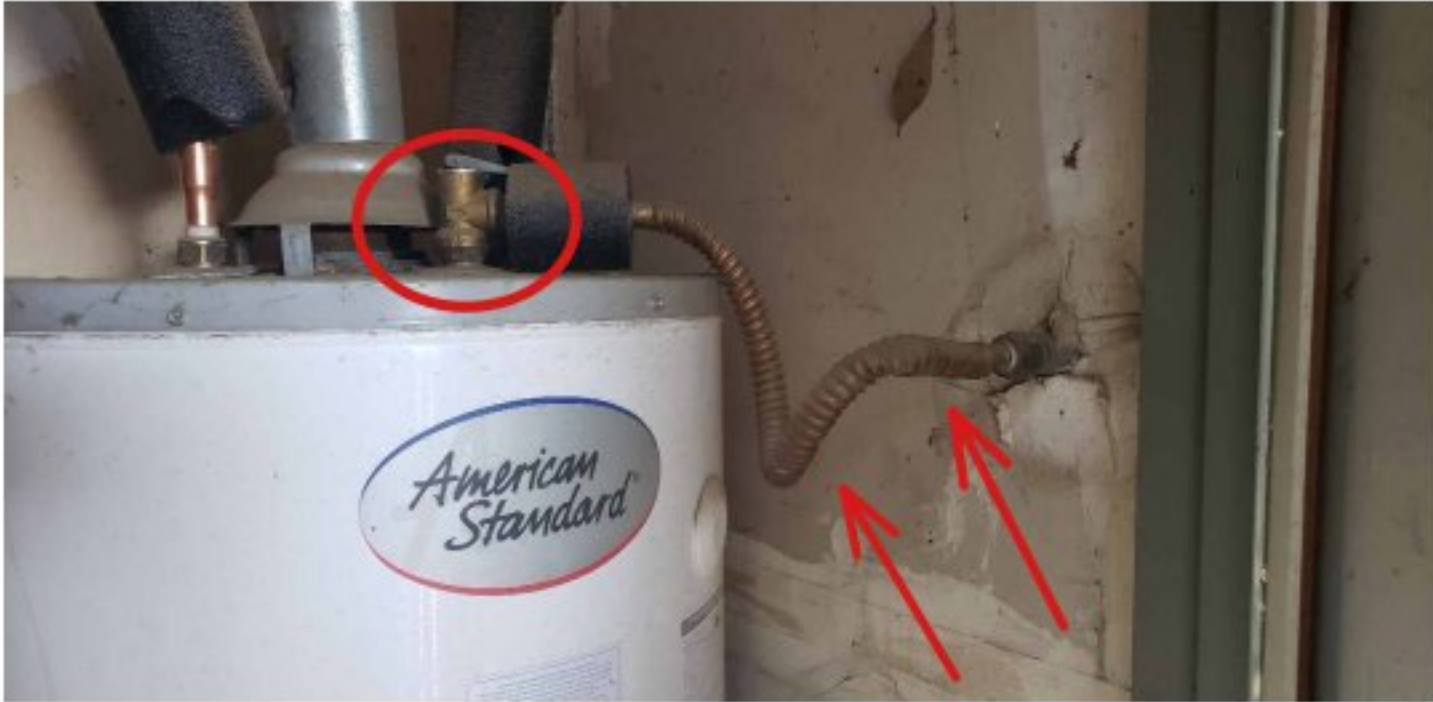
110: TPR (Temperature and Pressure Relief) valve drainage line runs uphill and is intended to run downhill and terminate within 6" of finished floor or ground. Recommend evaluation and repair by qualified professional.

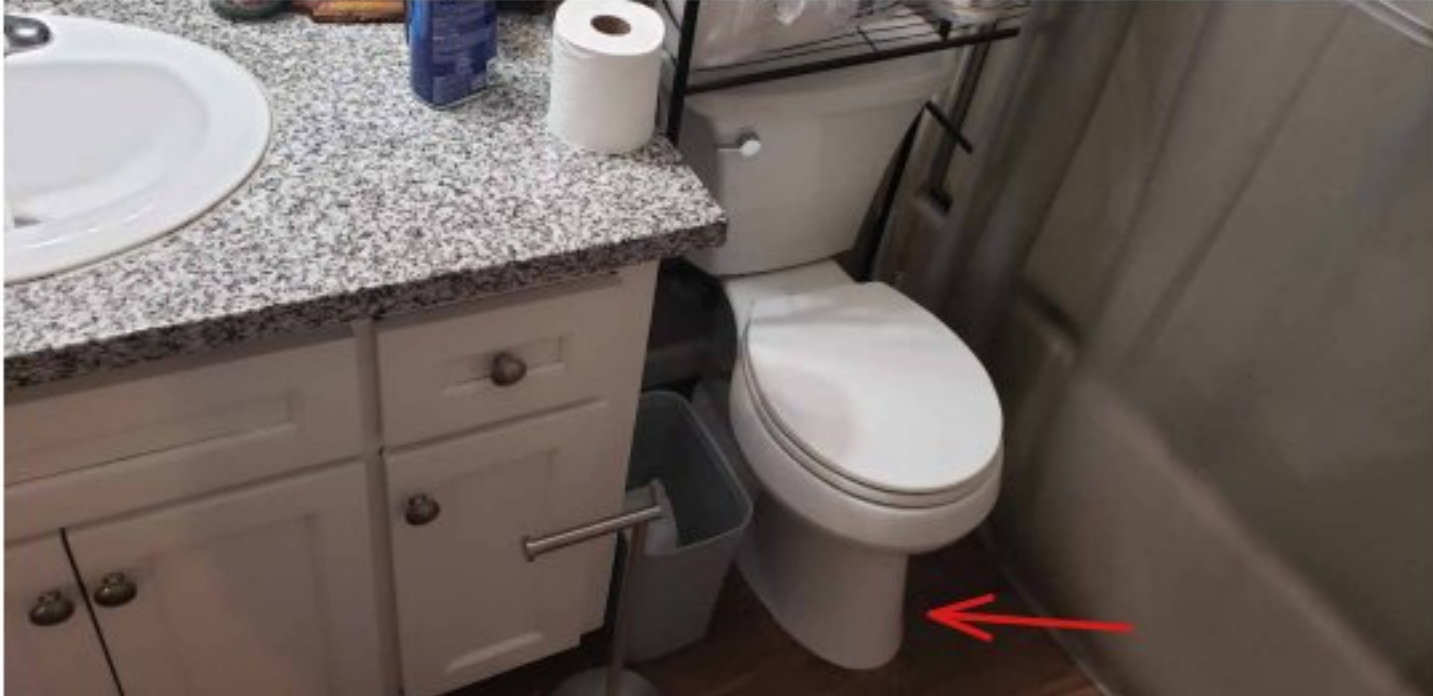
103: Toilet bowl noted to be loose to the floor. Recommend evaluation and repair as needed by qualified professional.

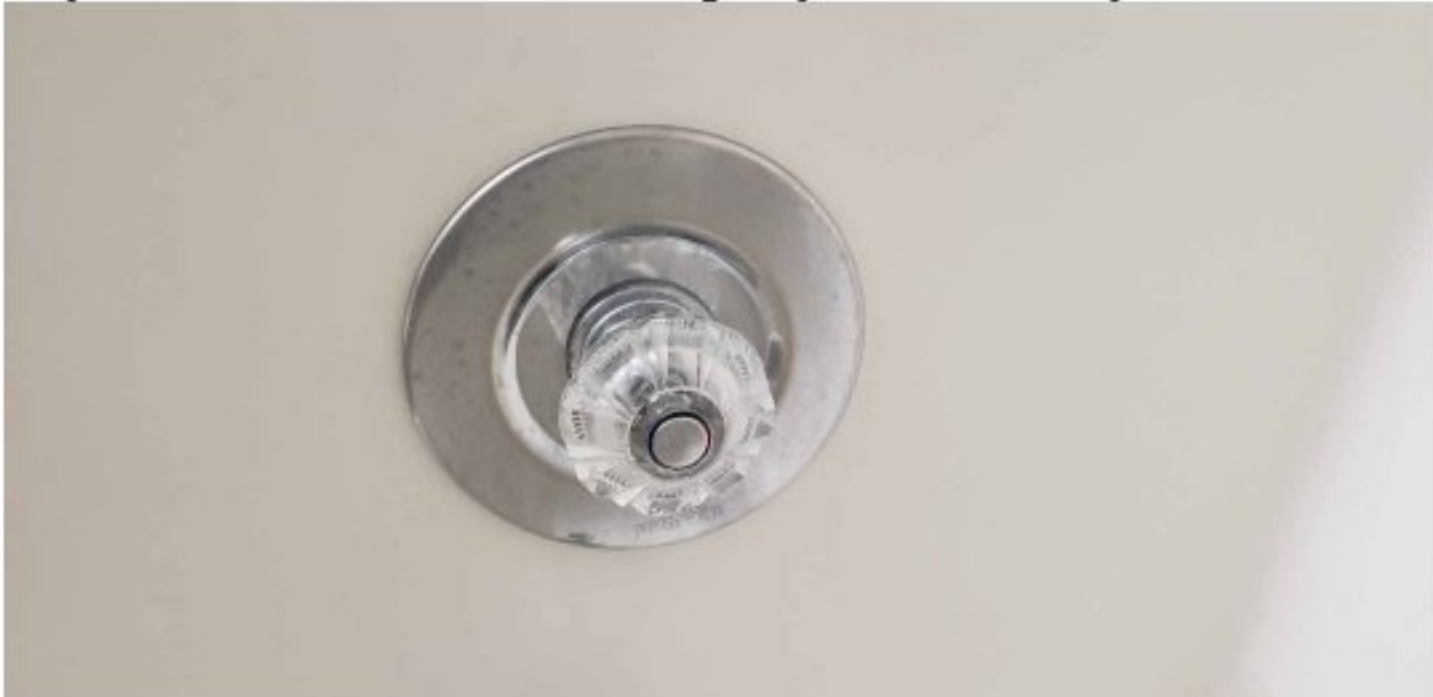
106: Hot/cold water noted to be reversed at tub valve. Recommend evaluation and repair as needed by qualified professional to prevent potential scalding.

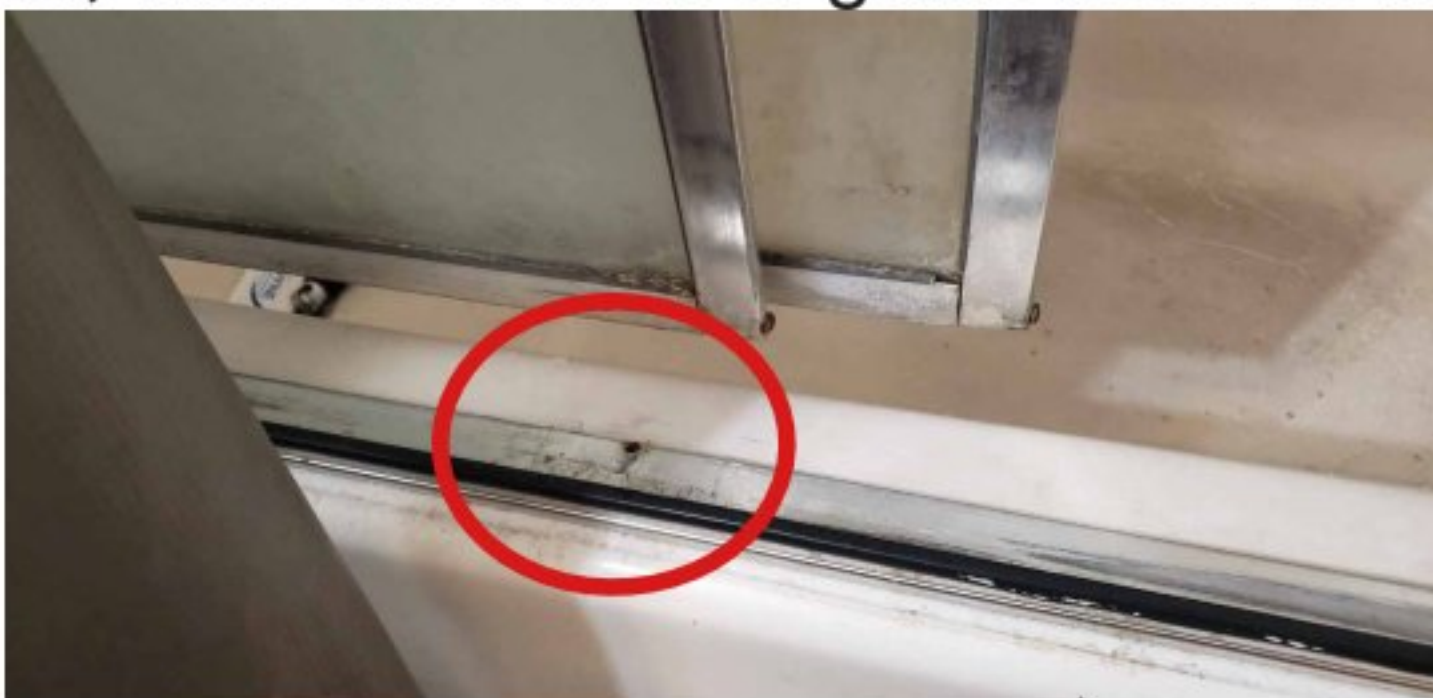
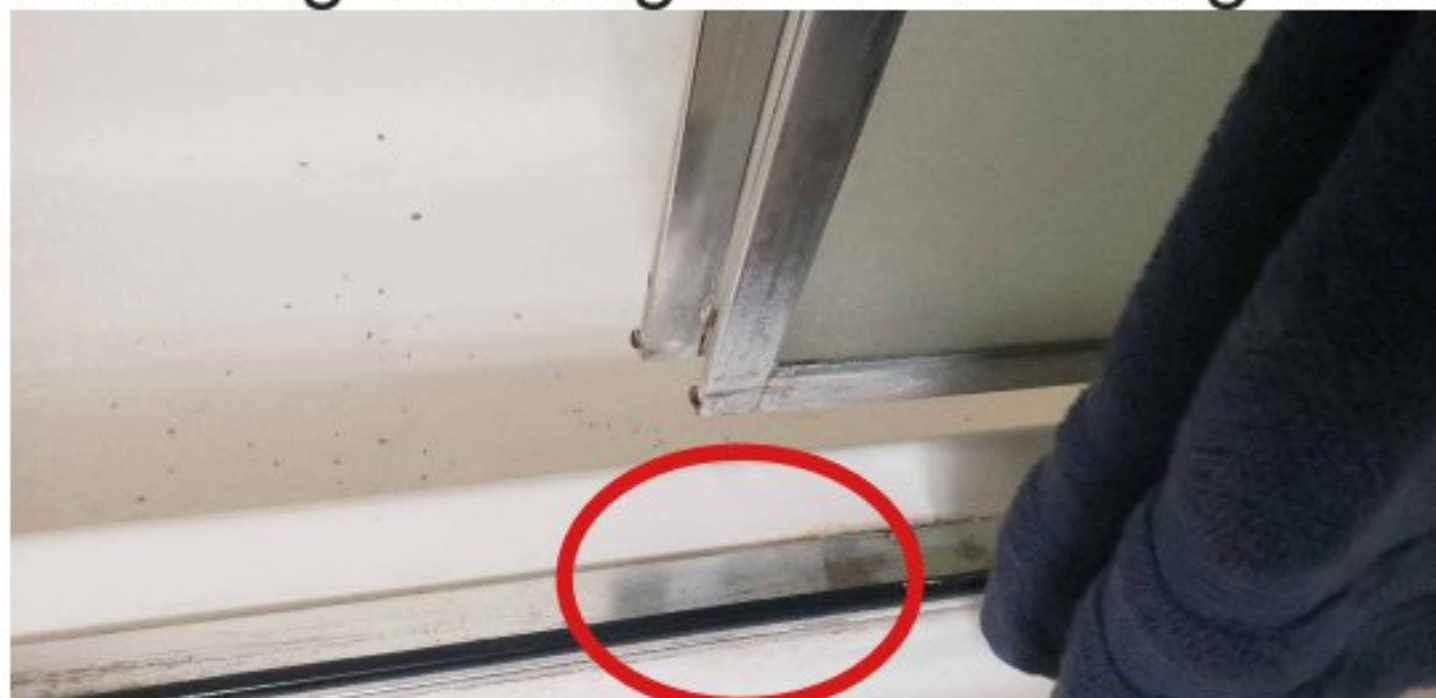
103, 106: Shower door guide noted to be missing allowing doors to swing inward.

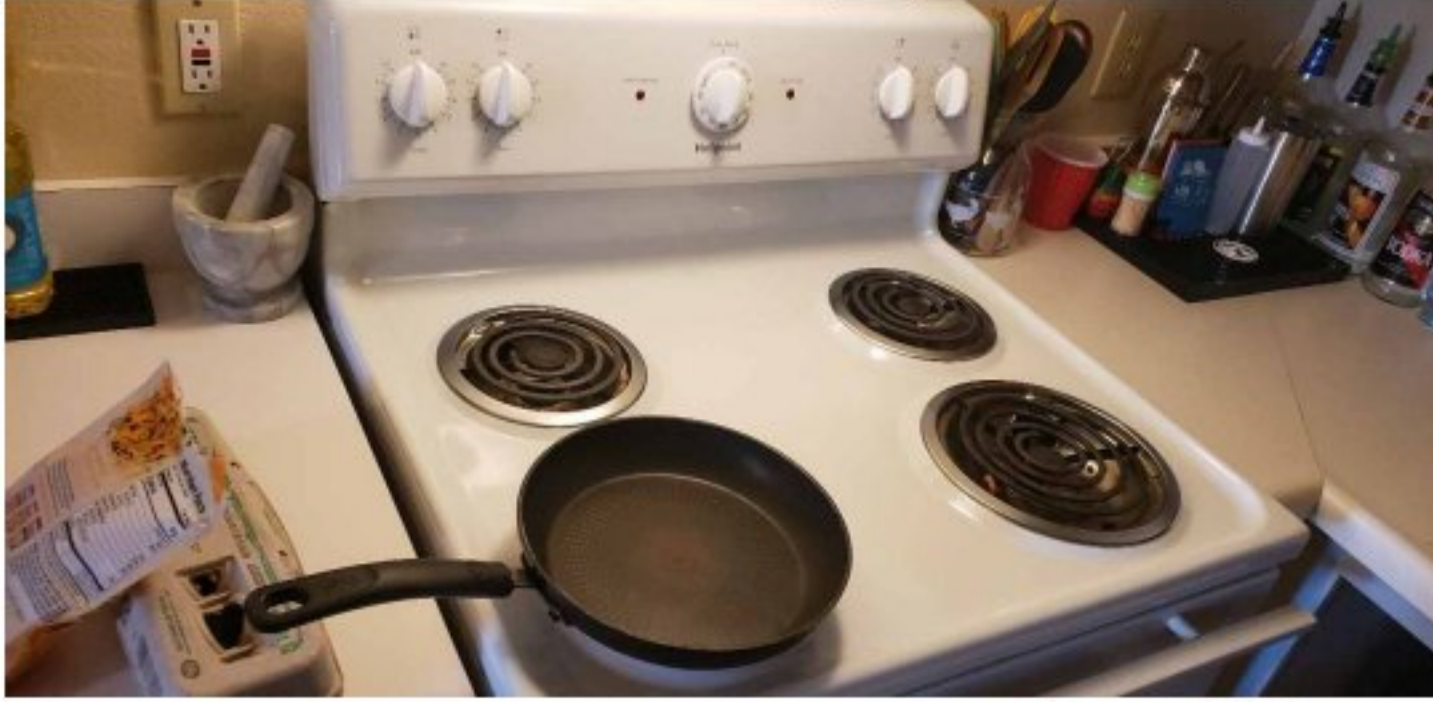
110, 117, 120: Front right burner did not turn on when tested. Recommend evaluation and repair as needed by qualified professional.

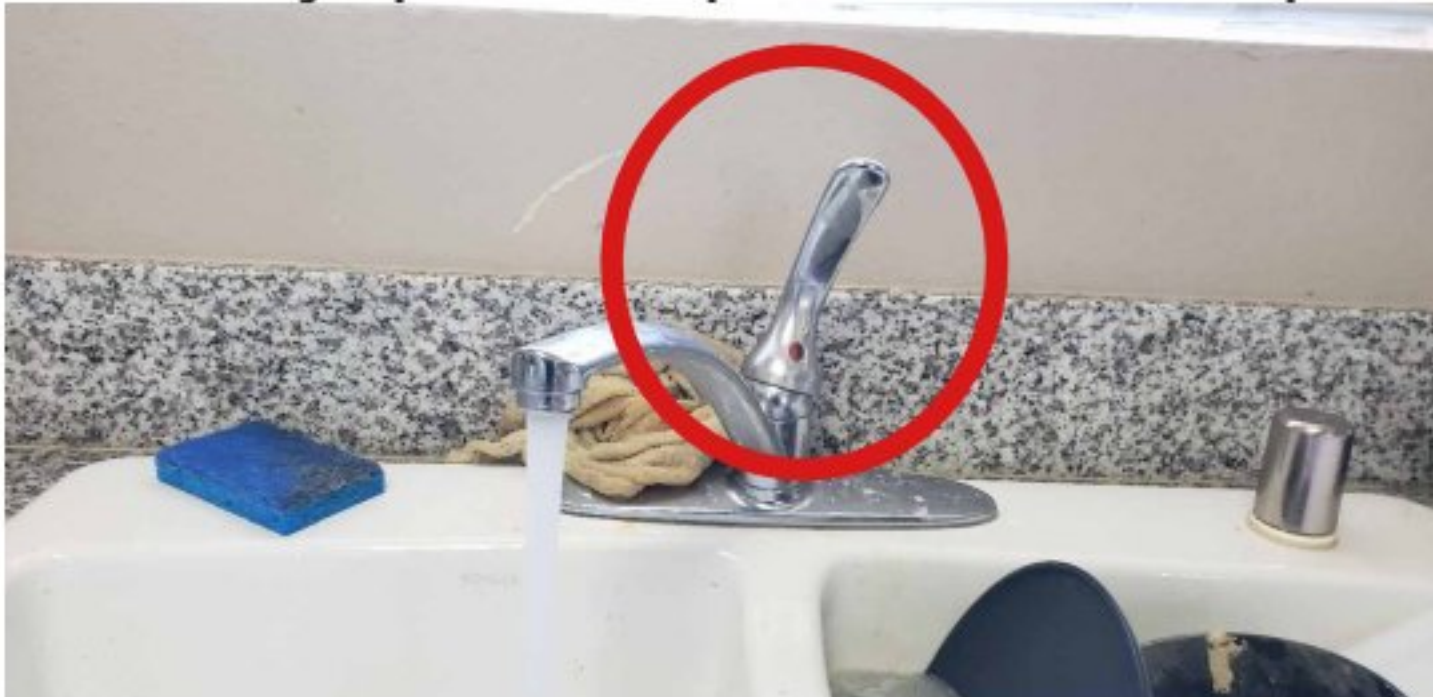
Unit 101: Hot/cold water noted to be reversed. Recommend evaluation and repair as needed by qualified professional to prevent potential scalding.

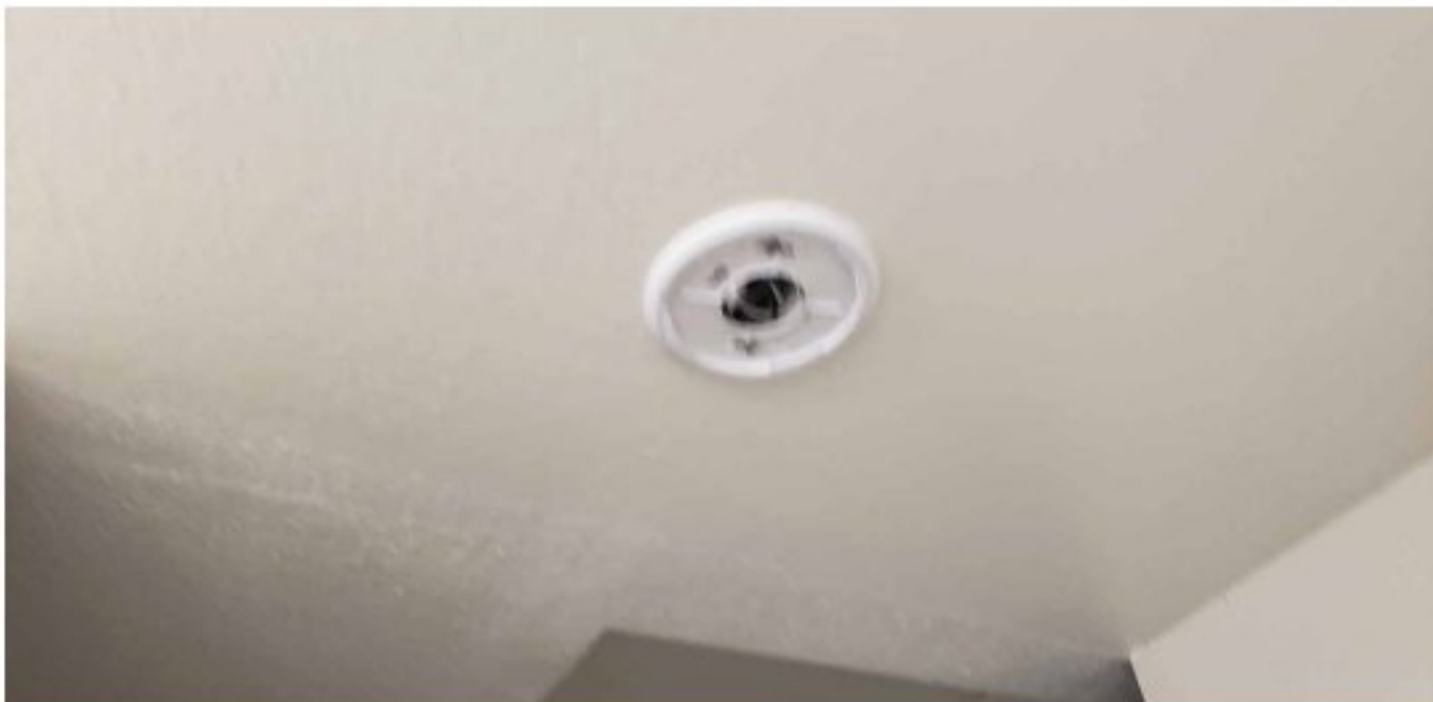
104, 115, 119, 121, 122: Recommend installing and maintaining functional smoke detectors in hallway and each bedroom for safety.

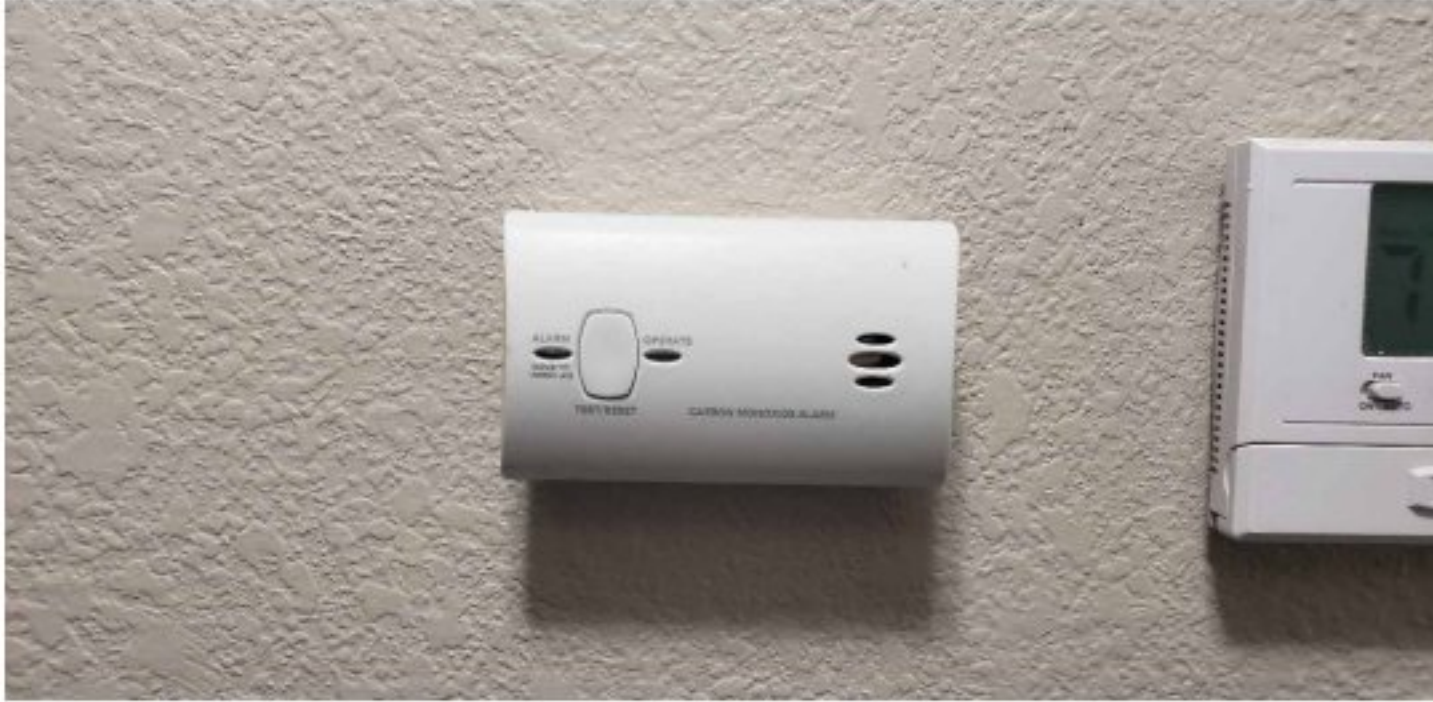
106, 115, 119: CO detector did not work when tested. Recommend evaluation and repair as needed.

107: CO detector noted to be missing.

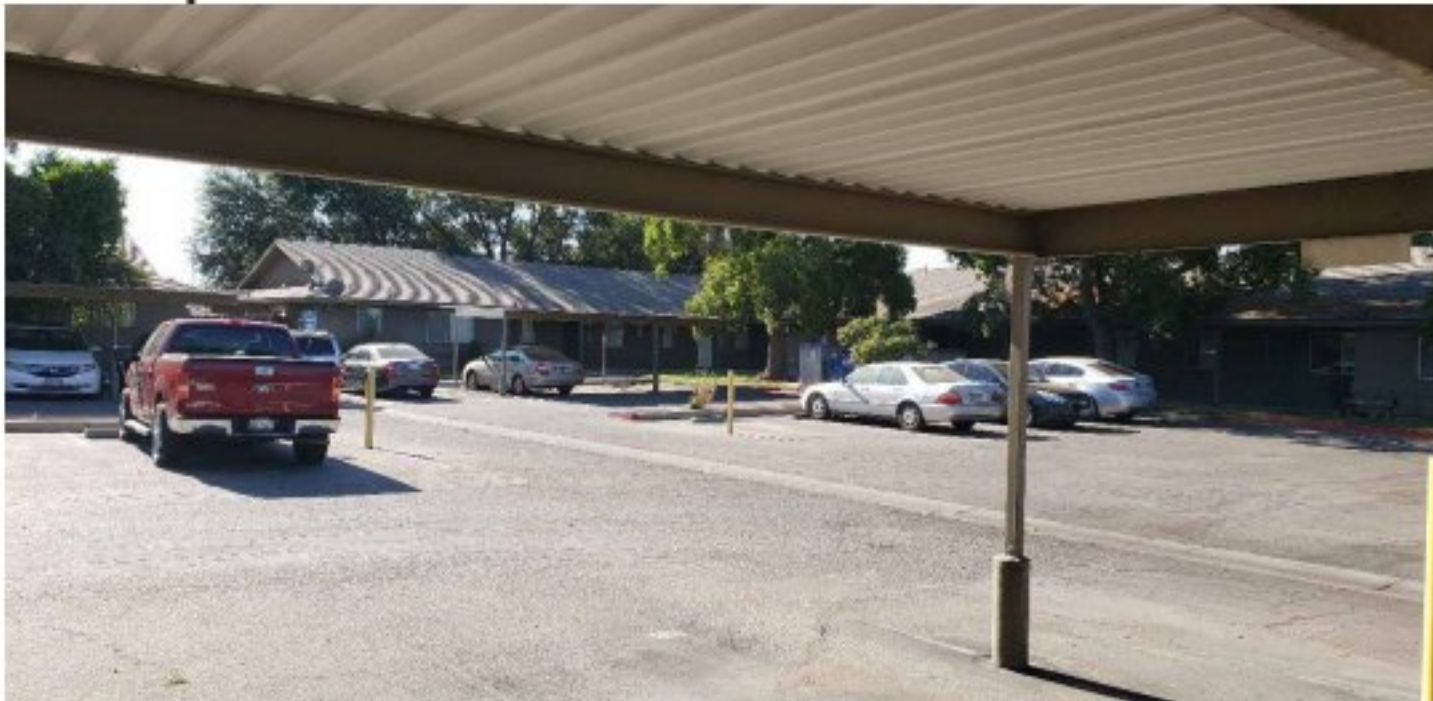
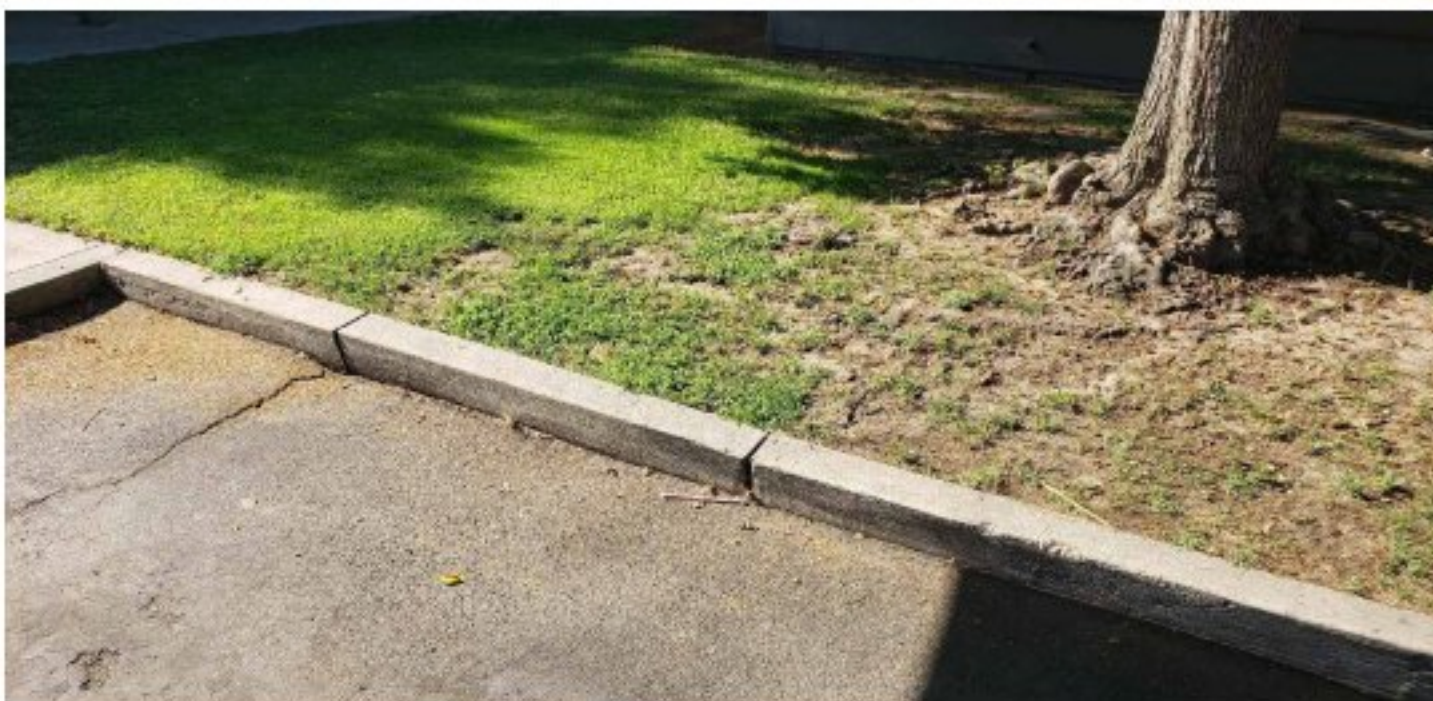
Tree roots noted to be affecting asphalt in a couple locations. Recommend evaluation and repair as needed.

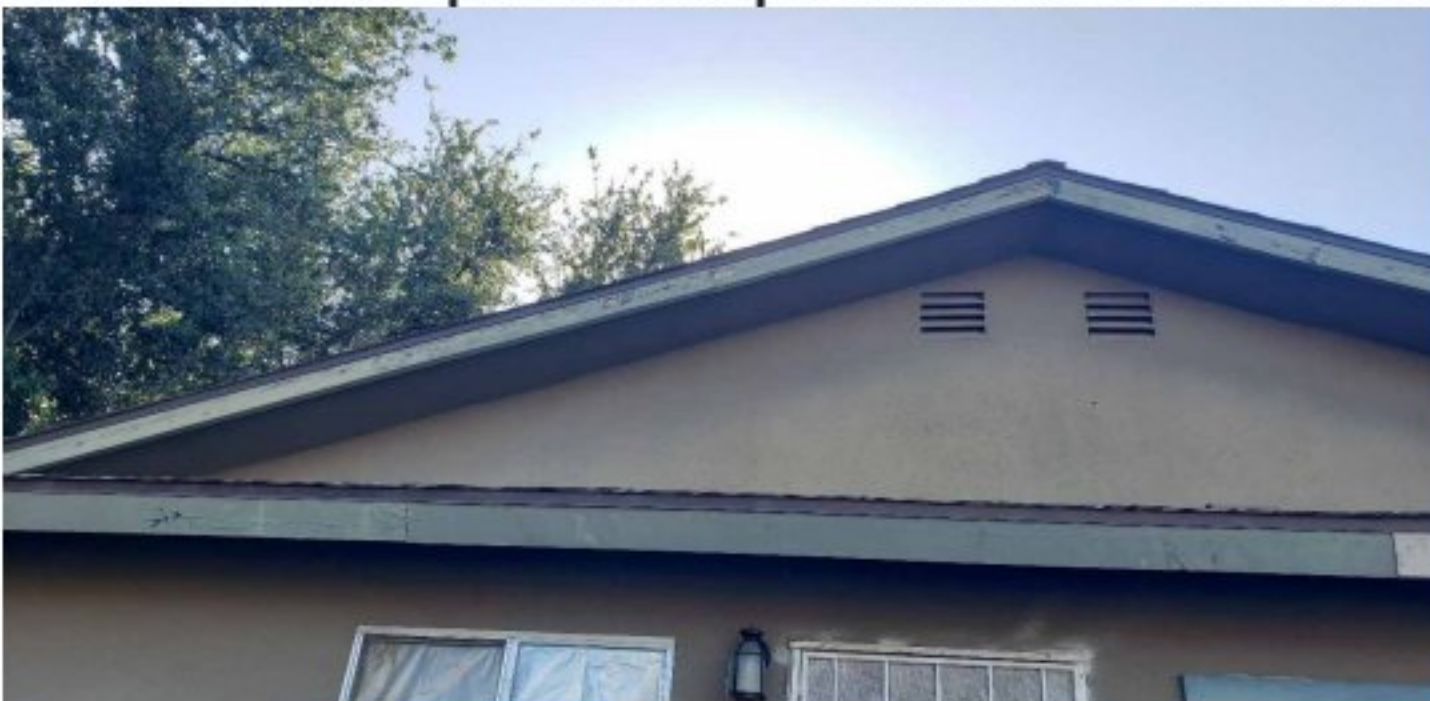
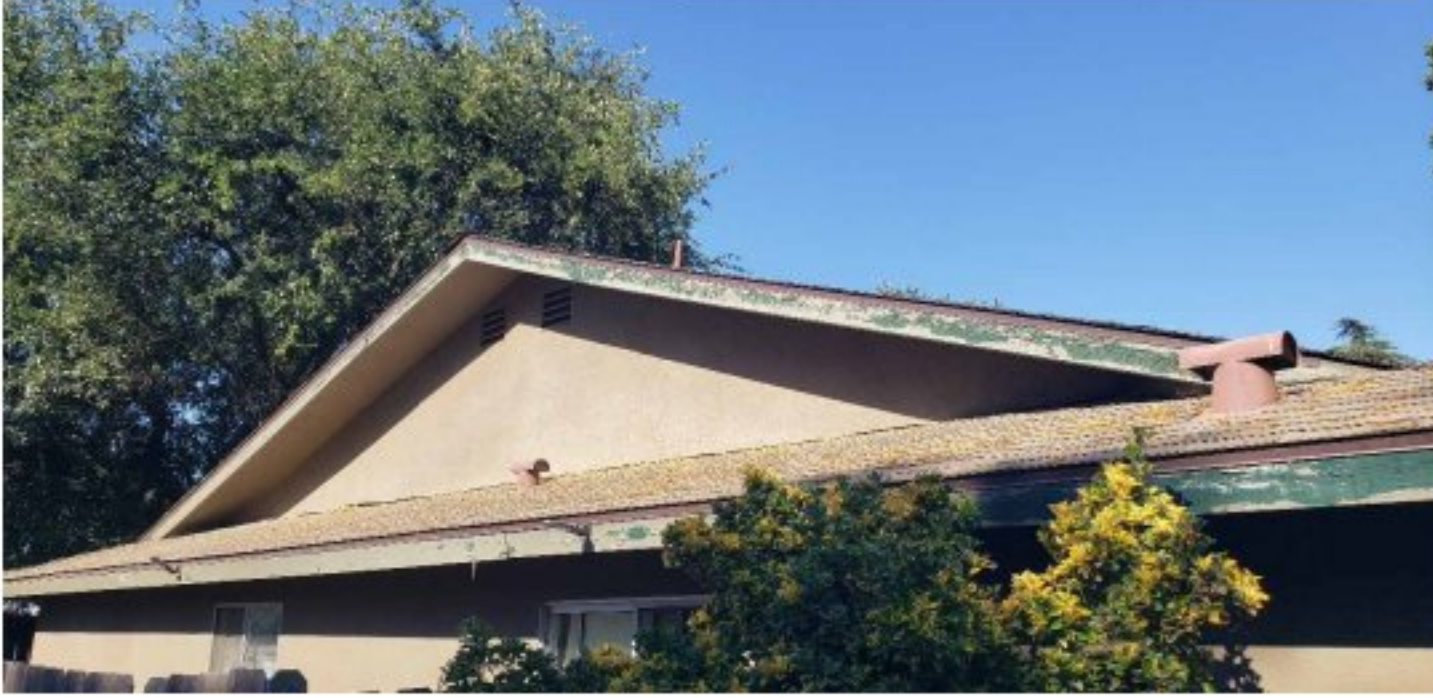
Chipping/peeling paint noted. Recommend keeping a good coat of paint on all exterior surfaces to prevent premature deterioration.
