Jonathan Bray Home Inspections  
P.O.Box 3971  
Fresno, CA 93650  
jbrayinspections@yahoo.com

# PROPERTY INSPECTION REPORT

Prepared Especially for Jimmy Cannizzaro  
1262 N. Marks Ave., Fresno 93722  
June 23, 2026

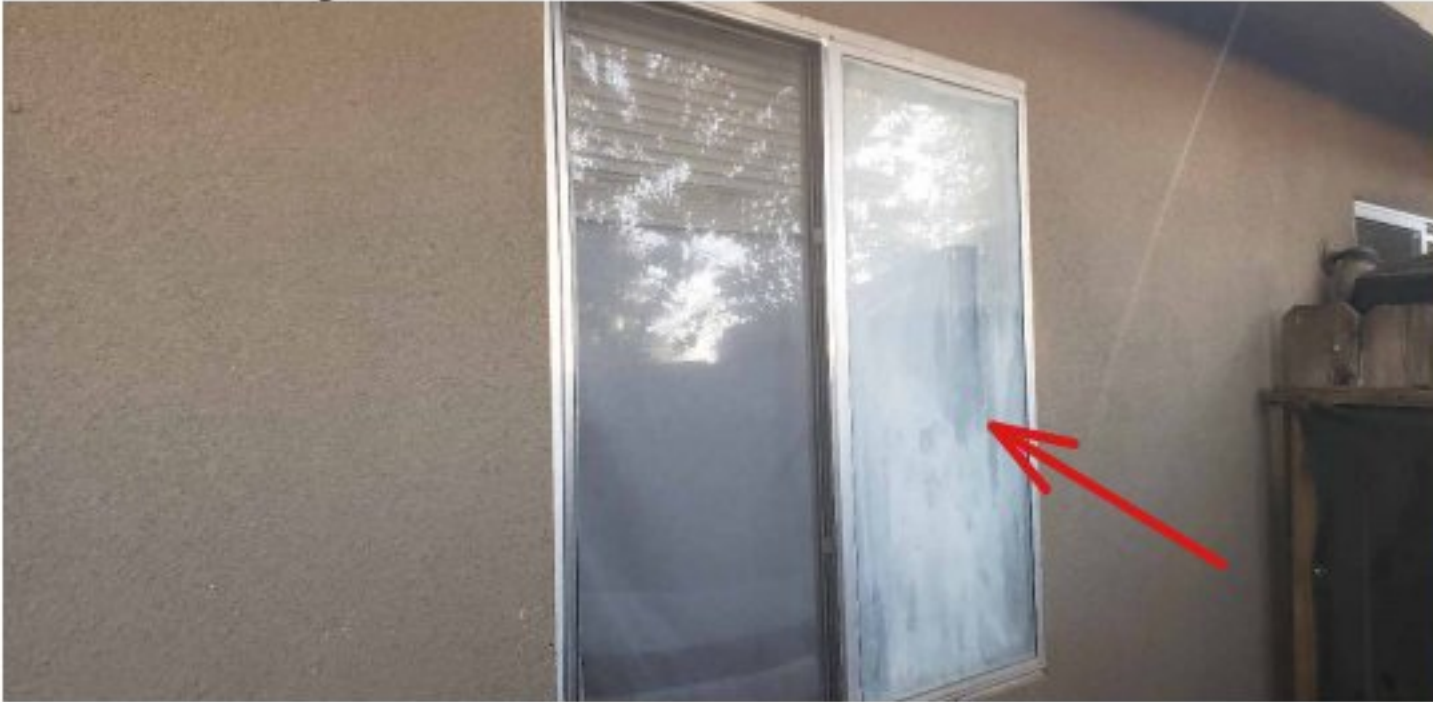
105, 120: Dual pane window noted to be fogged up indicating seal has failed. This not only allows condensation to build up between the panes, but also negates the energy efficiency of the window. Recommend evaluation and repair by qualified professional.

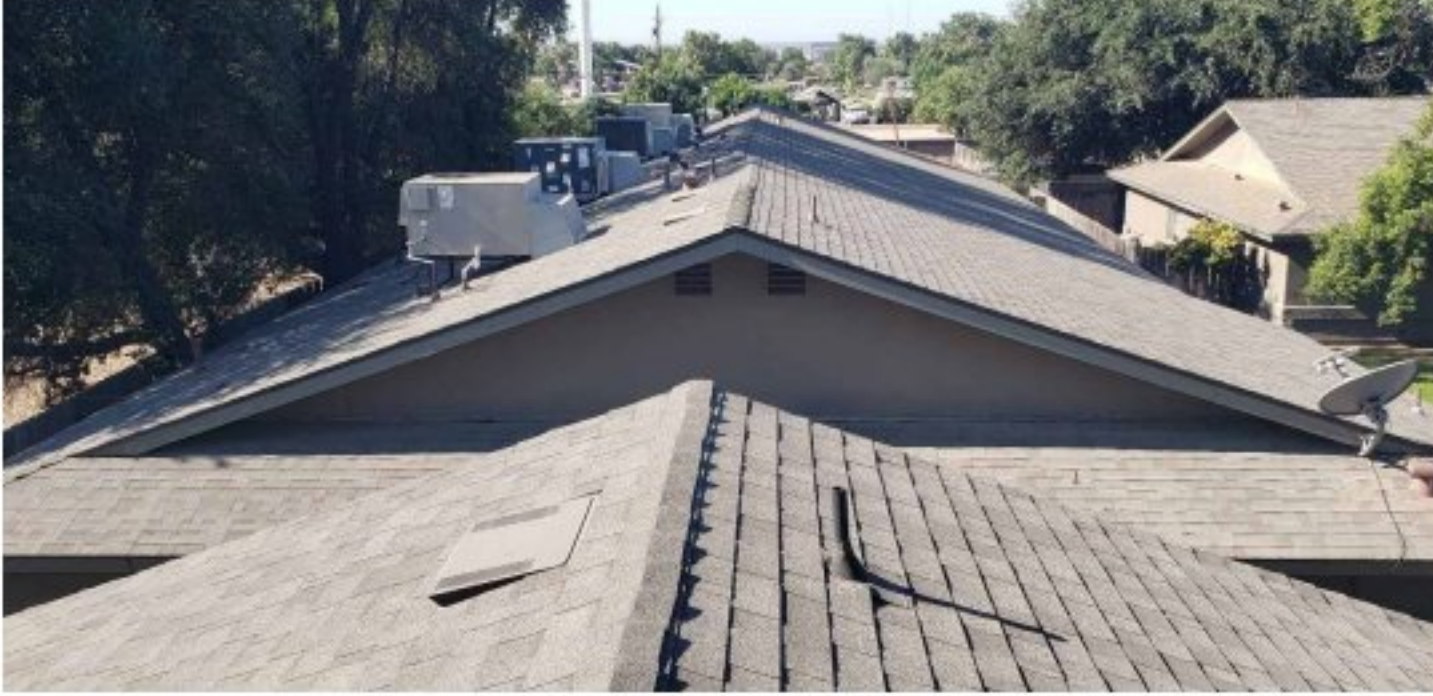
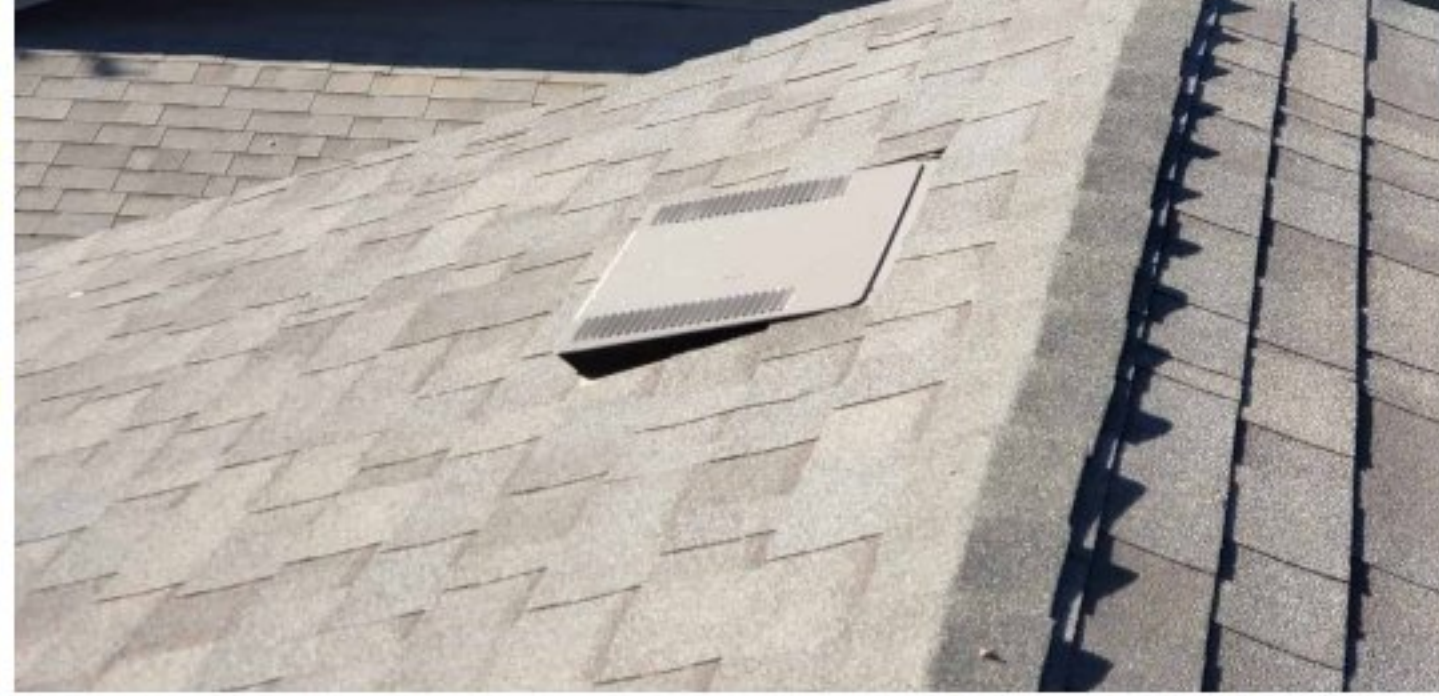
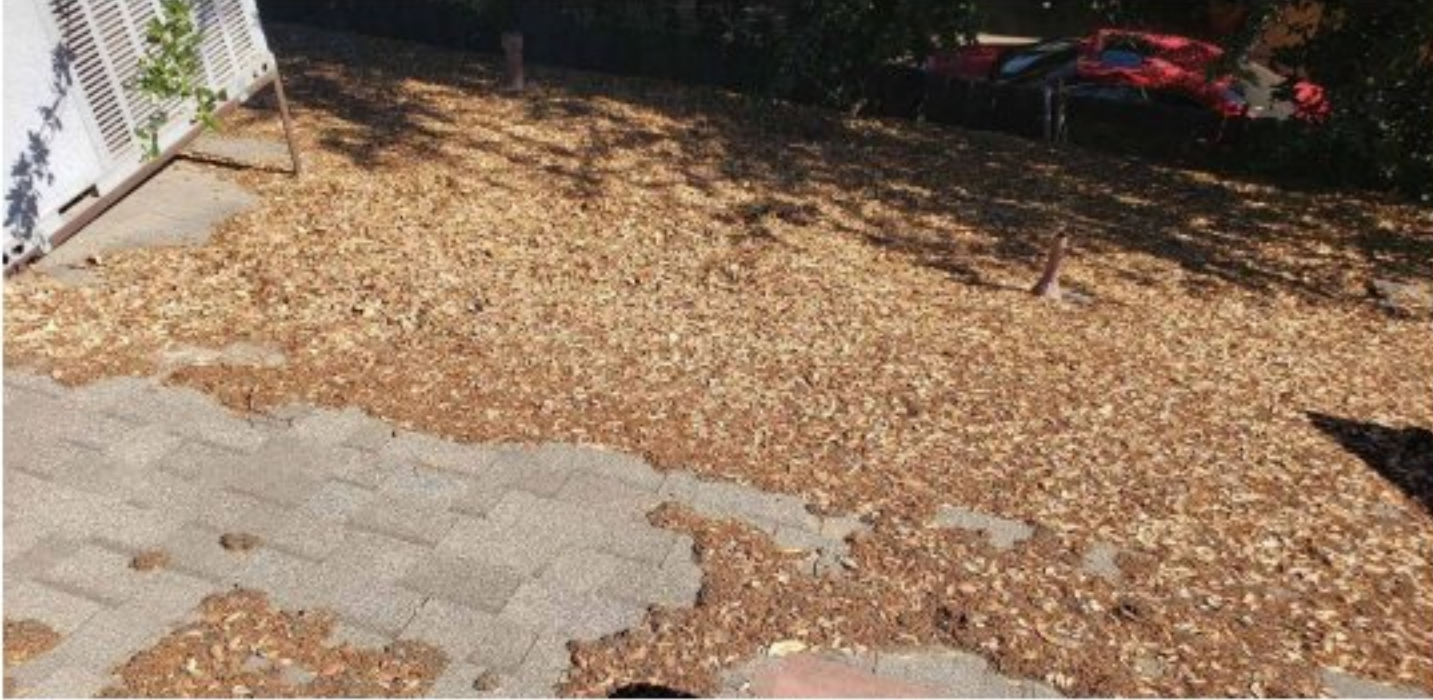
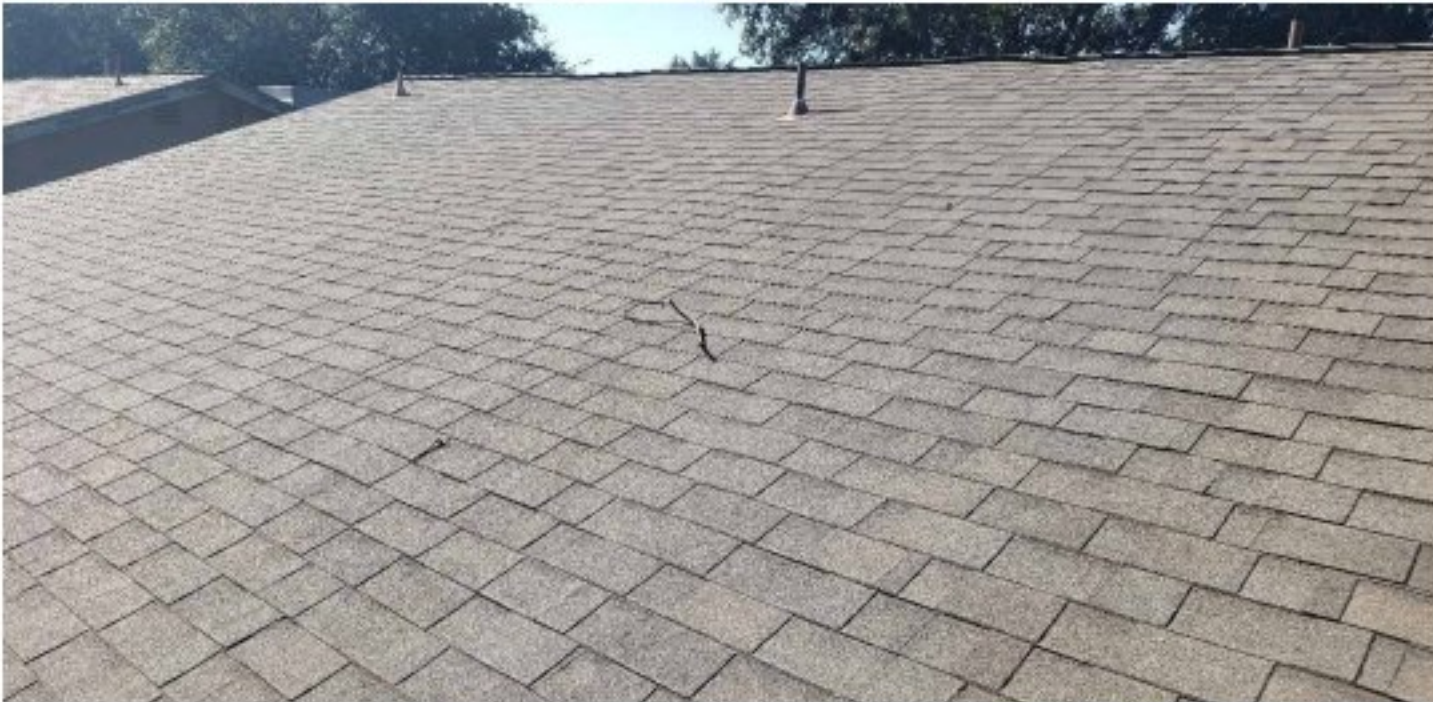
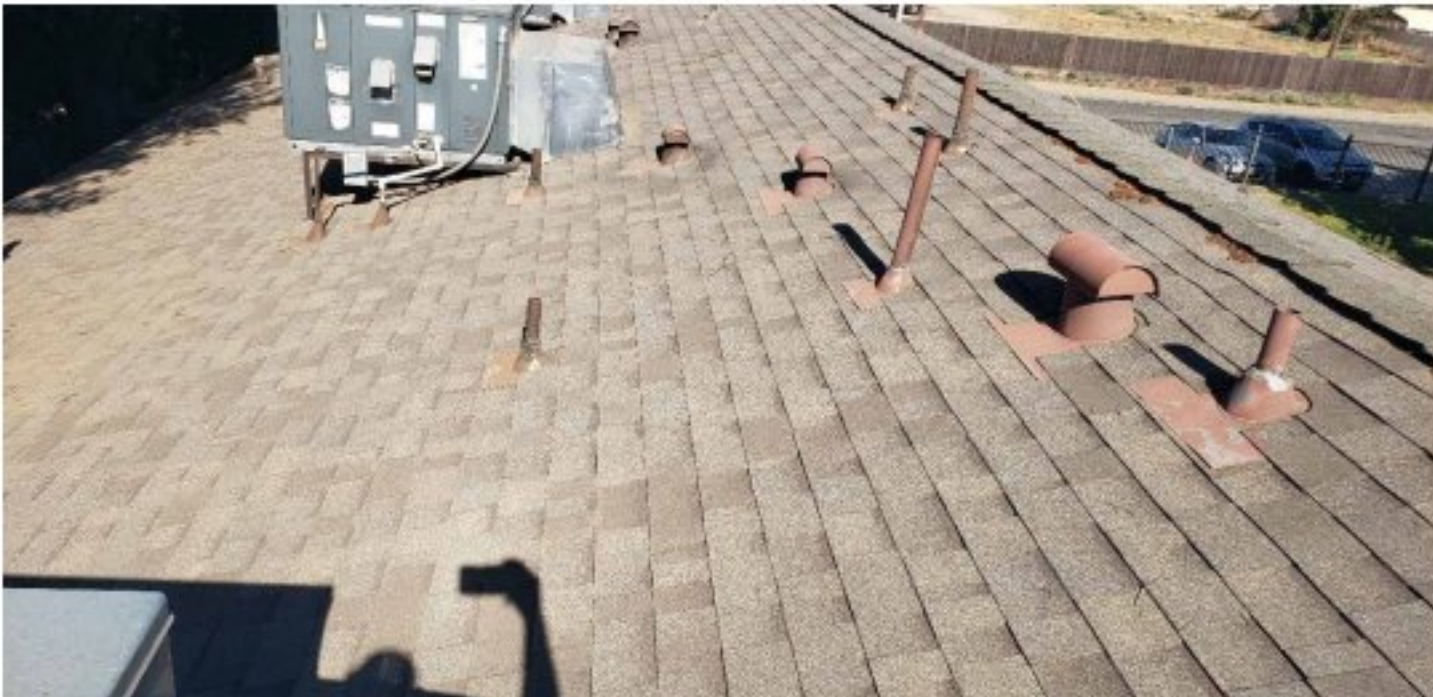
- 1. Material:** Asphalt shingle (Approx. 10-12 yrs. Old) -  
Recommend keeping leaves and debris off of roof materials to prevent premature damage.

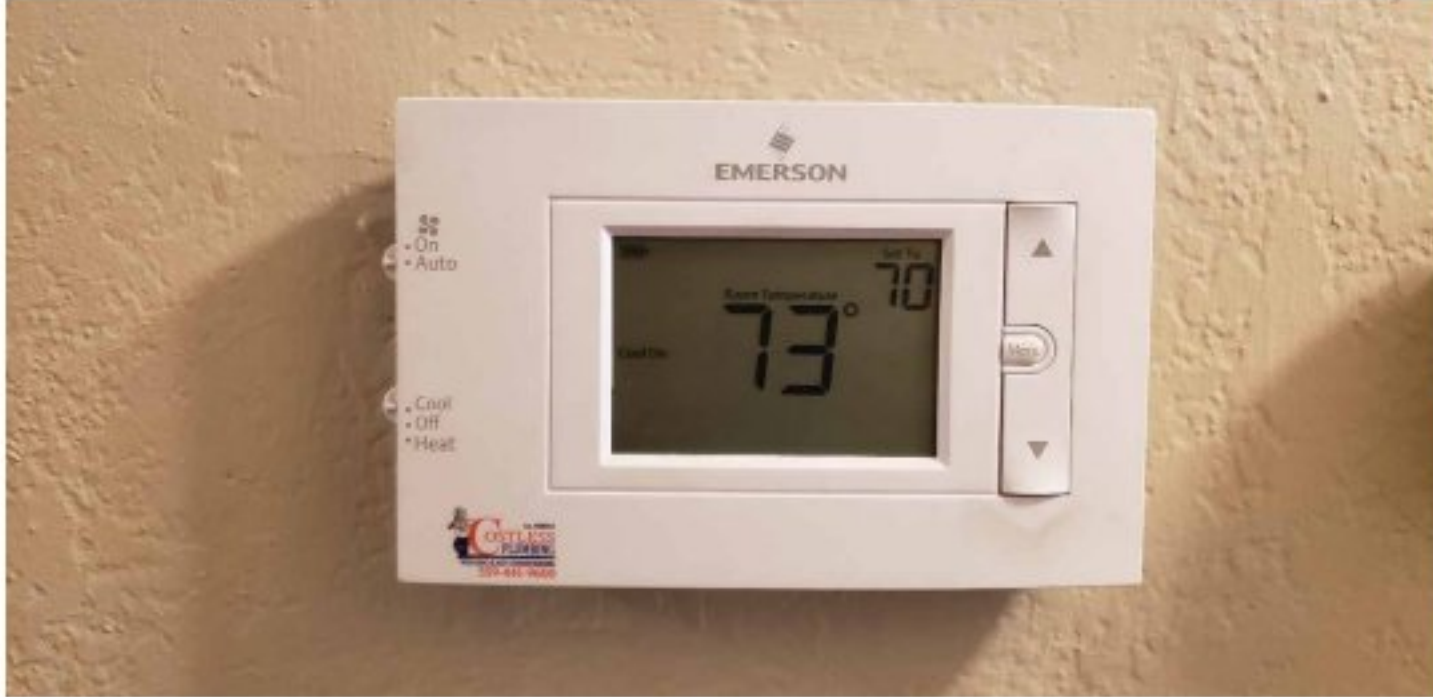
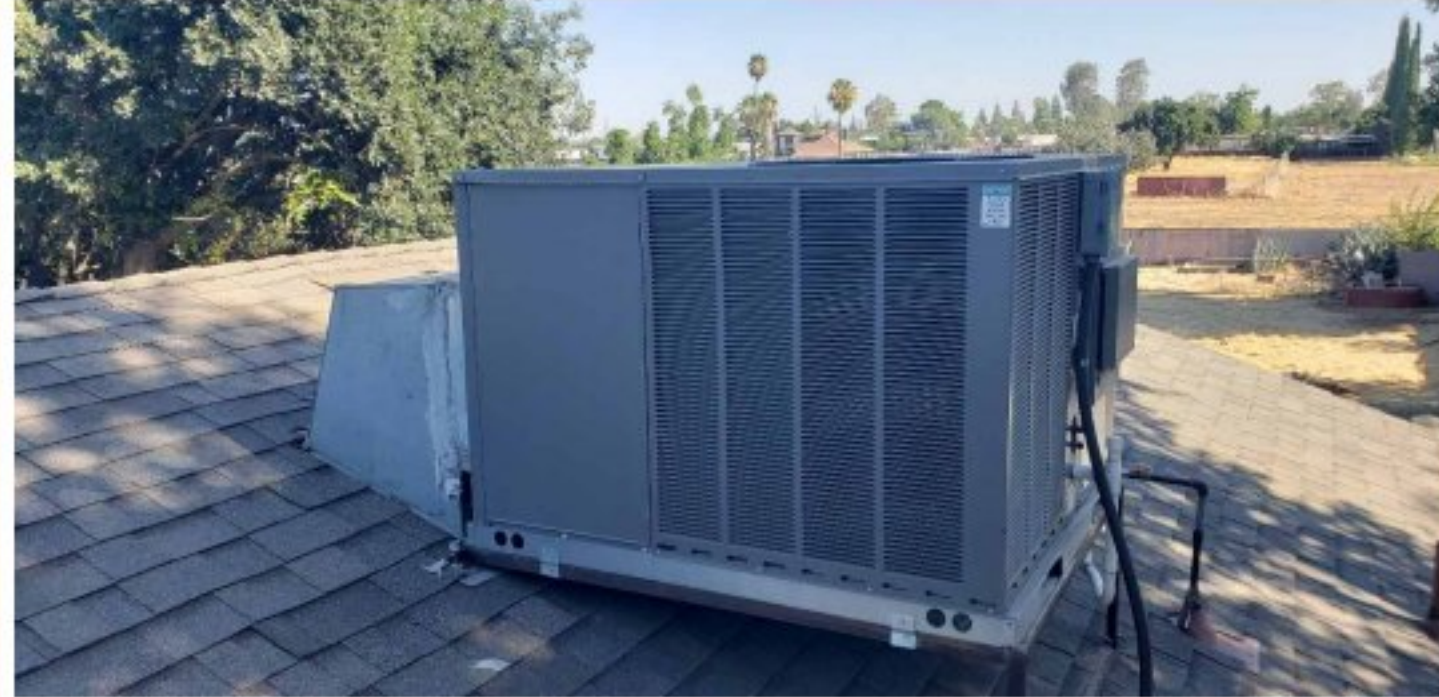
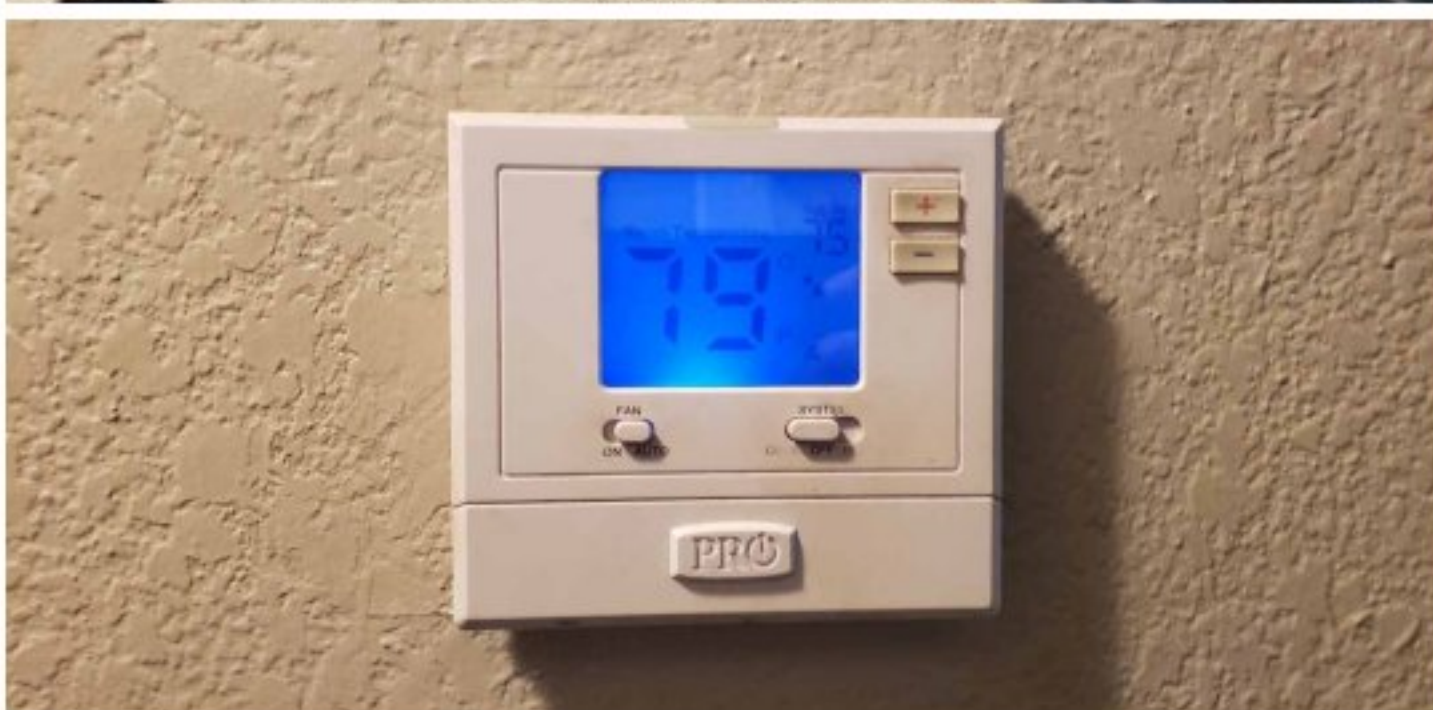
2. **A/C System Operation:** Appears serviceable -  
104, 115, 117: Air coming out of vents was not cooled as expected. Temperature differential did not reach the desired -18 to -25 degree. Recommend evaluation and repair as needed by qualified HVAC professional.

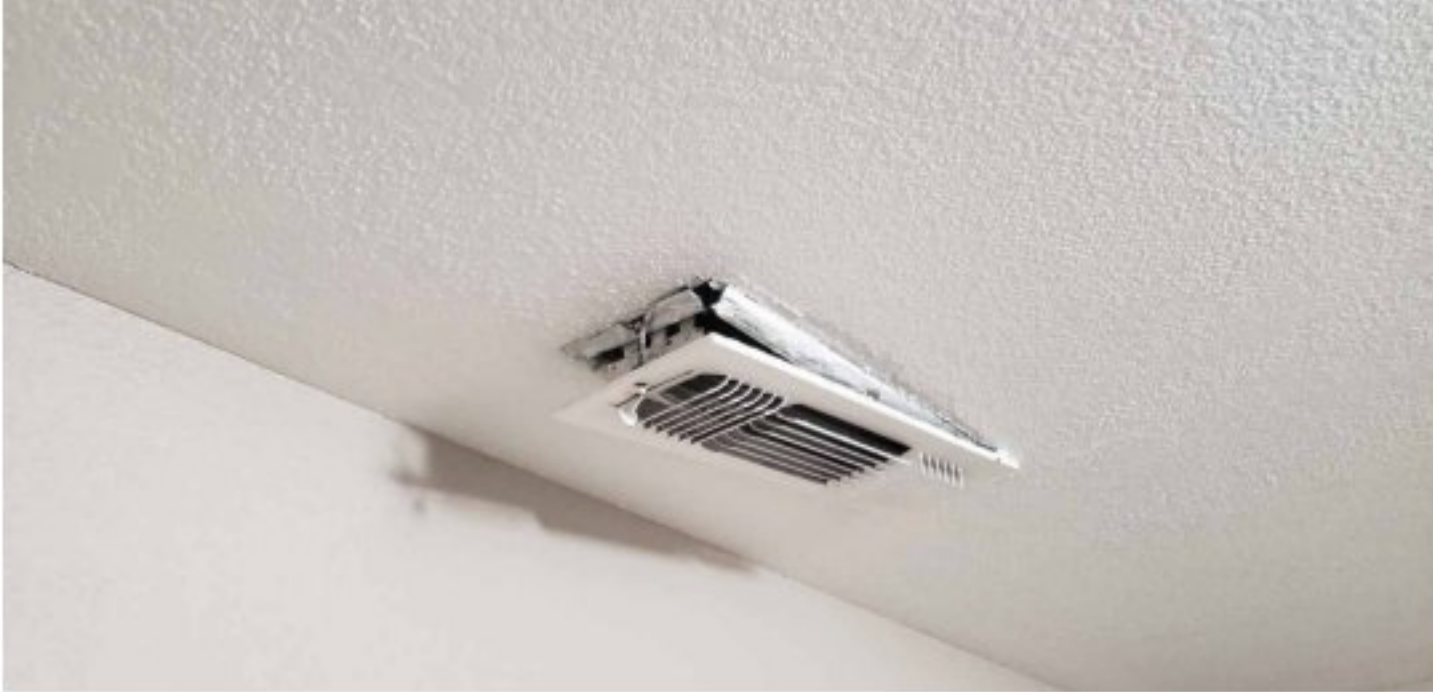
- 6. Distribution:** Insulated ductwork -  
111: AC grille noted to be coming away from the ceiling.

111: AC grille noted to be coming away from the ceiling.

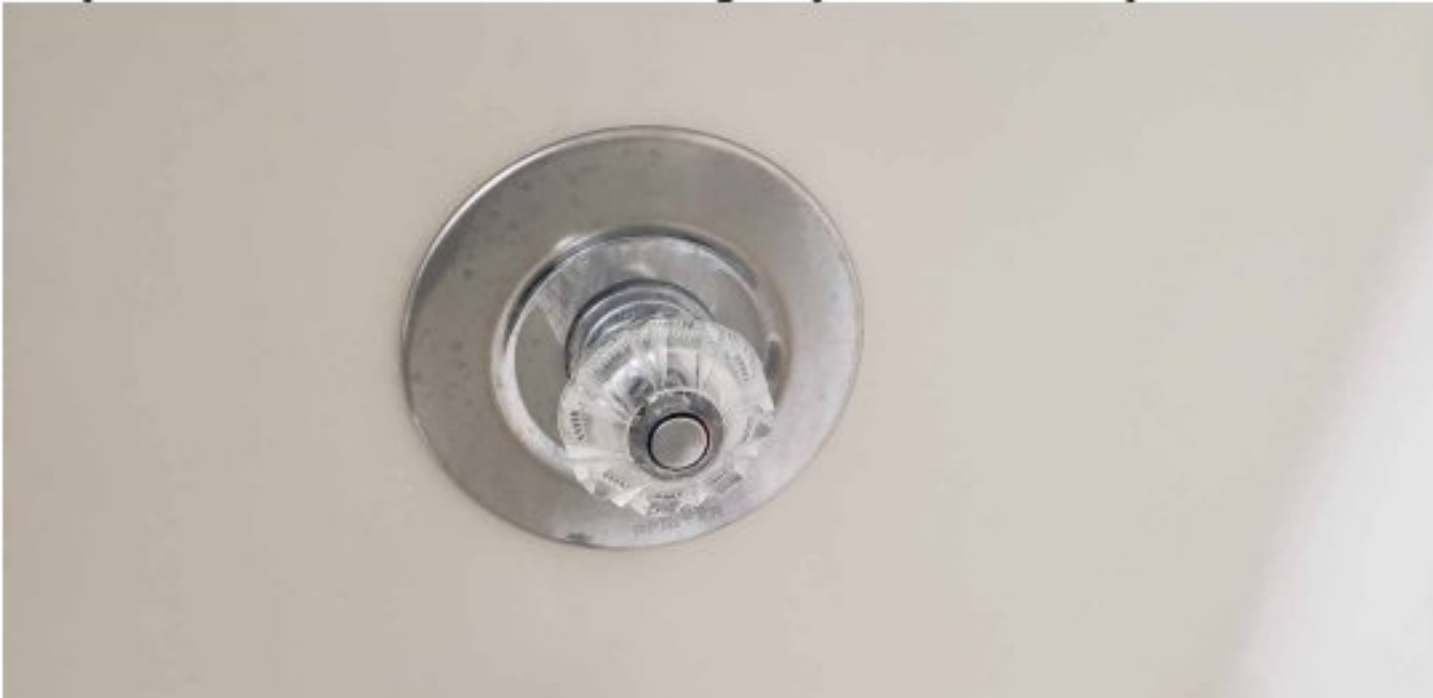
106: Hot/cold water noted to be reversed at tub valve. Recommend evaluation and repair as needed by qualified professional to prevent potential scalding.

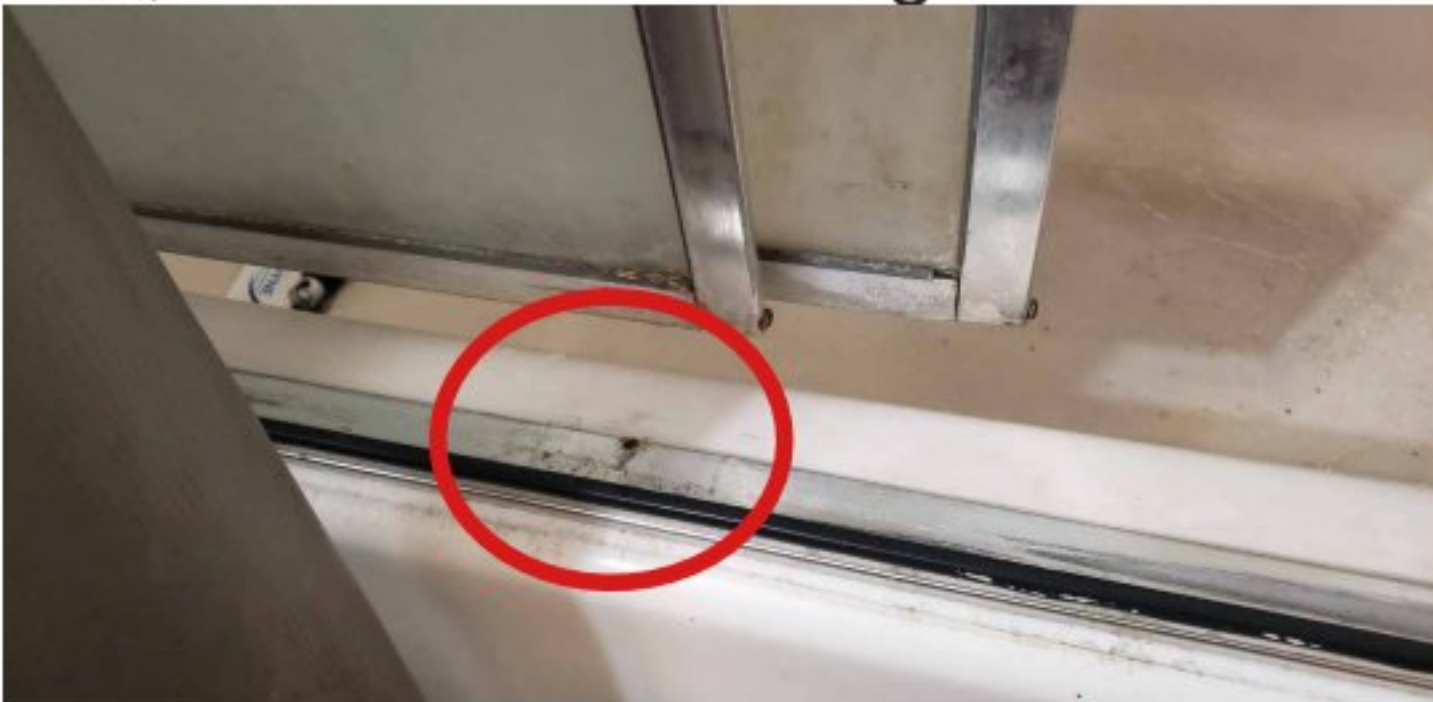
103, 106: Shower door guide noted to be missing allowing doors to swing inward.

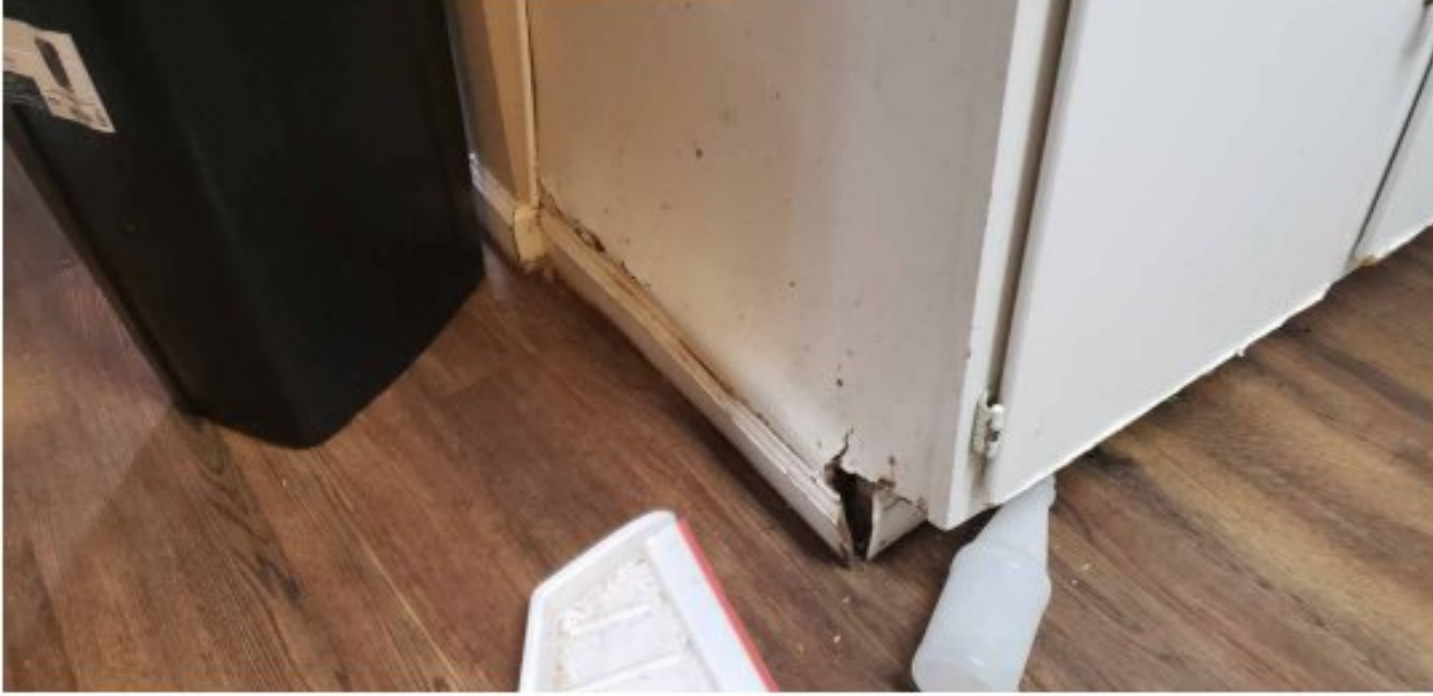
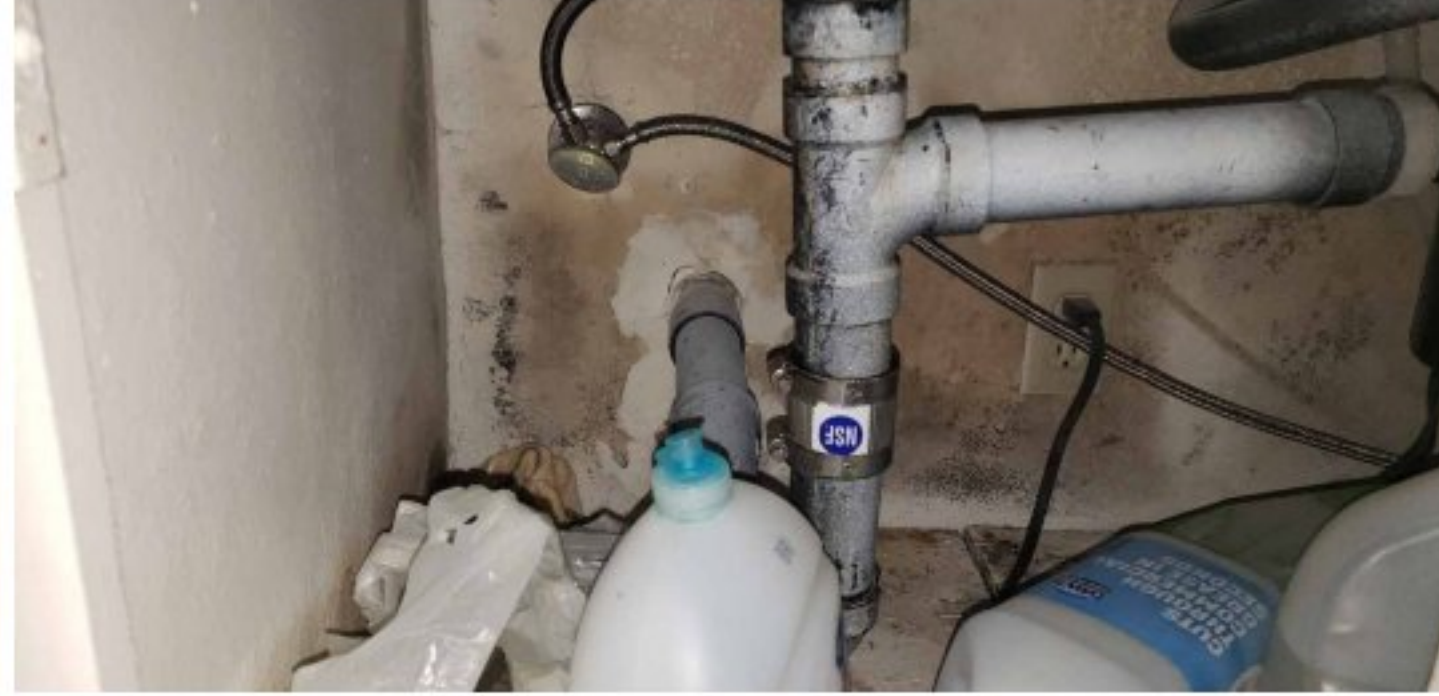
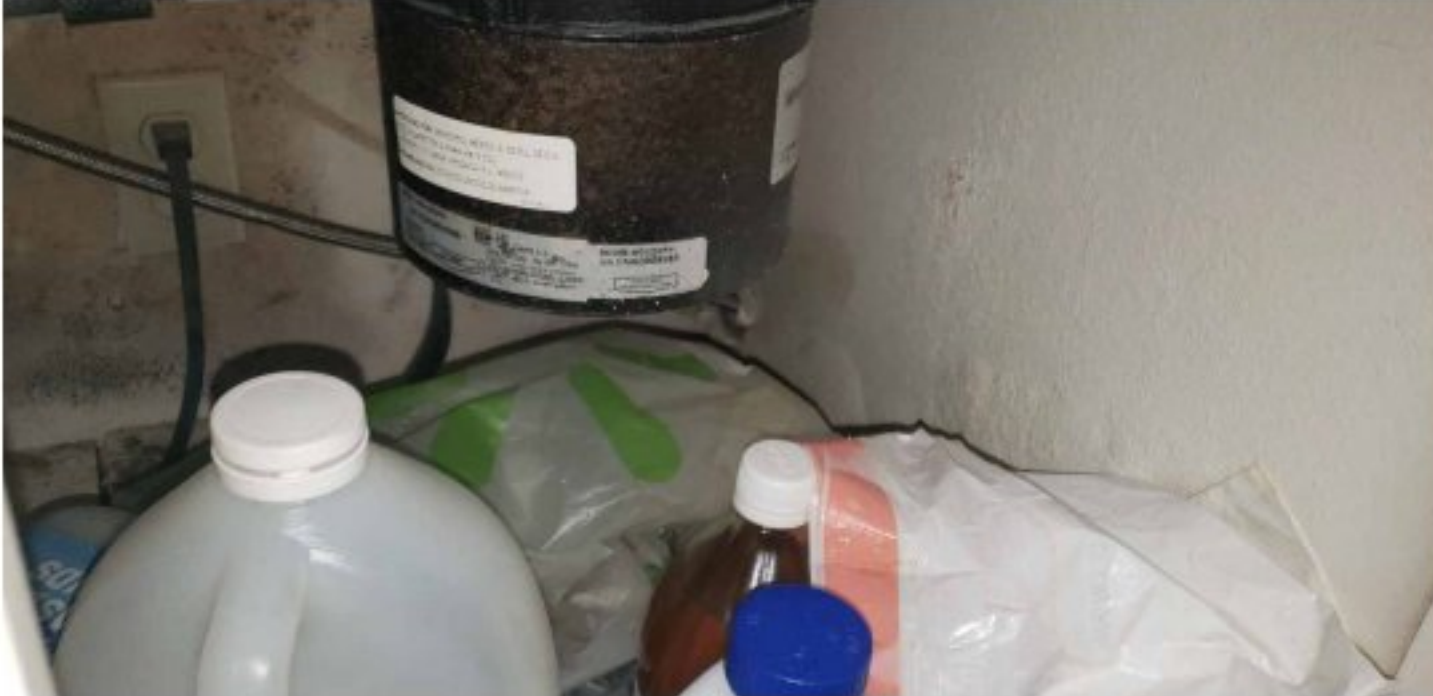
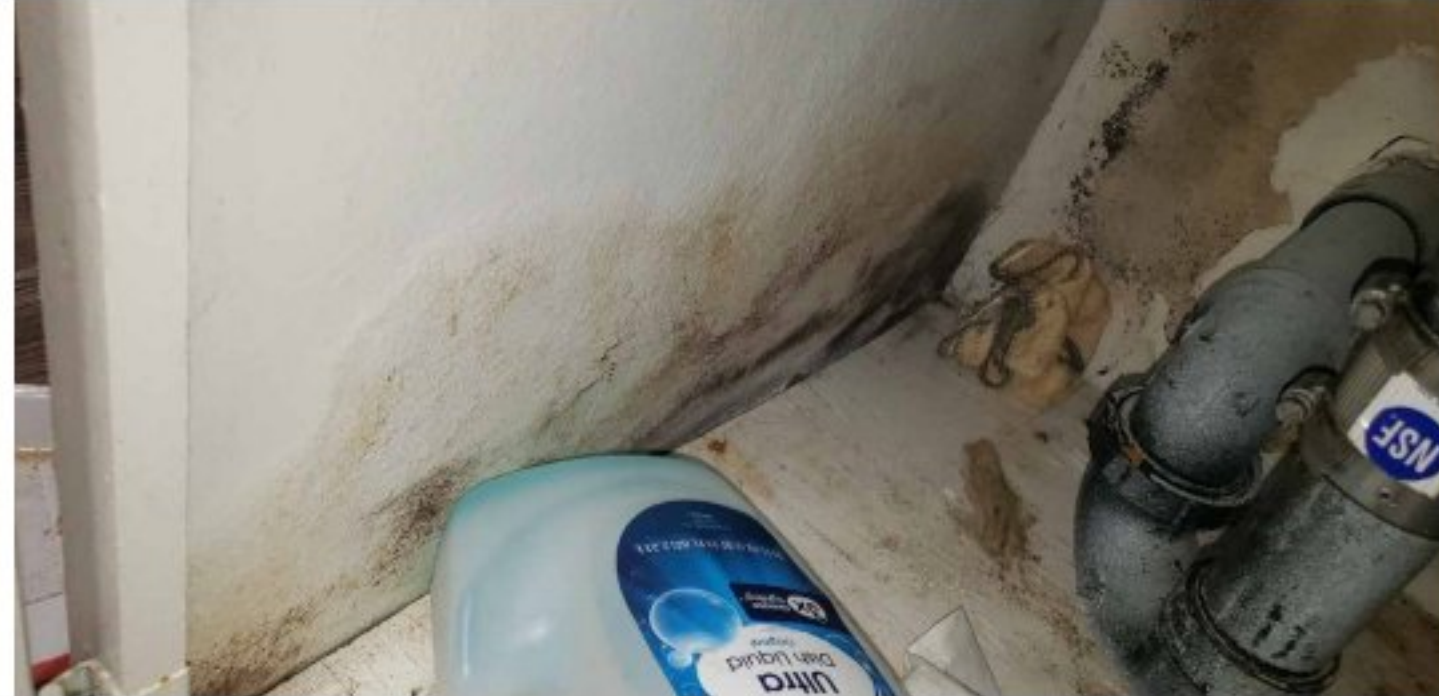
121: Kitchen cabinet noted to be water damaged under kitchen sink. Recommend evaluation and repair as needed by qualified professional.

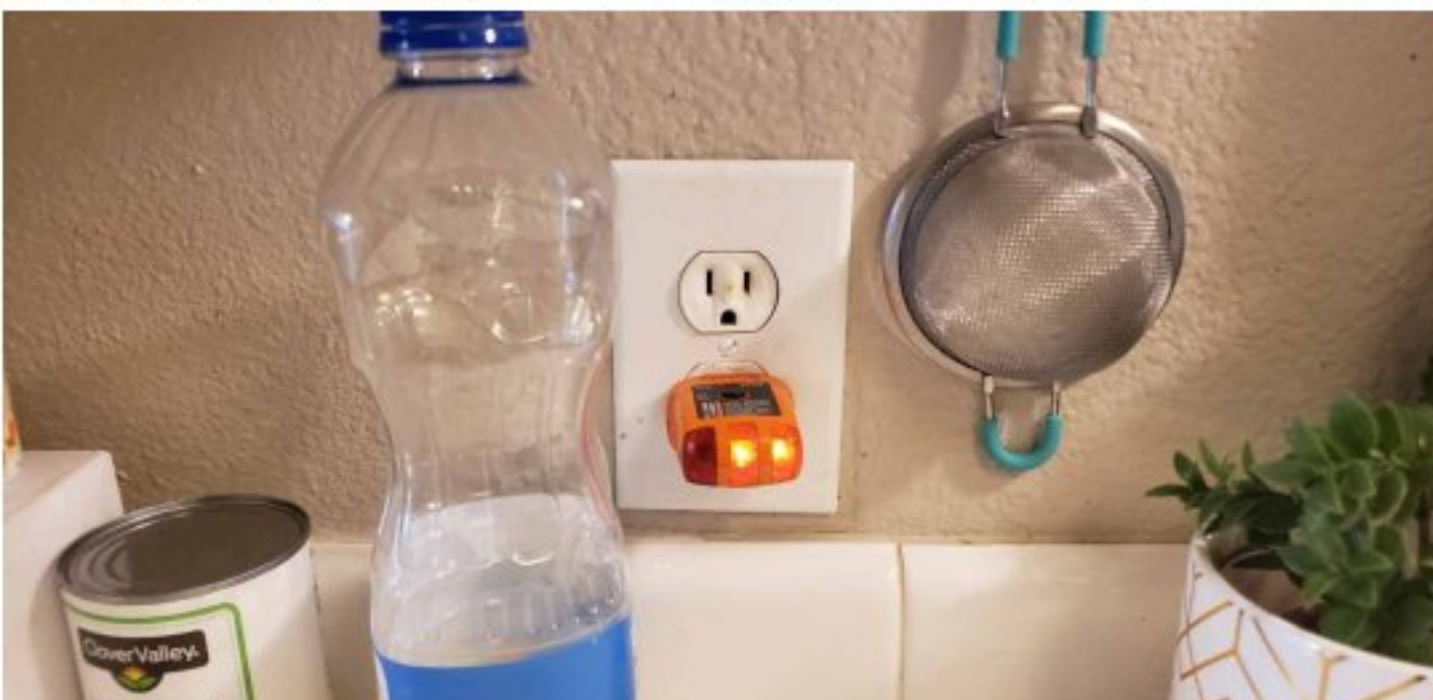
104, 105, 113: Kitchen outlets are recommended to be protected by GFCI outlets. No GFCI protection was detected in kitchen. Recommend evaluation and repair as needed by qualified professional.

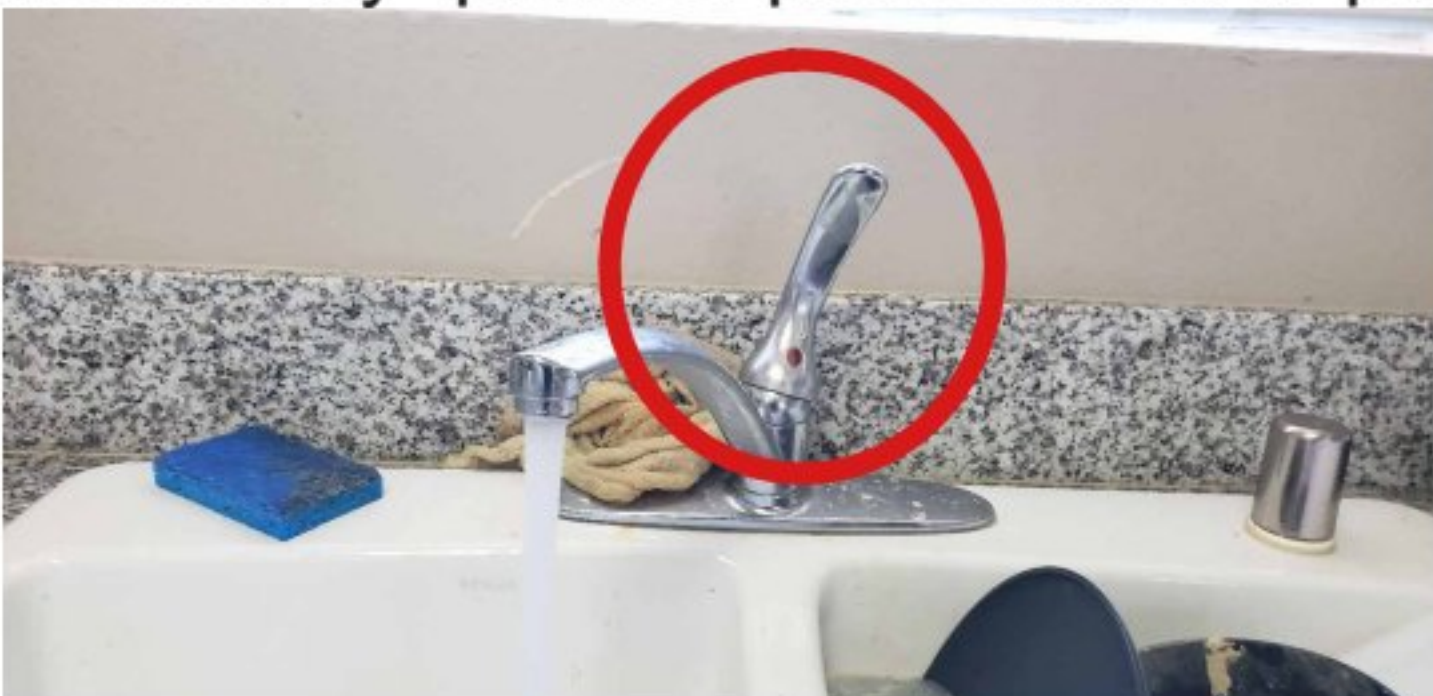
Unit 101: Hot/cold water noted to be reversed. Recommend evaluation and repair as needed by qualified professional to prevent potential scalding.
