Jonathan Bray Home Inspections  
P.O.Box 3971  
Fresno, CA 93650  
jbrayinspections@yahoo.com

# PROPERTY INSPECTION REPORT

Prepared Especially for Jimmy Cannizzaro  
1262 N. Marks Ave., Fresno 93722  
June 23, 2026

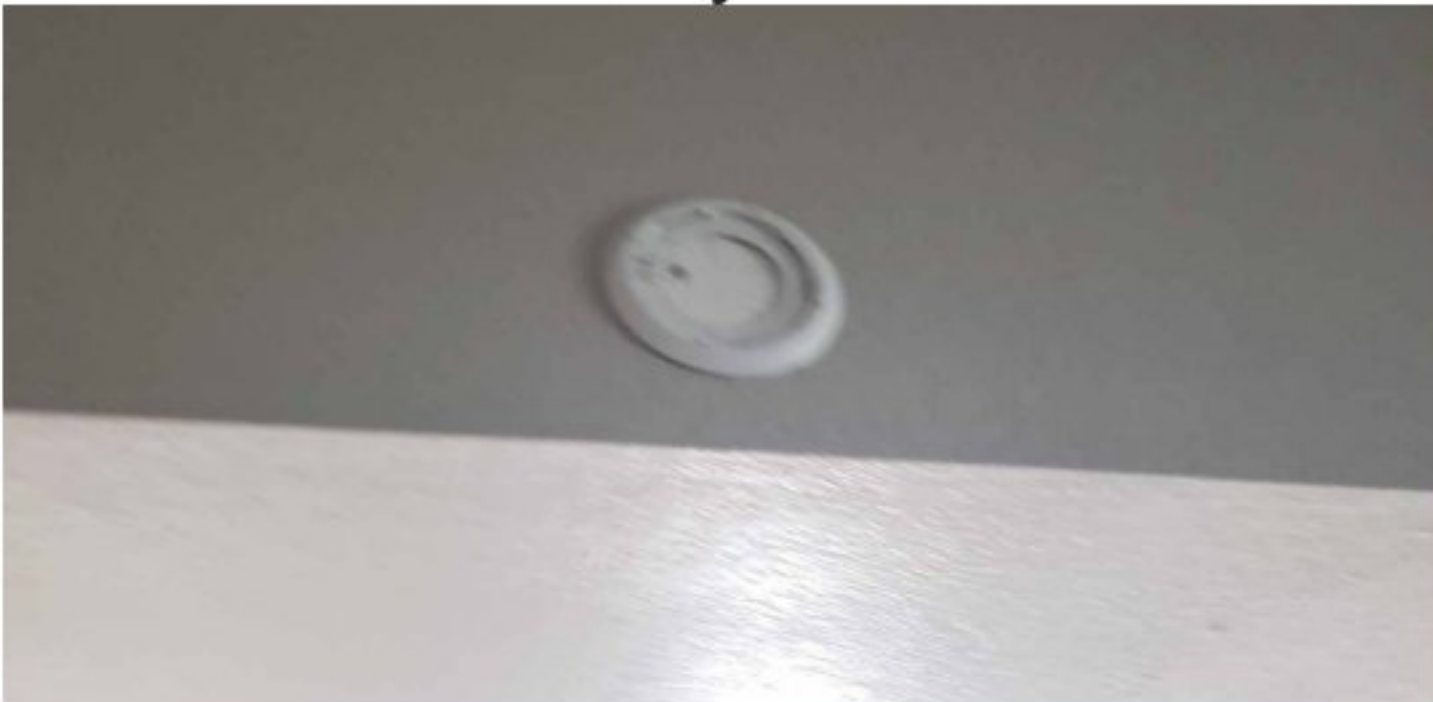
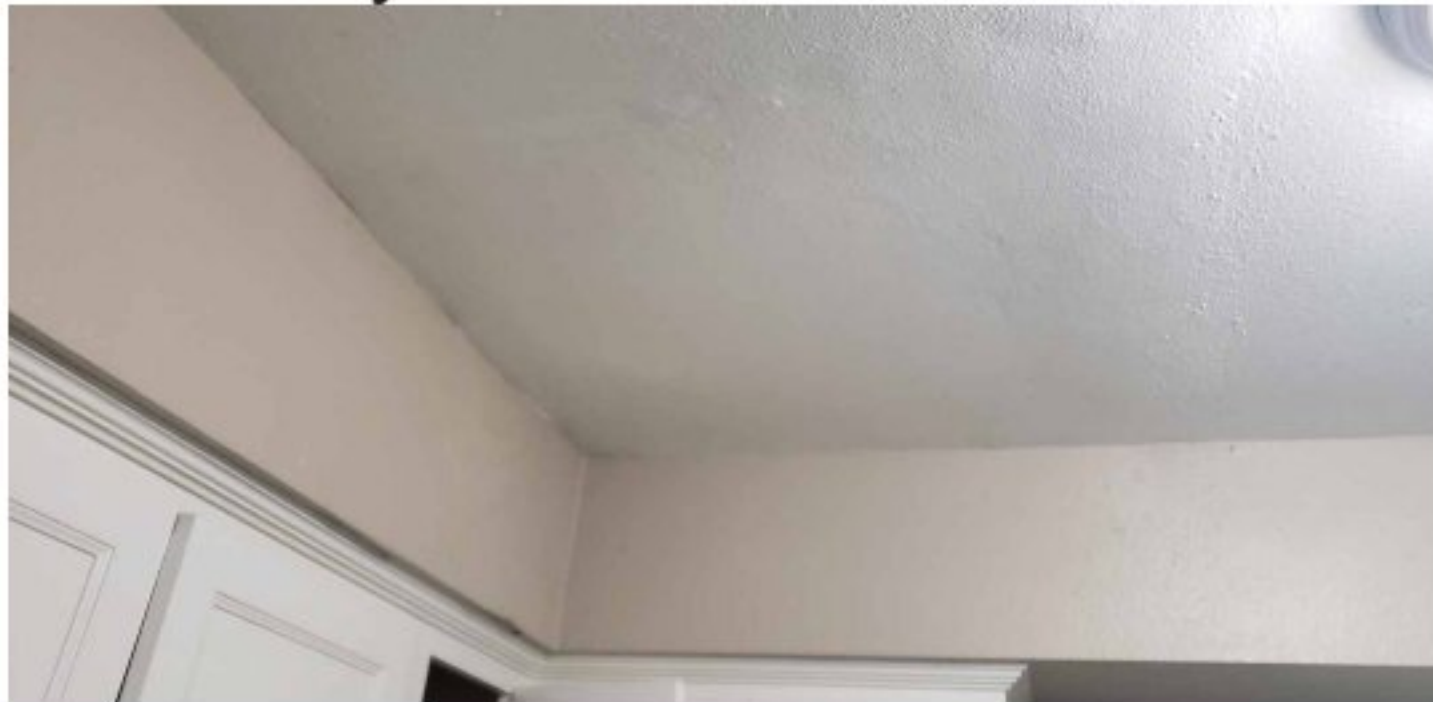
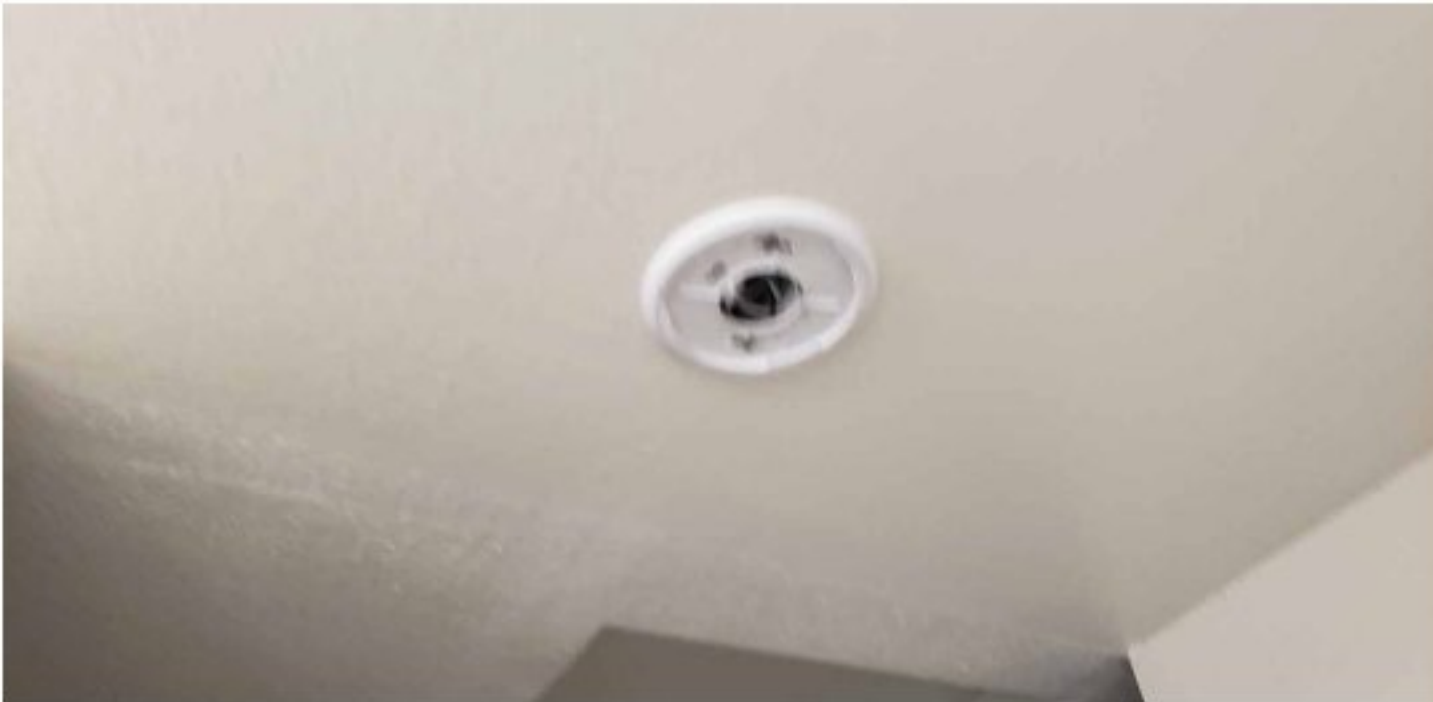
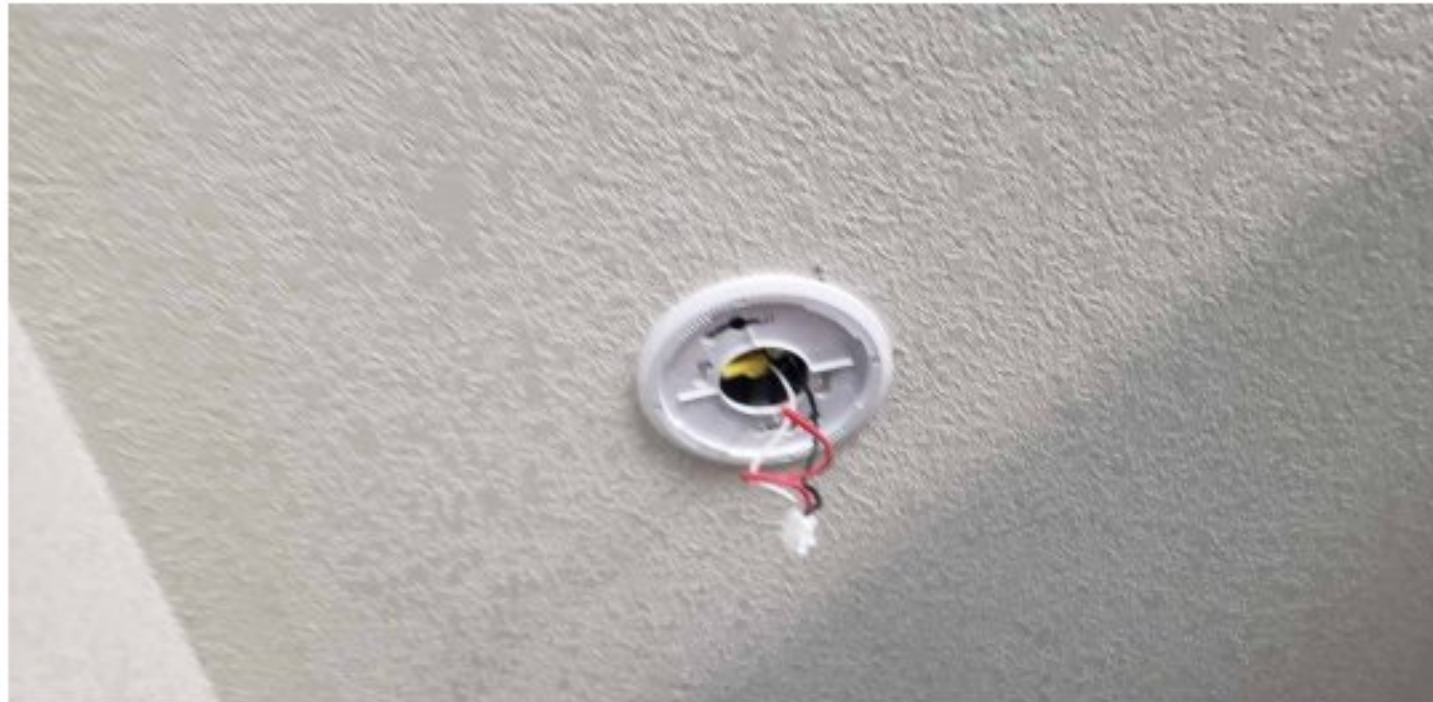
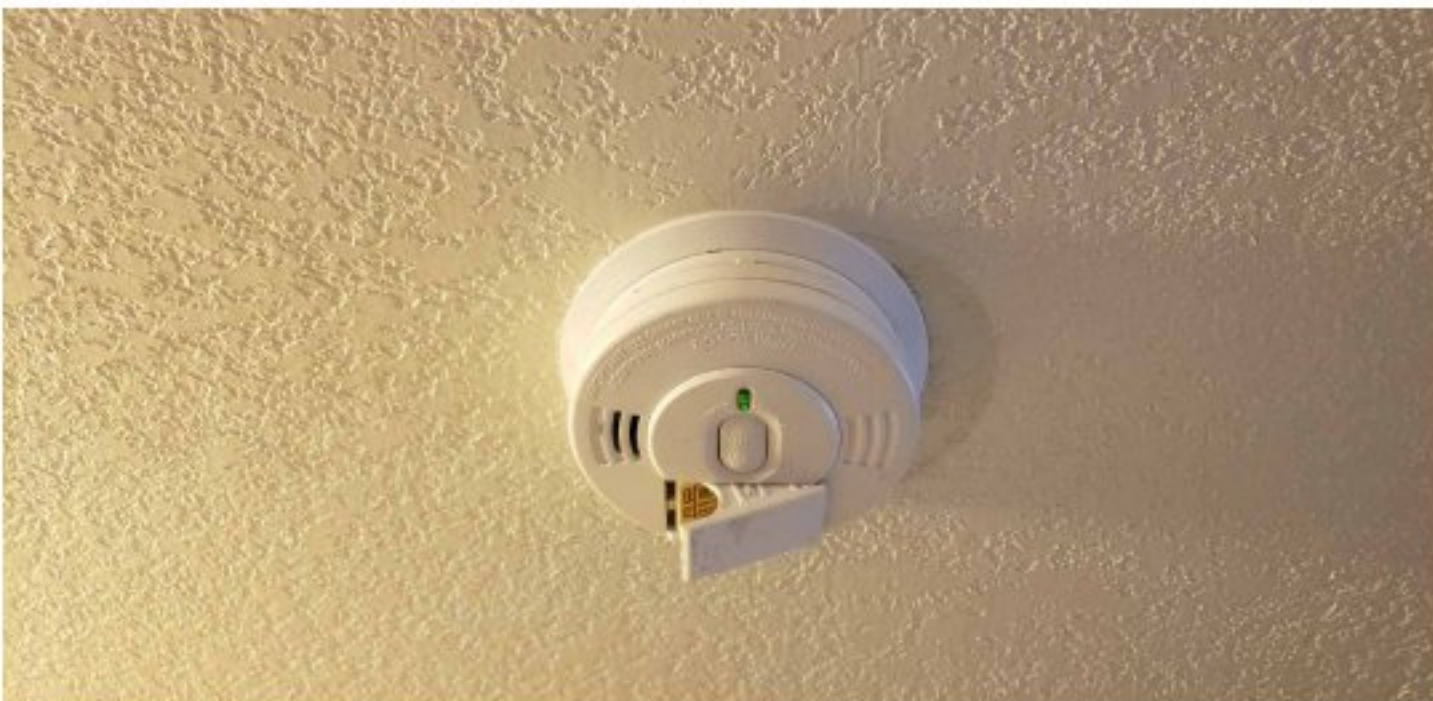
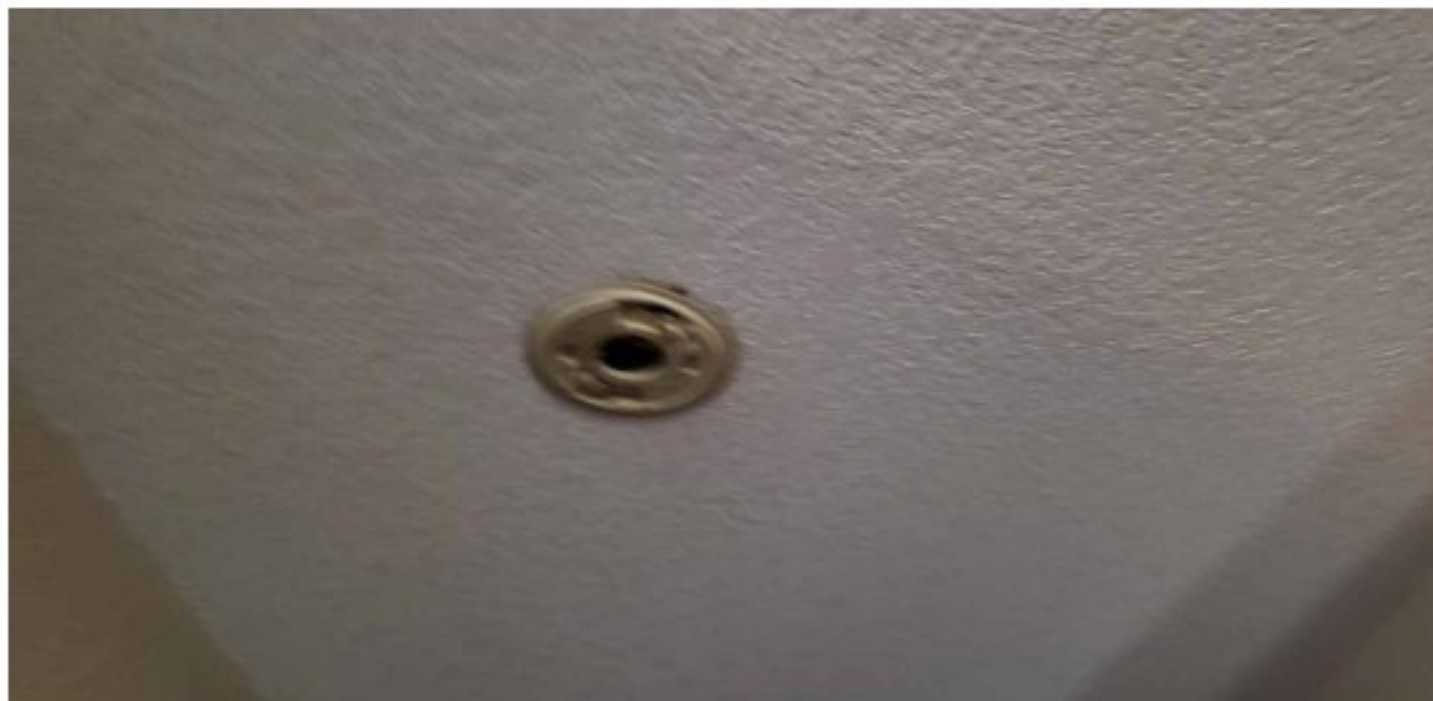
104, 115, 119, 121, 122: Recommend installing and maintaining functional smoke detectors in hallway and each bedroom for safety.

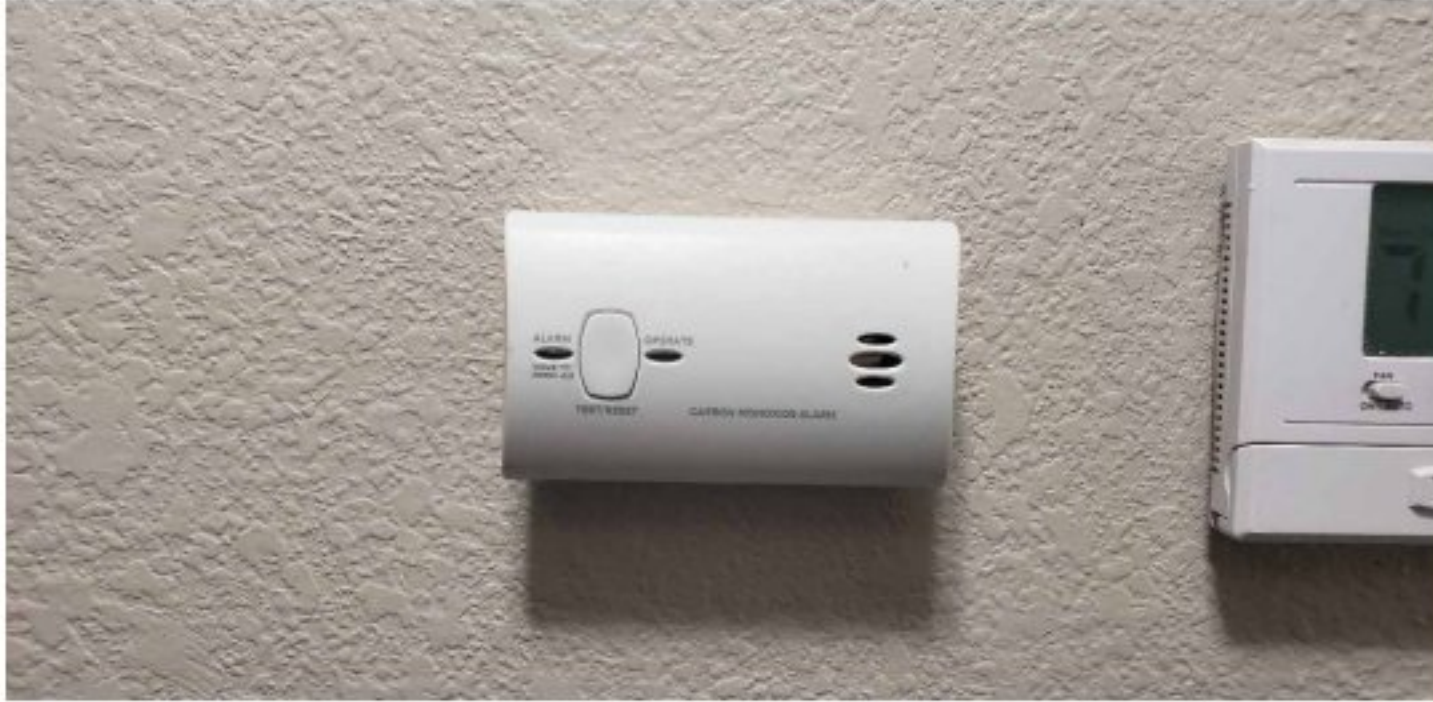
106, 115, 119: CO detector did not work when tested. Recommend evaluation and repair as needed.

107: CO detector noted to be missing.

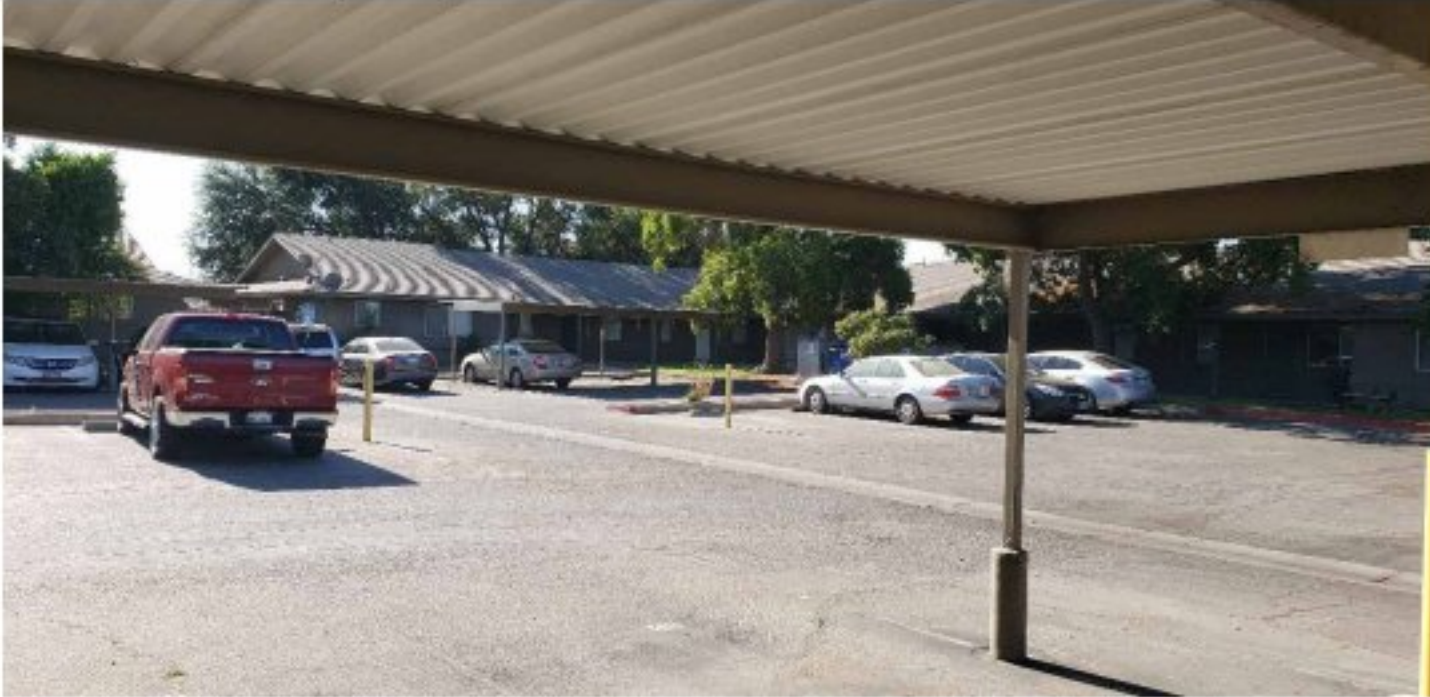
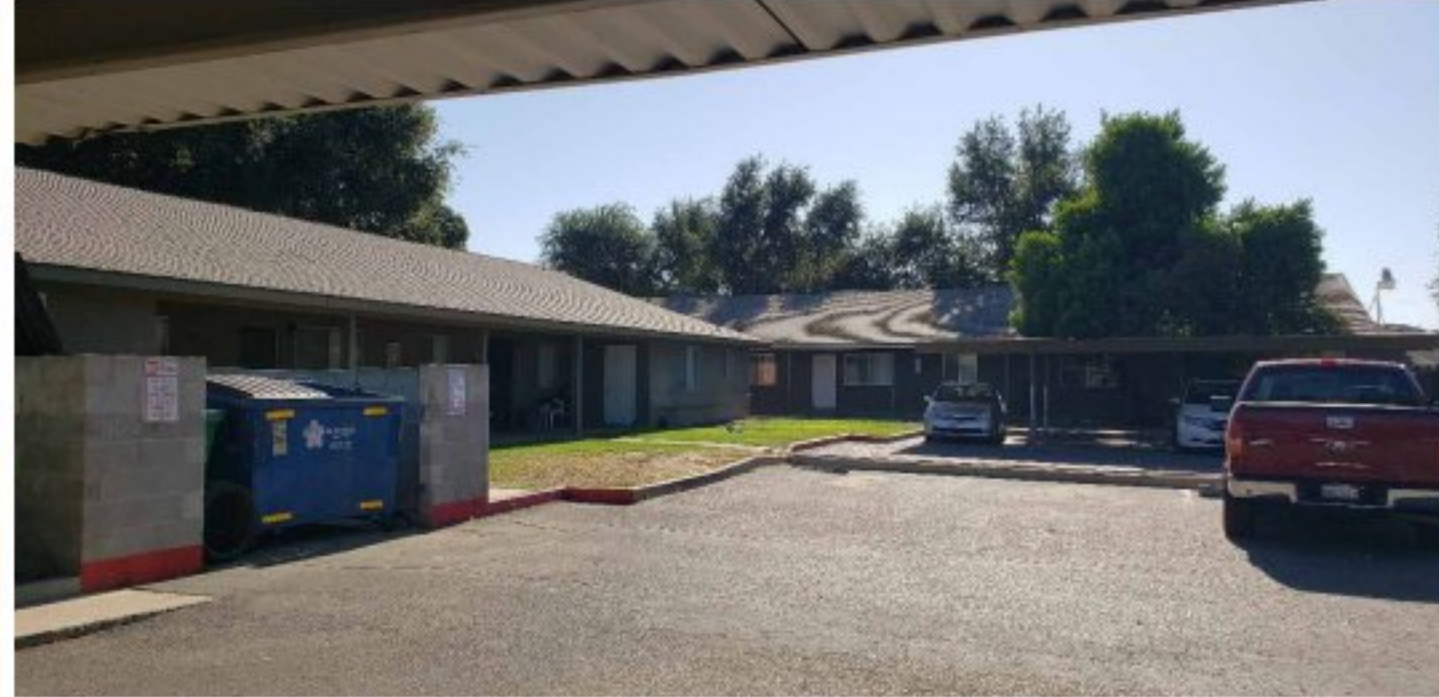
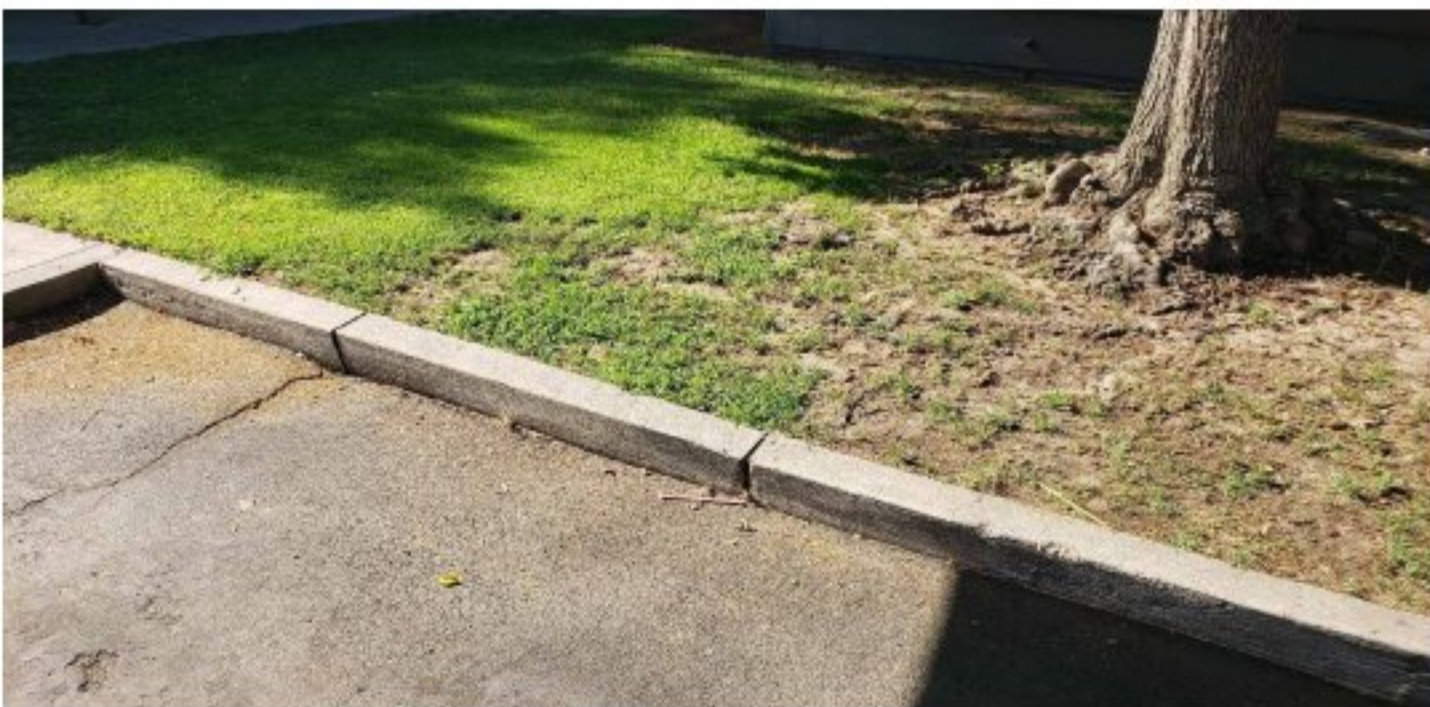
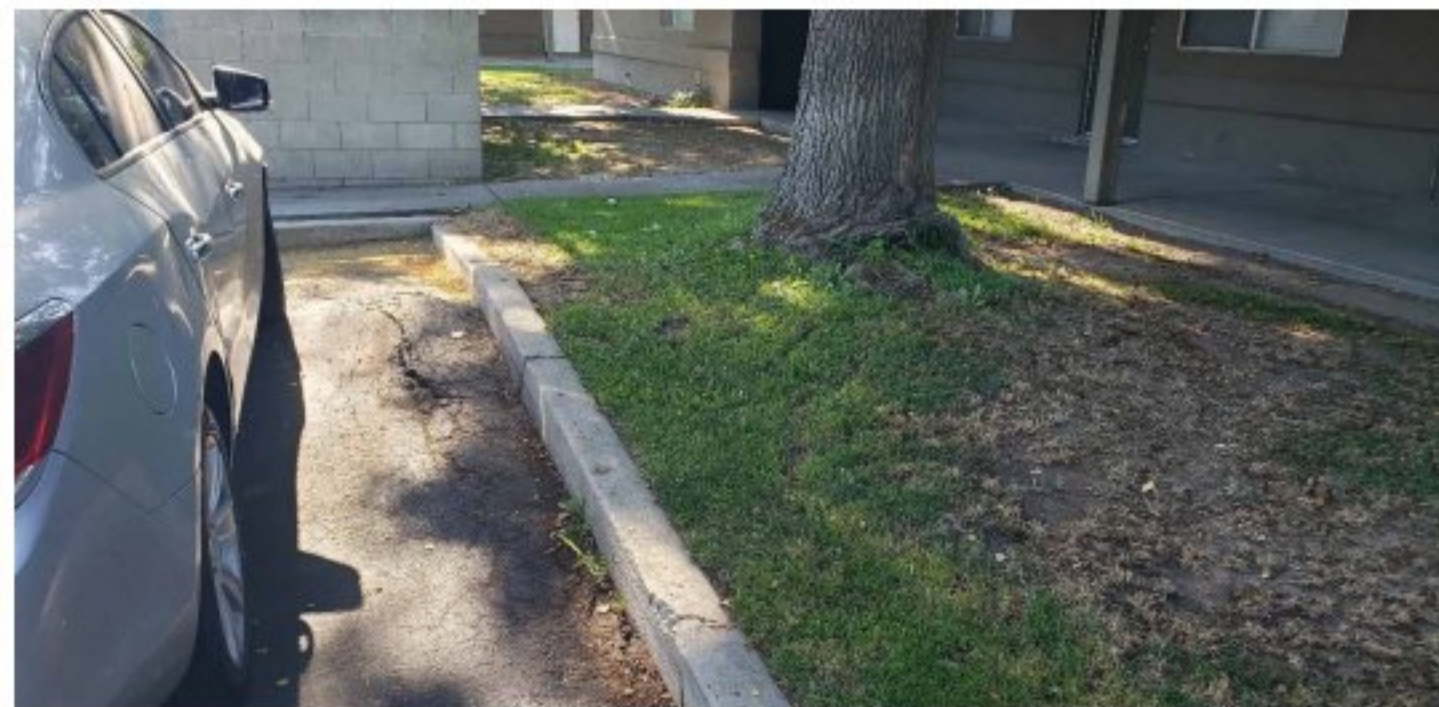
Tree roots noted to be affecting asphalt in a couple locations. Recommend evaluation and repair as needed.
