1 West Regent Street, Glasgow

A Post-Occupancy Evaluation

Final Report

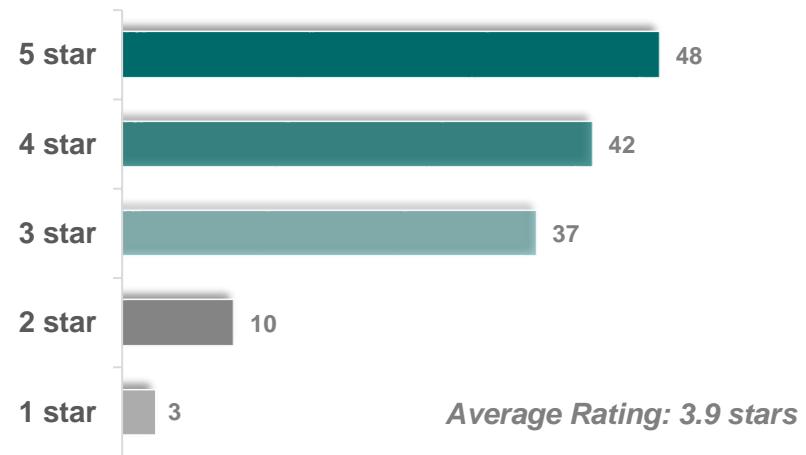
How satisfied are you with the design and layout of the toilets?

The toilets were not rated as favourably. This was due to how they looked in use, as opposed availability. Allowing access to toilets between floors meant that they were in communal areas so fewer toilets needed to be provided. However, this did not appear to have been an issue for tenants. In use it was found that the taps splash out of the sink and on to the black Corian surface too easily, and this left prominent watermarks. As a result, some people felt that it regularly looked messy and less than pristine.

In addition, there were some concerns raised about views into the toilets, as the staff noted that they could clearly see out on to adjacent buildings and were worried that people could see them in the toilets.

Average Rating: 3.9 stars

9. Consider whether bathroom fittings could be adapted or replaced to reduce water marks on the Corian surfaces.
10. Review the finishes that are specified, when they are replaced, to determine if something more robust, but in-keeping with the aesthetic, could be selected.

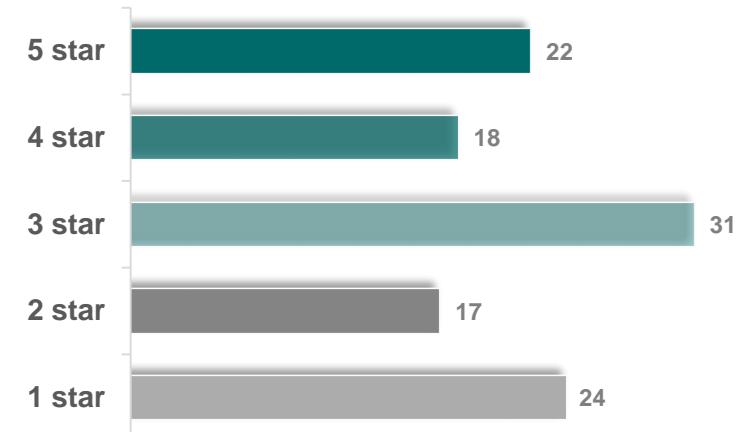
How satisfied are you with provision for parking?

One tenant organisation relied heavily upon cars, as employees spent a lot of time out visiting clients. They had had to take parking spaces in a nearby multi-storey carpark, and found this to be expensive. However, they appreciated that they chose the office knowing that there was limited parking available.

Average Rating: 3.0 stars

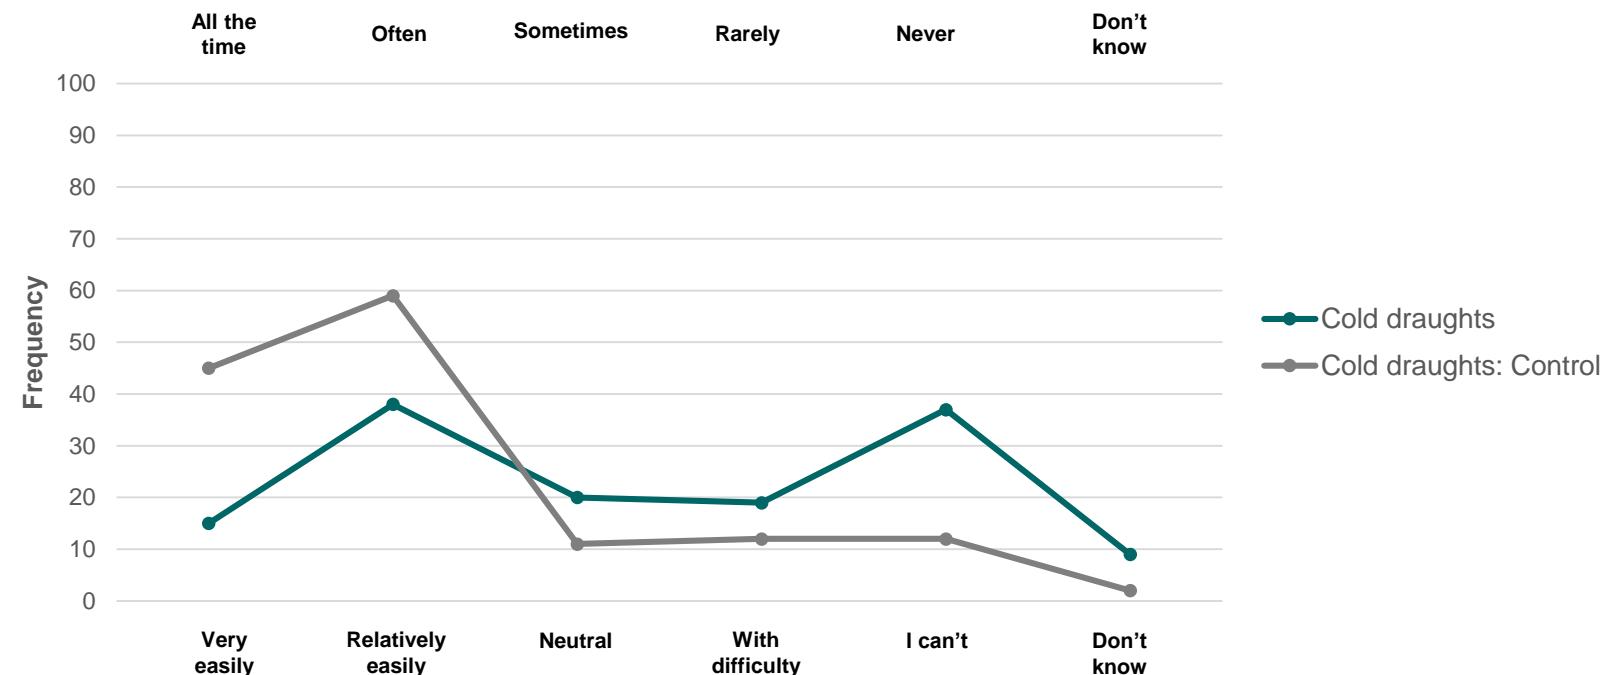
How often do you experience the following in your office?

More consistent was the response on control, with 50% of occupants saying they could not make adjustments, or could only make adjustments with difficulty, to alleviate discomfort from cold draughts. This is demonstrated by the grey line on the graph.

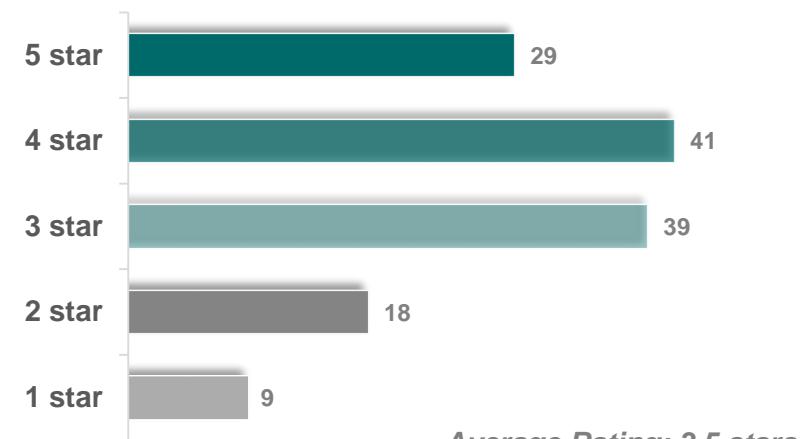
How satisfied are you with the wear and tear of the building?

Tenants reported that some finishes within the building had not worn as well as they would have liked. This includes the finish on the panels inside the lifts and internal door push plates.

The surfaces of lift panels were scratched. One panel in particular was noted to be vandalism, but there were scratches on other panels which were due to people's bags in the lift, etc. Tenants felt that it made the lifts look scruffy and a more durable finish may have been more effective.

Invisible fixings were specified for the internal door push plates. Tenants reported that in a number of locations, these had come loose and appeared warped.

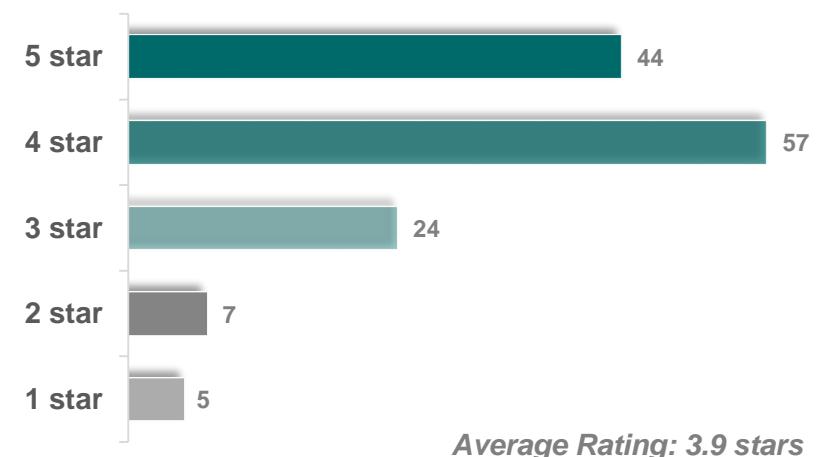
How satisfied are you with the cleanliness of the shared areas of the building?

There were also issues raised in relation to some finishes which showed up dirt or looked unclean with use. For example, stainless steel surfaces in high use areas and Corian surfaces around the toilet washbasins which show up watermarks.

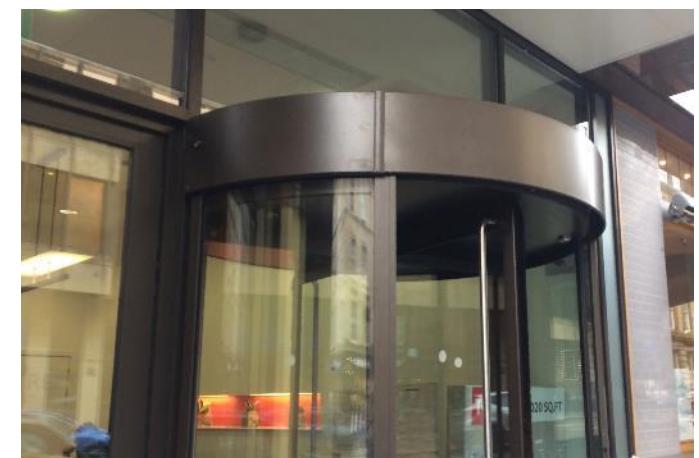
Figure 11 – revolving door in a nearby building, without a glass roof

In contrast, other revolving doors tend to have opaque roofs, so that any water marks or bird droppings on the outer roof are not visible to people entering the building. They also have surfaces which do not highlight marks and dirt so easily (Figure 11).
