235 W. Travis Street | La Grange, Texas | July 09, 2021

**EXISTING CONDITIONS**

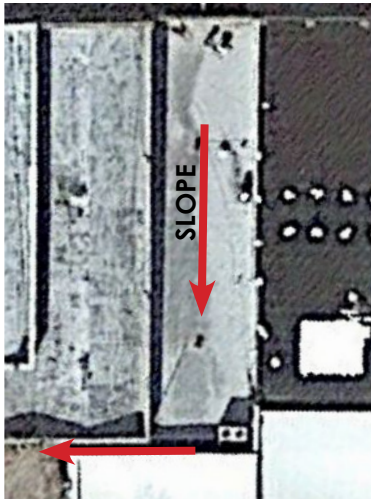
**AERIAL VIEW**

5. **Roof** currently slopes towards the front of the property to the existing collection boxes and downspouts. In the images provided on the following pages, the roof shows deterioration of membrane, which appears to lack adhesion and protection from support elements (parapet cap, drip edge, flashing). (5a)The roof membrane appears not properly installed, facilitating deterioration due to the exposure to wind, water, ultraviolet rays, and debris that could be puncturing the roofing material. (5b)The absence of a wall cap at the facade and back parapet walls increases the possibility for damage due to water infiltration. (5c) There is no flashing at party walls to protect from water. (5d) There appears to be evidence of water ponding in this area. Concerns due to ponding need to be investigated for hidden damage.

**Roof Option 1.** This option is the least invasive and more cost effective. Maintain exterior drainage at front facade, adjusting the location of scuppers and downspouts and eliminating the drain at the center of the building. In this option the new canopy's width needs to be adjusted to allow space for vertical downspouts.

**Roof Option 2.** The owner has expressed an interest in the roof draining to the alley. This option might not be cost effective, further investigation of existing conditions and evaluation of other options is necessary. Redirecting water toward the south will require the design and installation of a new roof drainage system. This will require the reconfiguration of the entire roof slope, connection to collection box, horizontal and vertical downspouts to the ground level at the rear of the property. In order to change the roof slope, it is recommended to carefully install tapered insulation with membrane on top, altering slope of building from front to the back without adding additional roof framing. A new roof membrane would be placed on top of tapered insulation per manufacturers recommendations and roofing best practices. (Red arrows) Existing gaps between buildings at south end of the property suggest a possibility for horizontal downspout. It would require an agreement with adjacent property owners and approval from the city to drain the water this way. It is **not** recommended to build a new roof on top of existing in order to change the slope towards the back.

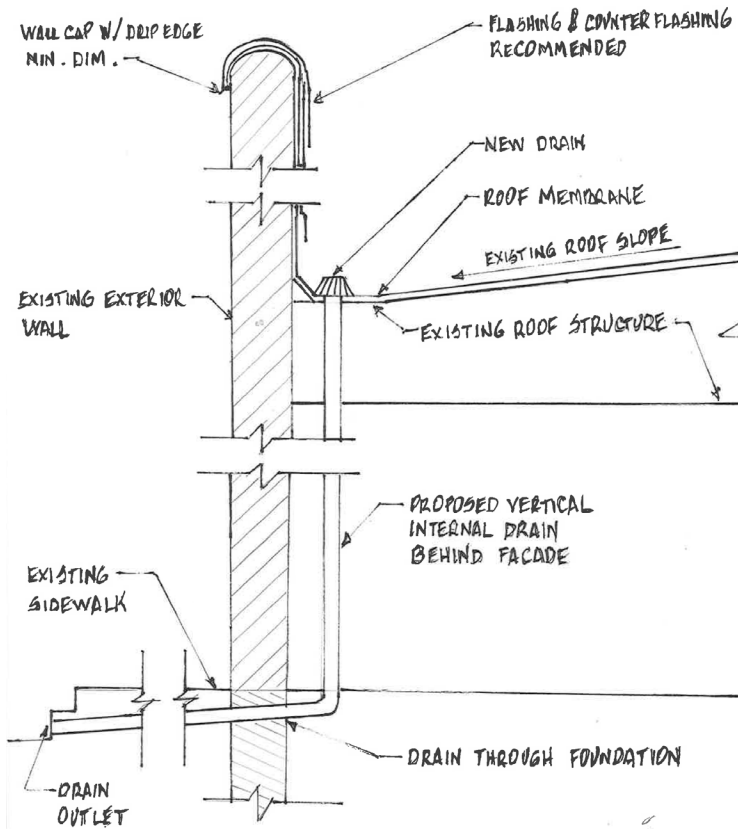
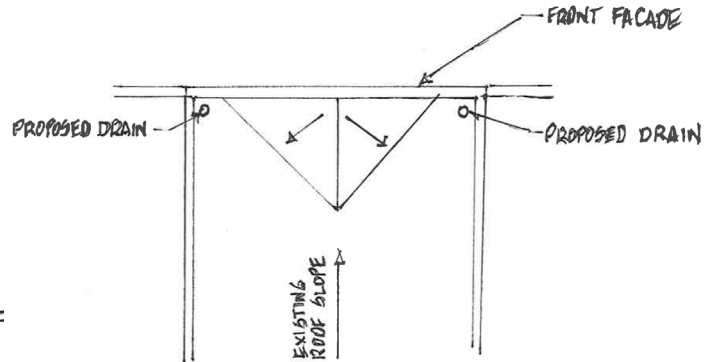
**SECTION DETAIL**

**Roof Option 3.** This option is likely the most invasive and expensive. (Yellow arrows) At corners of the property behind walls suggest the possibility of internal drainage that would include a drain pipe at interior of space (not inside facade wall), passing through the floor, foundation underground and continuing under the sidewalk to the storm sewer (or daylighting at the curb and gutter). Existing conditions should be reviewed with contractor prior to any work to determine best option available. Refer to: [Preservation Brief #4 "Roofing for Historic Buildings"](#)
