Geologic Reconnaissance Study
Preliminary Geotechnical Evaluation,
Proposed Development
Lake View Condominium Development
Silver Creek
Grand County, Colorado

Job Number 99-1123

**Preliminary Geotechnical Evaluation
Geologic Hazards Study
Proposed Lakeview Condominium Development
Grand County, CO**

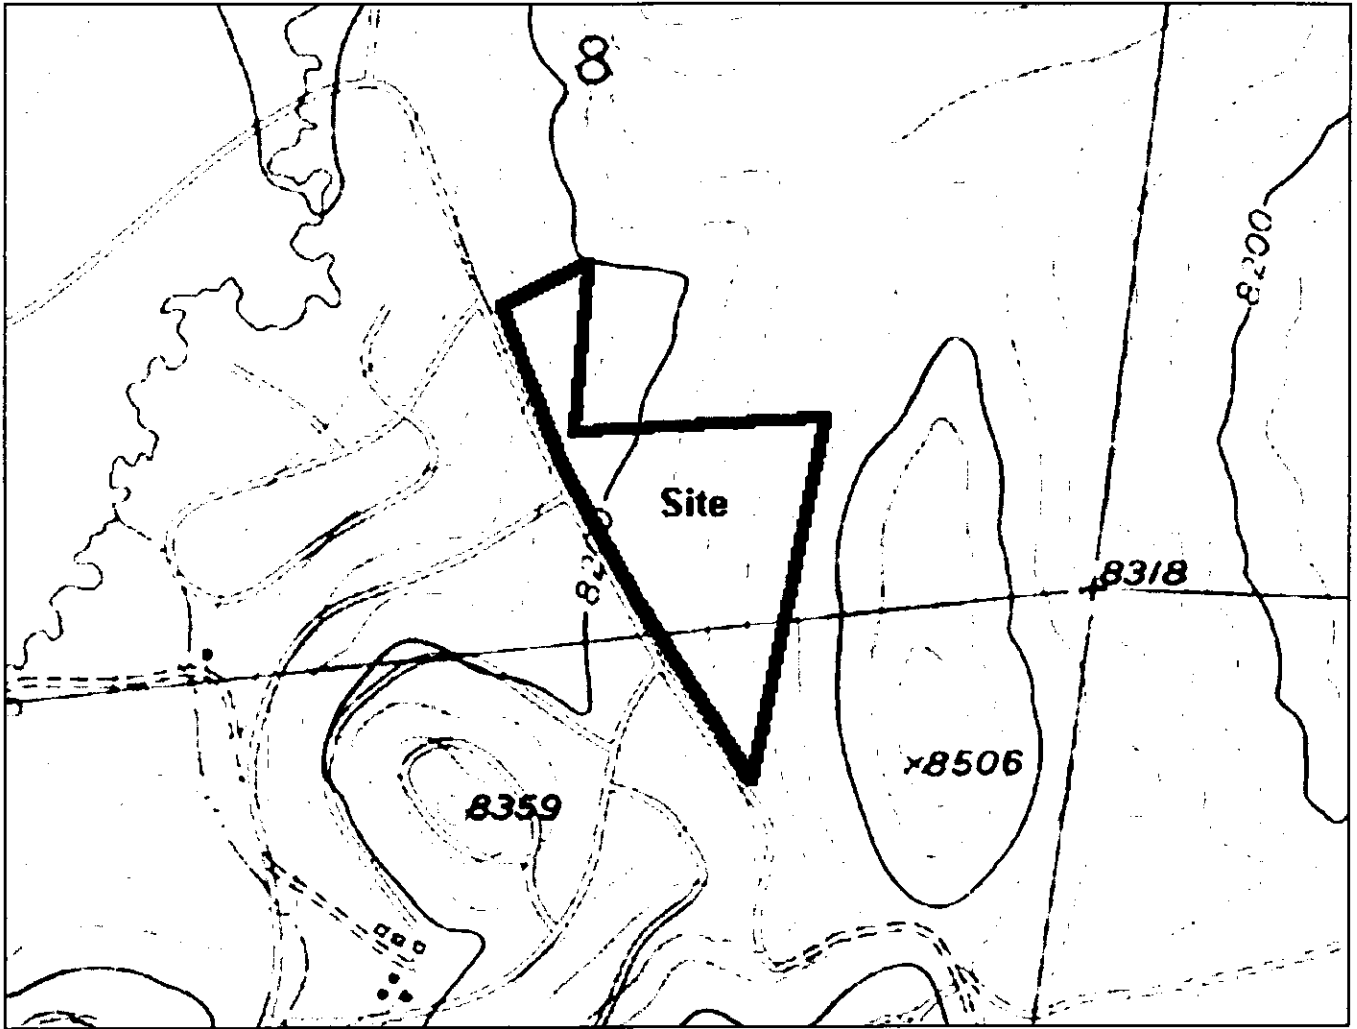
GROUND ENGINEERING CONSULTANTS	
SITE VICINITY MAP	
JOB NO. 99-1123	DRAWN BY: HB
FIGURE: 1	APPROVED BY: JN
CADFILE NAME: 1123SITE1.DWG

From the Topographic Map of
 Granby Quadrangle, Grand County,
 Colorado, USGS Revised 1978

This report presents the results of a preliminary geologic reconnaissance and geotechnical evaluation for the proposed Lake View Condominium Project located in Grand County, Colorado. The project area is shown in Figure 1.

The project area is typically vegetated with typical alpine grasses and sage. Colluvial material was observed on the surface of most of the site area, and contained cobbles and boulders of Dakota Sandstone. A site vicinity map is shown in Figure 1.

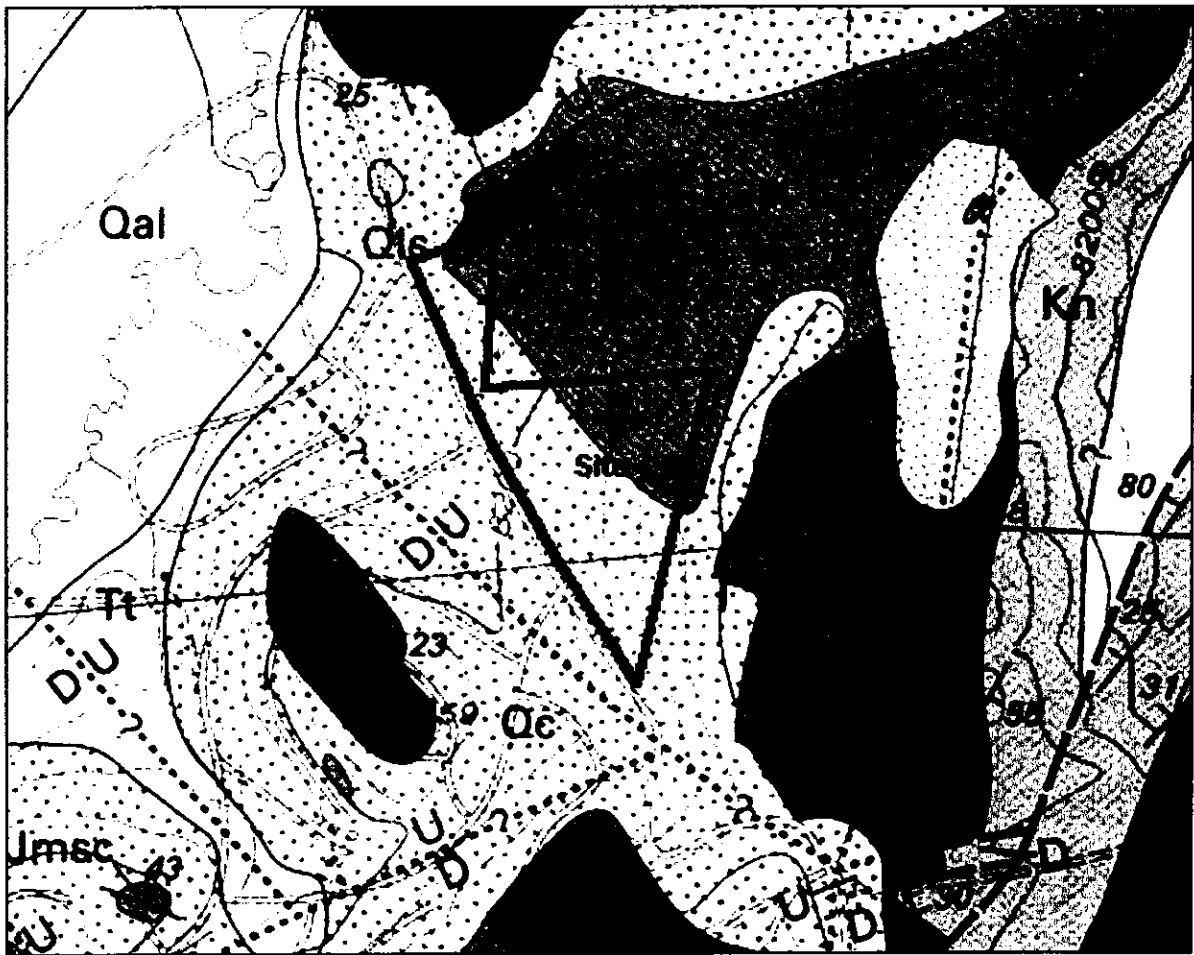
GROUND ENGINEERING CONSULTANTS	
SITE GEOLOGIC MAP	
JOB NO. 99-1123	DRAWN BY: HN
FIGURE: 2	APPROVED BY: JN
CADFILE NAME: 1123SITE2.DWG

Qls Holocene and late Pleistocene Landslide Deposit - Jumbled material commonly composed of Troublesome Formation, Benton Shale, Pierre Shale or Morrison Formation with respective superjacent units.

From the Geologic map of the Granby Quadrangle
Grand County, Colorado USGS-GQ-1763

The site is situated on the western flank of the Front Range of the Rocky Mountains just south of the North Park Basin. The underlying bedrock in the site area is the Jurassic Age Morrison Formation (Schroeder 1995). This Mesozoic sedimentary unit, along with others is located in an uplifted horst block environment as a result of Larimide Age mountain building events. Subsequent folding of the bedrock resulted in the occurrence of a northward plunging to almost level anticline structure mapped as the Ten Mile Anticline. The bedrock underlying the site in the east portion of the site is located along the axis of the anticline with no apparent dipping of beds noticeable in the test pits. The west portion of the site is located in the west leg of the anticline, with poorly defined apparent bedding dip angles of up to approximately 20 degrees to the west observed in the test pits. Subsequent erosional processes have shaped the topography seen today. A geologic site map is shown in Figure 2.

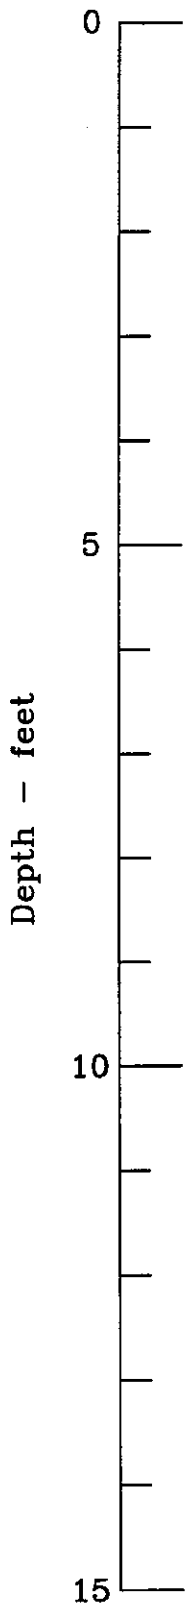
GROUND ENGINEERING CONSULTANTS	
LOGS OF TEST HOLES	
JOB NO. 99-1123	DRAWN BY: HN
FIGURE: 4	APPROVED BY: JN
CADFILE NAME: 1123LOG1.DWG

Test Hole
3

Test Hole
4

The soil samples obtained from the investigation were examined and classified in the laboratory by the project engineer. The graphic logs of the test holes are shown on Figures 4 through 6 with an explanatory legend and notes on Figure 7.

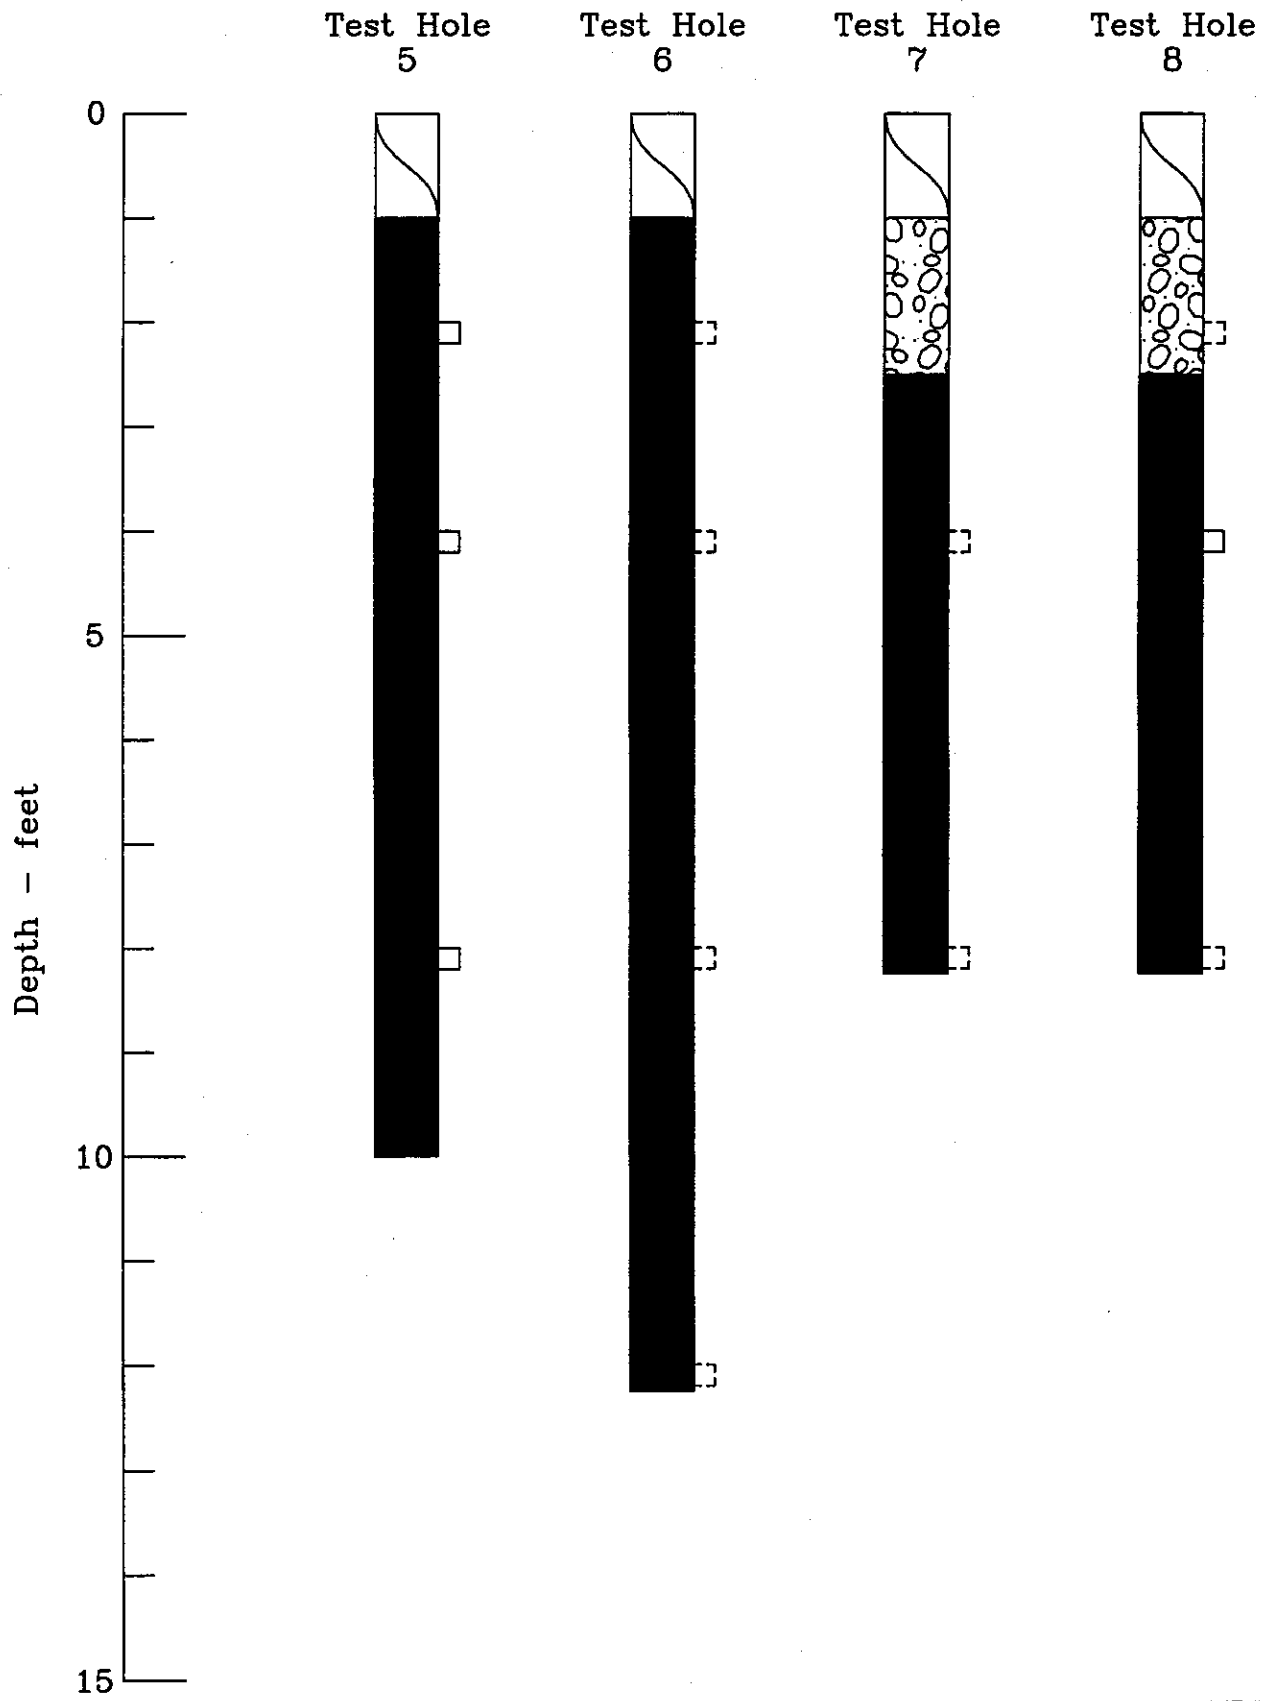
GROUND ENGINEERING CONSULTANTS	
LOGS OF TEST HOLES	
JOB NO.99-1123	DRAWN BY: HN
FIGURE:5	APPROVED BY: JN
CADFILE NAME: 1123LOG2.DWG

Test Hole
9

Test Hole
11

Test Hole
12
